**Architectural Conservancy of Ontario
Advisory Board
Appraisal of the 1905 Pumphouse, Waterworks Park,
Grimsby, Ontario**

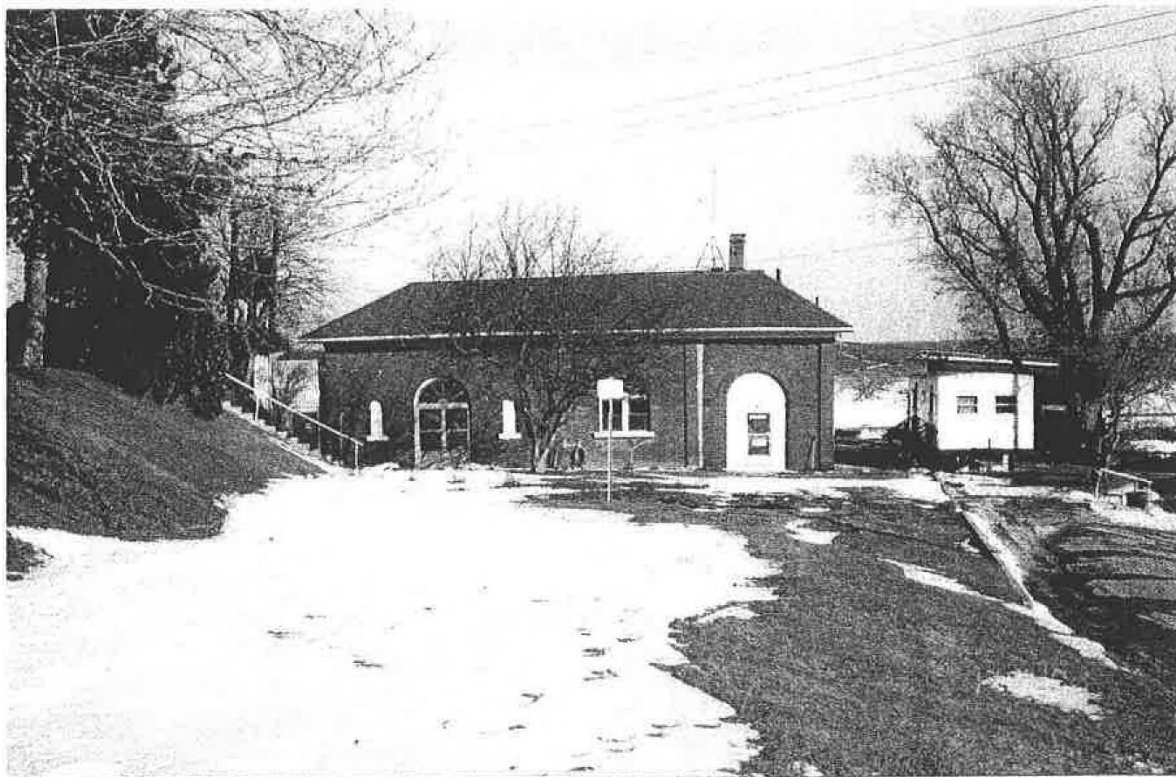
Although it has lost some of its original architectural features, the building is a good example of municipal buildings of its period. Examination of early photographs of the building shows the sloping portions of the roof were originally faced with standing-seam metal roofing, with a cast or wrought iron cresting around the perimeter of the flat central portion of the roof. The cresting is no longer in place, and the roofing material is now asphalt shingles, which were replaced about three years ago (photograph 1).

Exterior from south

2. Remove infill from east entrance and reinstate a pair of doors with fanlight above, to match west entrance.
3. When asphalt shingles require replacement, reinstate standing seam metal roofing with cast iron cresting, as shown in early photographs.

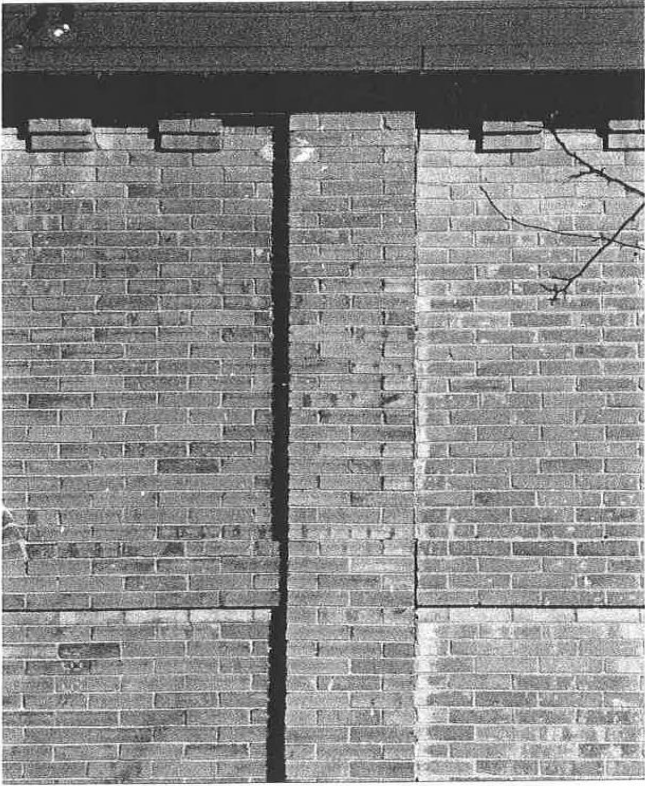
6. Image Exterior South wall pilaster, showing construction joint

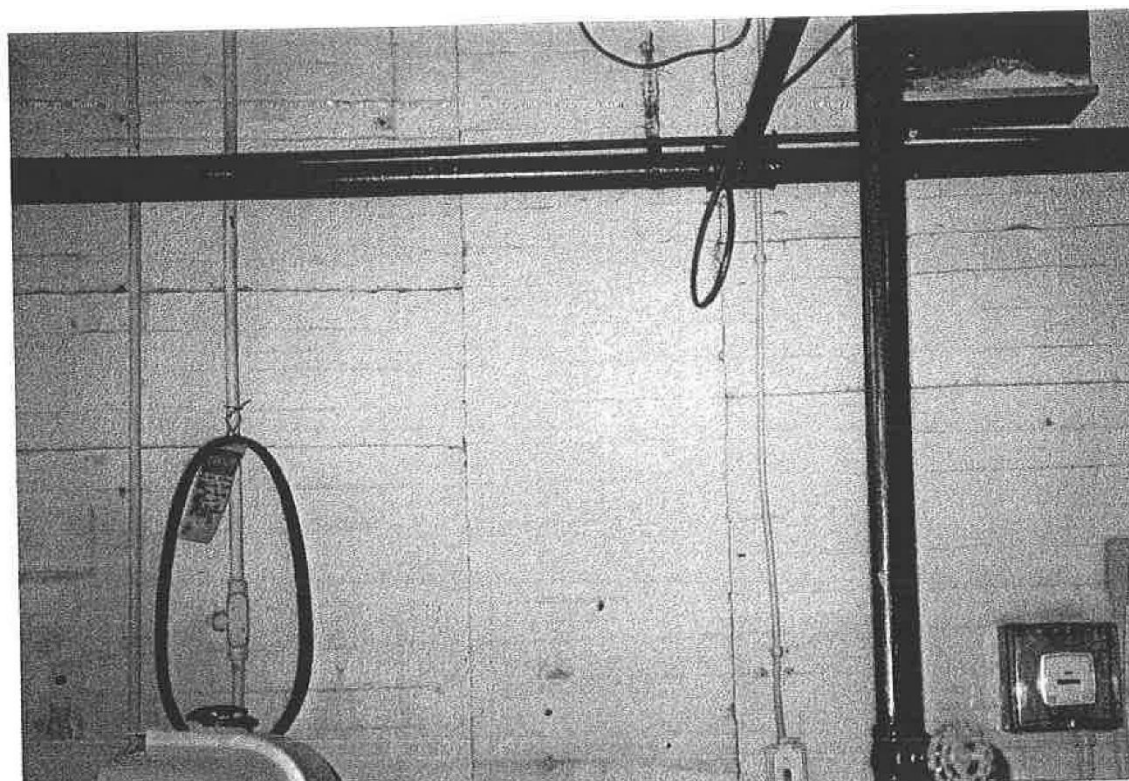
7. Interior, north wall of building, showing misaligned string course

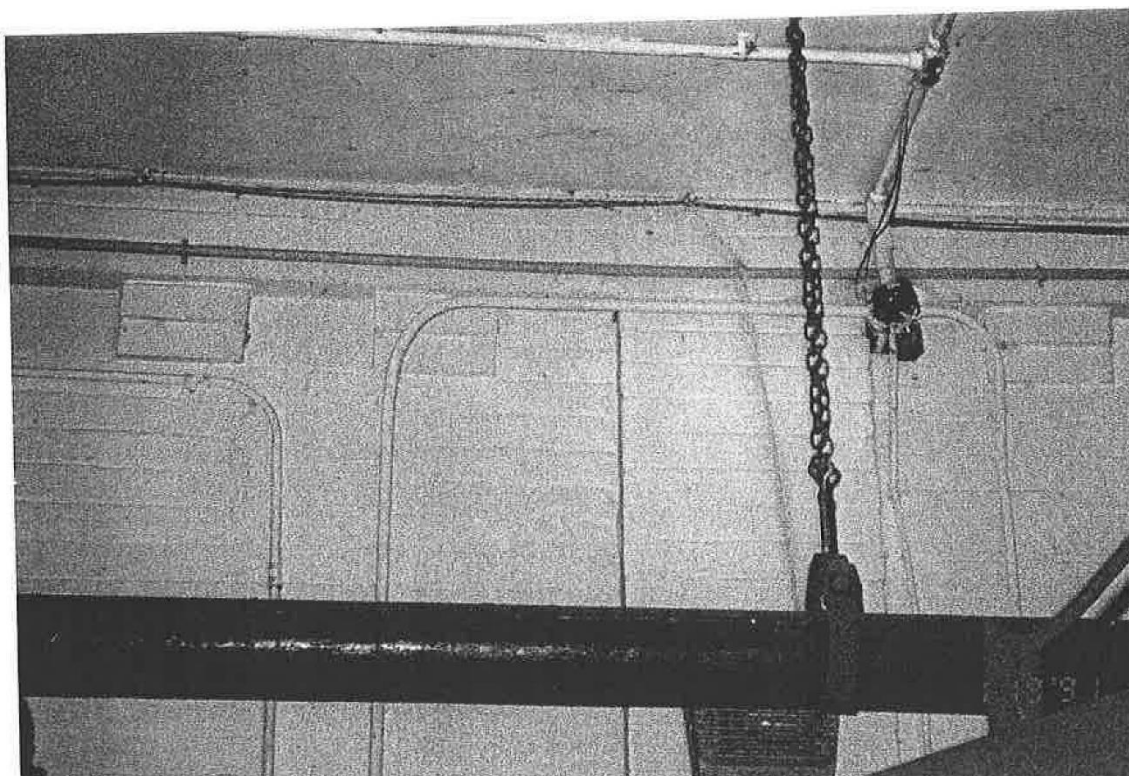
8. Interior , north wall of main building, showing construction joint

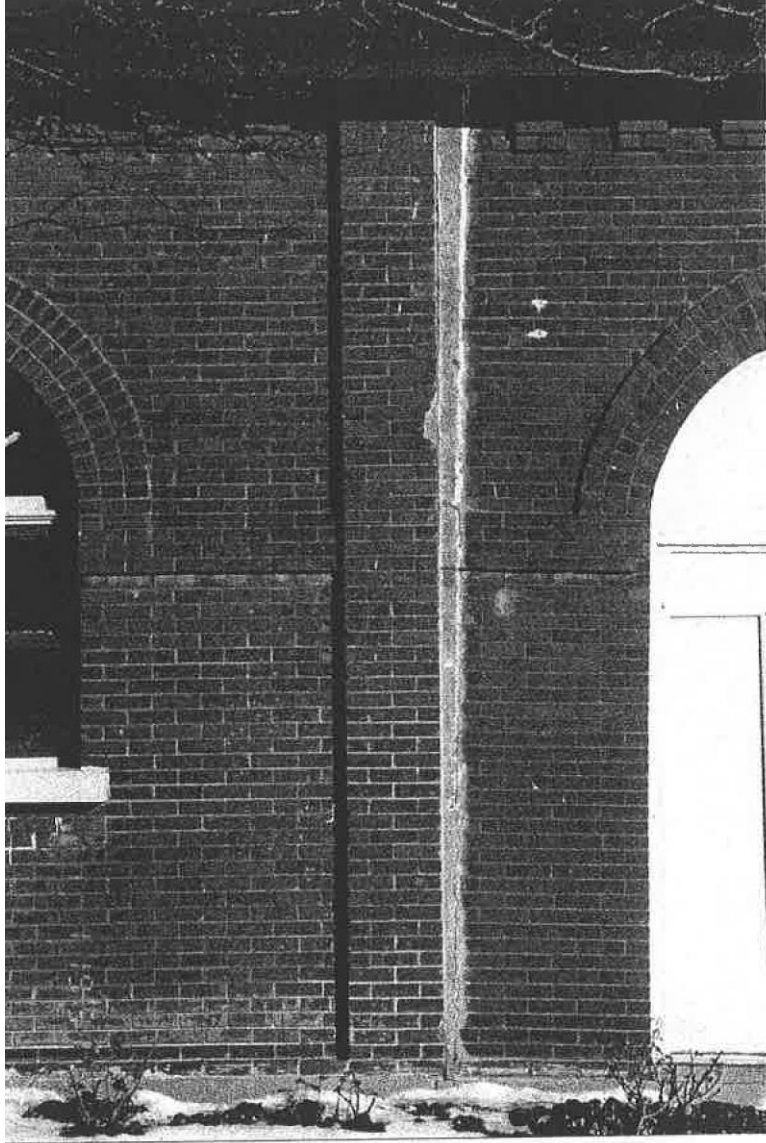
The easternmost section of the building is also separated from the adjacent construction and has moved away from it, leaving a large tapered crack which has subsequently been filled by conspicuous cement patching (photograph 11). The south side of this section originally contained a pair of doors, similar to those at the west end of the building, but has now been blocked up, leaving a single entrance into the office. This part of the building is divided into two small rooms. Both rooms are lighted by windows with fanlights above, which may have been relocated from the east wall of the second section, since they are identical to the window in the south side of that section. The east elevation (photograph 12)

Despite the considerable movement which occurred in the easternmost section of the building, there is little evidence of its continuation after the crack was patched (photograph 11).

11. Exterior, north wall showing settlement crack

1. Examine the patching of the settlement crack in the south and north walls of the main building, to determine whether a less unsightly method of closing the gap could be installed.

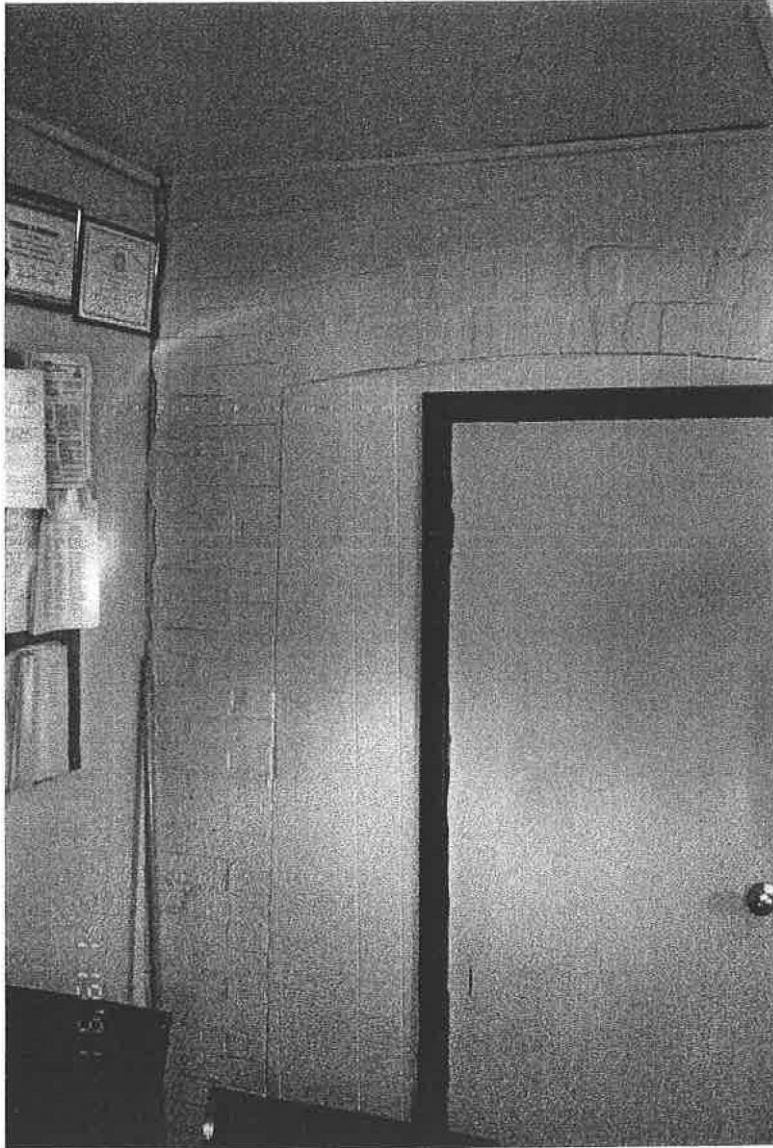
maintains the detailing and pleasant proportions of the main elevation. The two interior offices are separated by a brick wall, where evidence of movement can again be seen at the junction with the east wall of the second section (photograph 13).

13. interior, center wall in east section, showing settlement crack

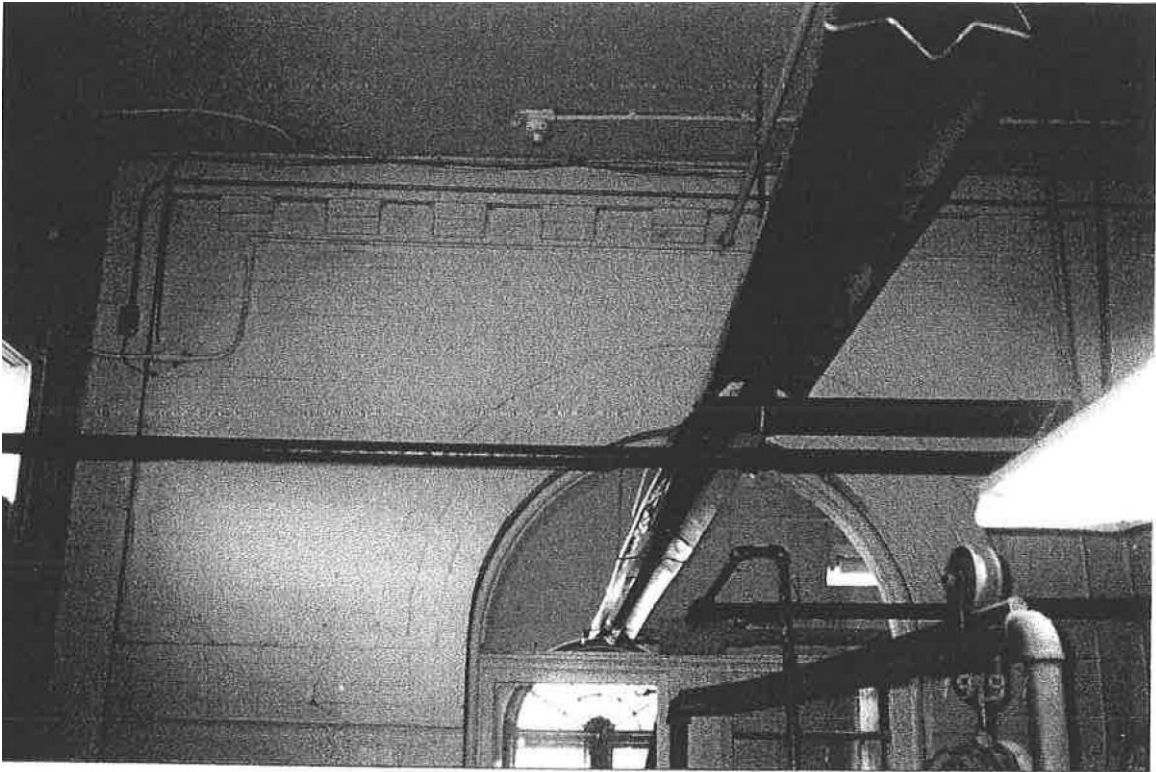
Except for the settlement in the easternmost section of the building, there is no evidence of structural deterioration. No cracks are visible in the brick masonry walls, not even in the walls of the easternmost section, despite the settlement which has occurred. Except for one entrance, the original doors and windows, complete with their fanlights, still exist; windows and fanlights in the north wall of the original building are still in place, except one fanlight, which has been removed (photograph 22).

22. interior, north wall of main building

- .2 Reinstall missing fanlight to east window.
 - .3 Reinstall missing pair of doors from central entrance.
5. Improve setting of building by reconstructing former Municipal Park, incorporating historic plaque.
