January 14, 2016

RE: Shoreline Hazard Assessment
Fifth Wheel Truck Stop Property, Grimsby, Ontario
Our file 15-2298

Figure 1
Fifth Wheel Truck Stop, Grimsby
Site Plan with Hazard Limits and Development Setbacks

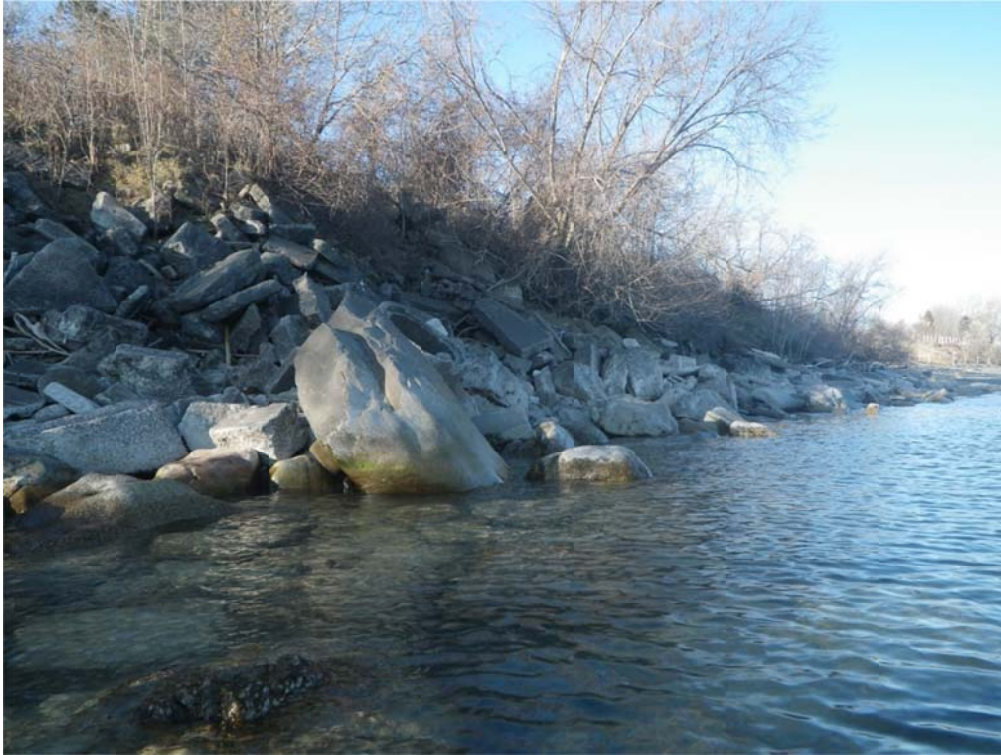
Photo 1 **Shoreline at west end of subject site**

The shoreline of the subject property is fronted by a high till bank. The bank is shown in Photos 1 to 3. The existing top of bank varies between elevations approximately 79.1 and 83.3 m. The existing toe of bank, as identified on the topographic survey, varies in elevation from approximately 74.9 to 76.6 m. The slope of the bank varies from approximately 2h:1v to steeper than 1h:1v. The upper slope is grassed and vegetated in some areas. The lower part of the slope is generally bare earth with exposed concrete rubble and debris in the slope (Photo 4).

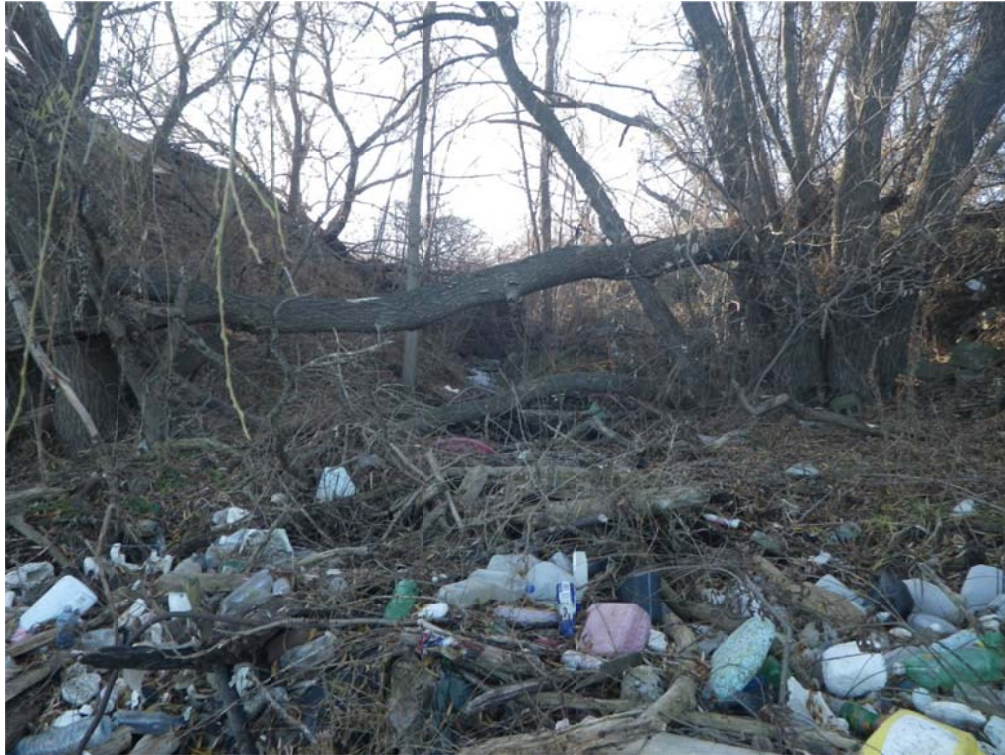
Photo 5 View looking up Ravine from shoreline

A ravine is located approximately 150 m west of the west property limit. The ravine is illustrated in Photos 5 and 6. The sides of the ravine are vegetated with some scattered concrete rubble visible on the slope. Cobble has collected at the mouth of the ravine. The ravine drains a 2 m diameter storm sewer outlet pipe with an invert elevation of 80.44 m. The outlet is located approximately 70 m up the ravine from the average toe of bank alignment through the adjacent sections of the shoreline.

The shoreline protection in the vicinity of the ravine will need to be considered in the detailed design of the shoreline protection. There are two main options for dealing with the storm sewer outfall and the ravine. Either of the two shoreline protection options described above could be continued across the ravine mouth. The 2 m diameter storm sewer pipe would be extended to outlet in the revetment slope and the area behind the revetment filled in and regraded. A second option would be to construct formal channel scour protection in the ravine and a formal armour stone outlet within the shoreline protection structure.

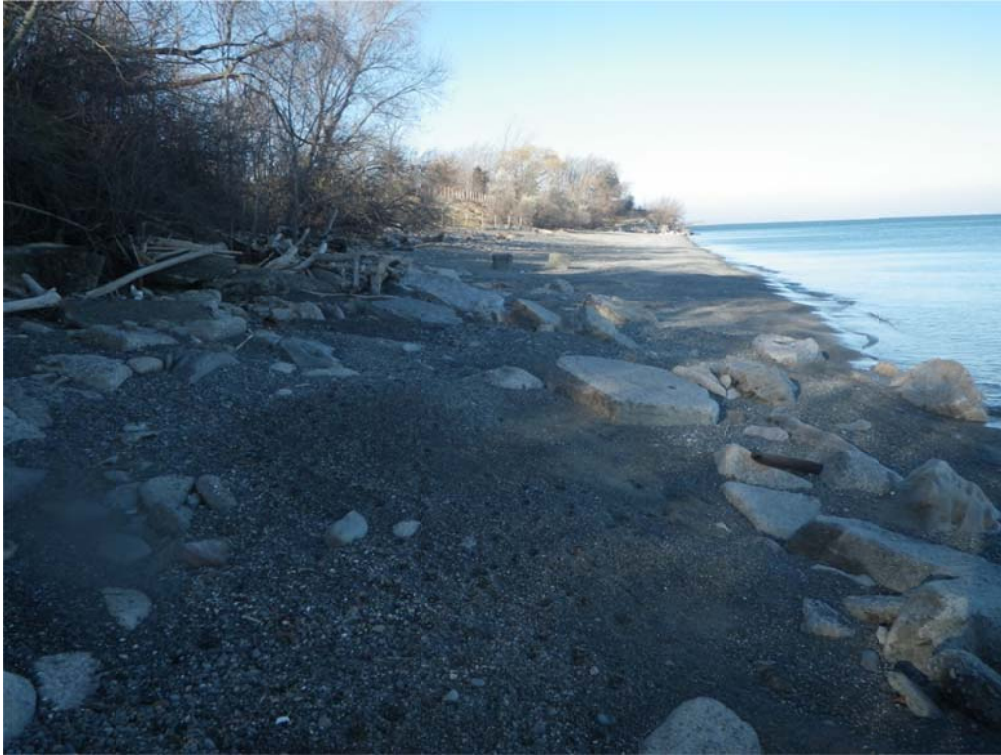
Photo 7 **View of shoreline to west of subject site**

The shoreline to the west of the subject site is a sand, gravel and cobble beach (Photo 7) backed by a high bank. The beach deposit is anchored by a concrete block wall headland at the end of Casablanca Boulevard. The shoreline to the east of the subject site (Photo 8) consists of a vegetated bank with some concrete rubble and stone at the toe of the bank and in the nearshore. Cobble beach material has collected at the toe of the beach. The cobble beach was approximately 8 metres wide at the property line on the day of the nearshore survey.

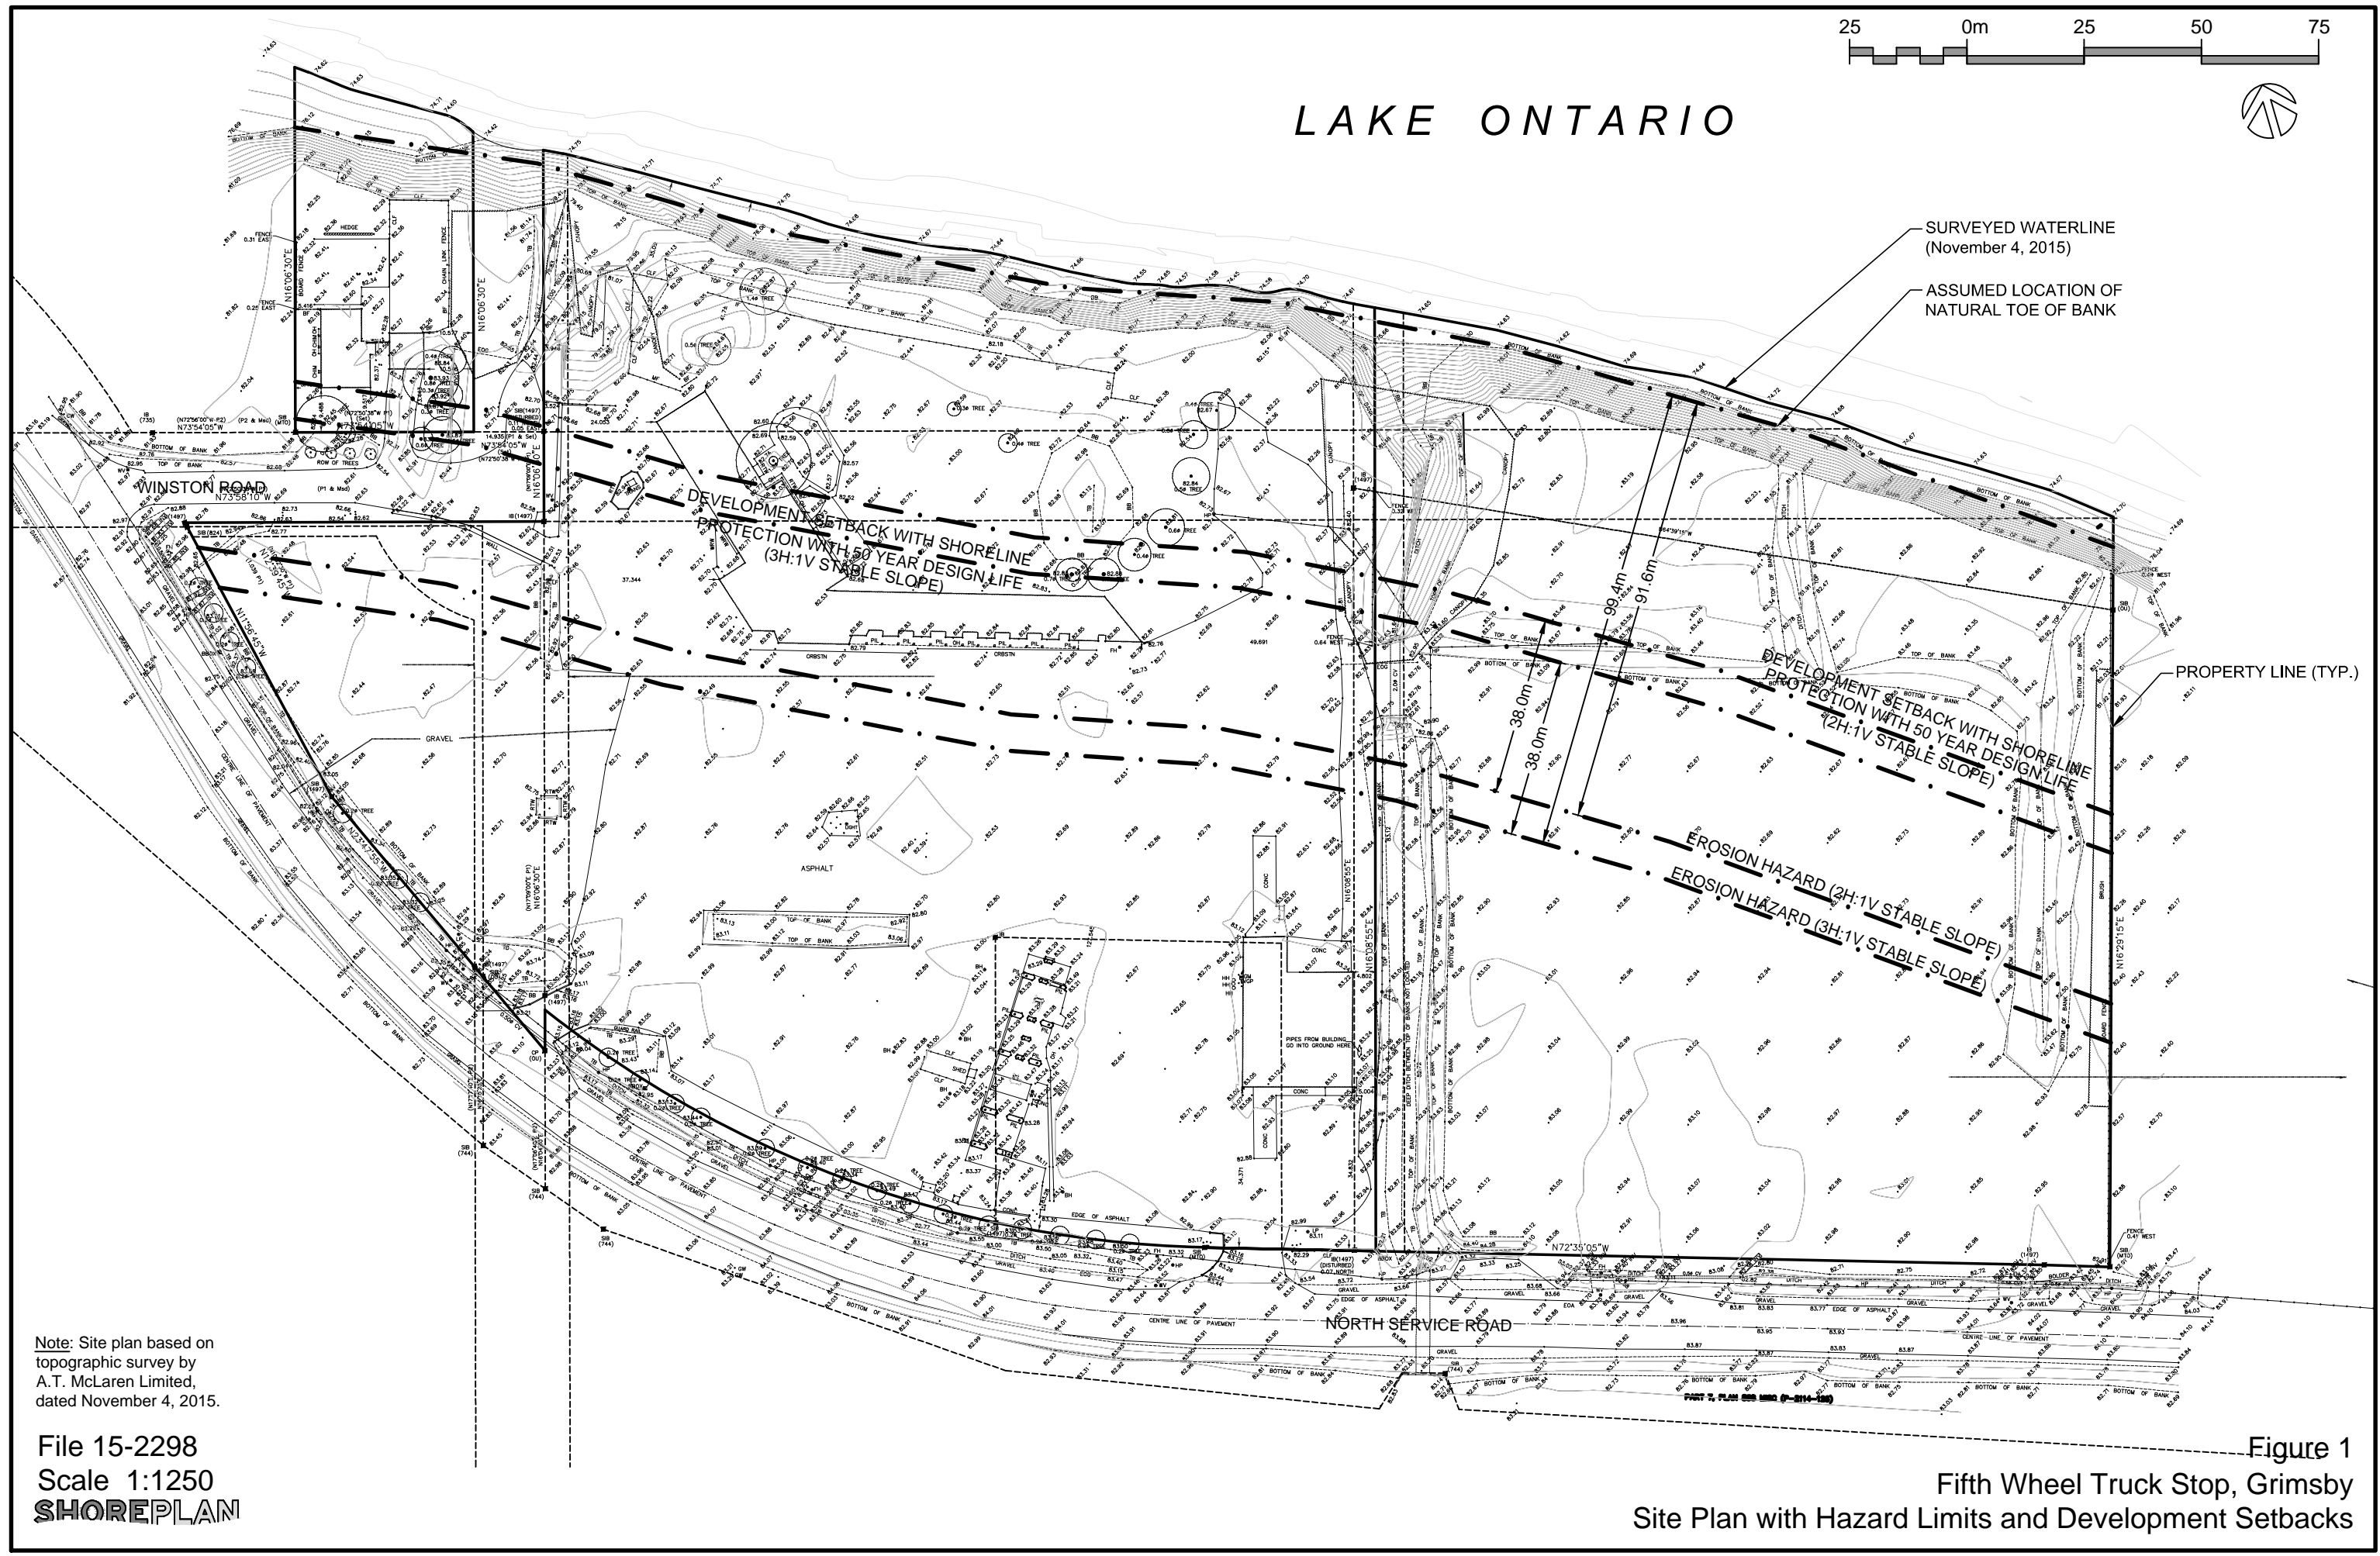
The stable slope allowance is the product of the bluff height and the assumed stable slope. The Technical Guides give a “default” stable slope of 3h:1v (MNR, 2001). The LOSMPU recommended that the default 3h:1v be used in the absence of a site specific geotechnical assessment. The tableland is relatively flat on the site. The average elevation of the tablelands in the vicinity of the erosion hazard is approximately 82.8 m. Based on the assumed natural toe of bank elevation, the stable slope allowance is 23.4 m $((82.8 - 75.0)m \times 3.0)$. The erosion hazard is 99.4 m $(76.0m + 23.4m)$. The position of the erosion hazard based on the 3h:1v stable slope is shown on the site plan on Figure 1.

2h:1v on the Fifth Wheel Truck Stop property would be a reasonable assumption, but subject to acceptance by NPCA. We have calculated the erosion hazard assuming a 2h:1v stable slope. The stable slope allowance using the 2h:1v stable slope is 15.6 m ((82.8 - 75.0)m x 2.0). The erosion hazard is 91.6 m (76.0m + 15.6m). The position of the erosion based on the 2h:1v stable slope is shown on the site plan on Figure 1. Note that this erosion hazard limit is subject to the acceptance of the 2h:1v stable slope by NPCA. NPCA may request a site specific geotechnical investigation to confirm the stable slope.

Typically development with shore protection works at this site could be located 38 m (50 years x 0.76 m/year) lake ward of the erosion hazard limit. Figure 1 shows the Development Setback lines using the 2h:1v and 3h:1v stable slopes with shoreline protection with a 50 year design life.
