September 19, 2023

RE: Shoreline Hazard Assessment
165 Lake St., Grimsby, Ontario
Our file 21-3490

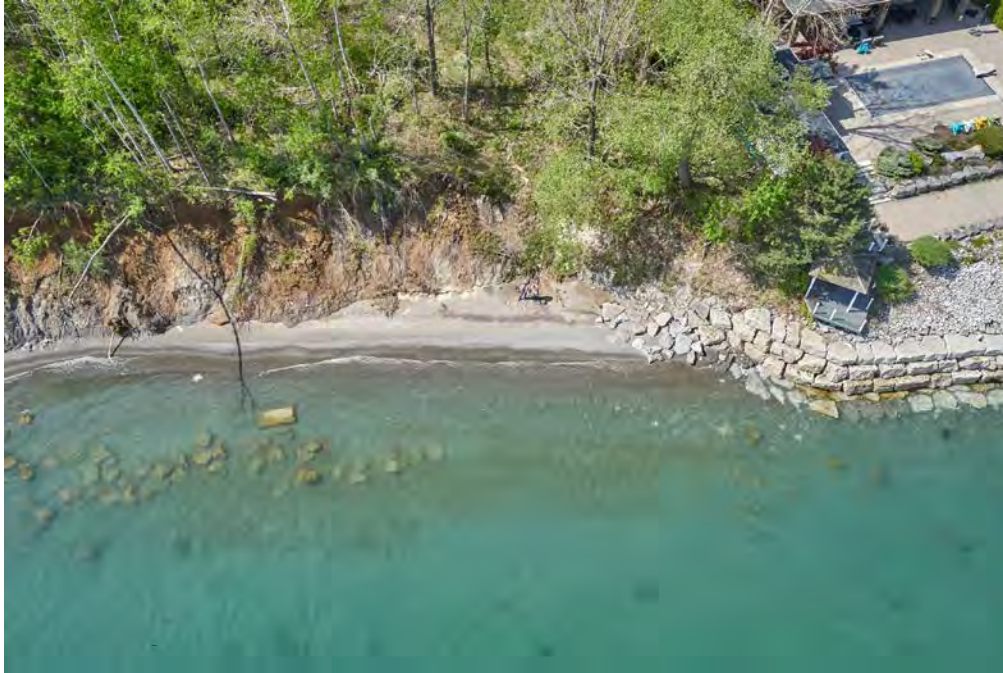
The shoreline of the subject property generally consists of a high bank which has both protected and unprotected sections. The existing condition of the shoreline is shown in Photos 1 to 3. The first approximately 5 m of the western end of the property is protected by a stacked armour stone wall with a cap elevation of approximately 78.1 m. This seawall extends onto the subject property from the adjacent property to the west.

Photo 1: View of the western extent of the subject property looking south.

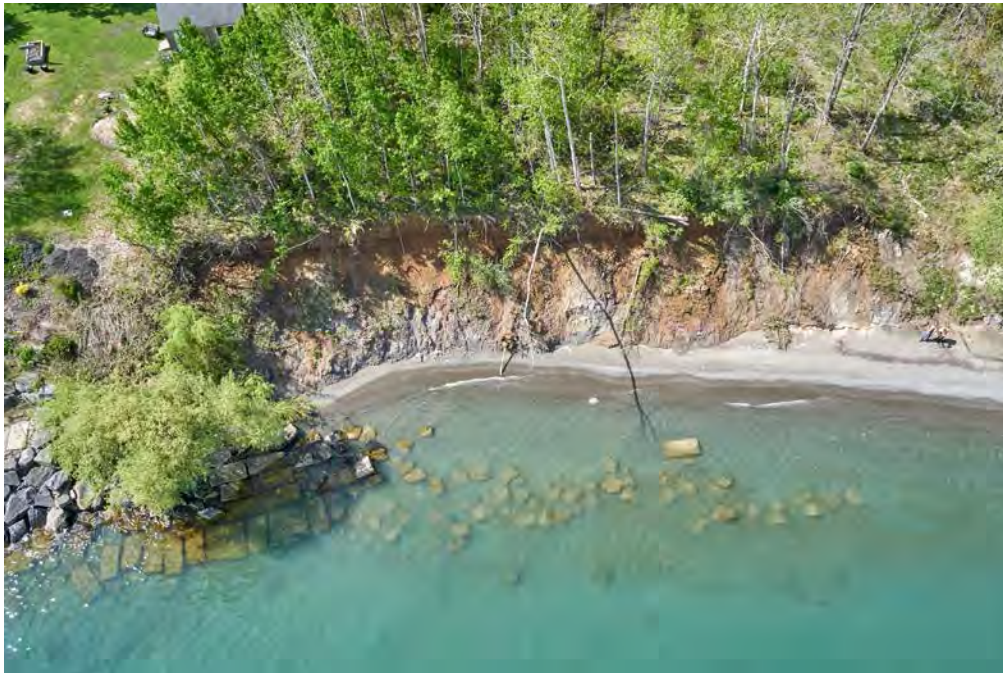
Moving eastward, the next approximately 60 m of shoreline consists of an unprotected high till bank which has a crest elevation of approximately 82.0 m to 84.5 m. The bank is fronted by a narrow beach. Armour stones are scattered in the nearshore area of the beach.

The following 32 m of shoreline are protected by a concrete block revetment that transitions to an armour stone revetment with a top elevation of approximately 78.0 m. The armour stone revetment is backed by a concrete block and stone patio and stacked armour stone retaining wall. The retaining wall has a cap elevation of approximately 78.0 m. The bank behind the armour stone wall continues up to an elevation of approximately 84.0 m.

Photo 2: View of the center of the subject property looking south.

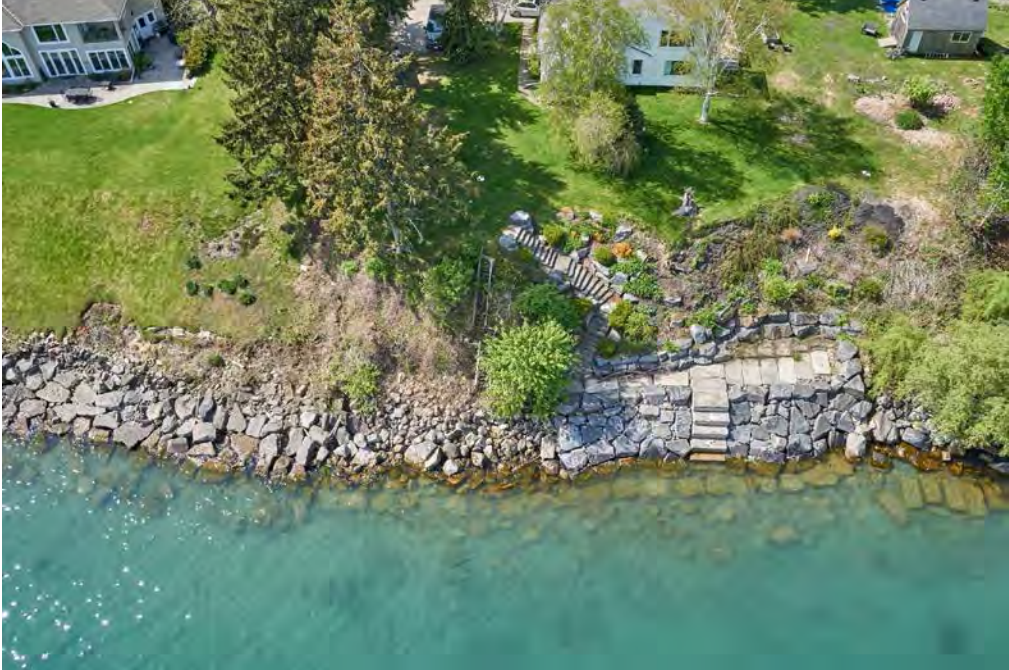
The last 18 m of the eastern end of the property are protected by an informal armour stone and rubble revetment. It appears to be a transition to an armour stone revetment on the adjacent property to the east. All stone is informally placed and relatively small in comparison to the armour on the adjacent property. The revetment has a crest elevation of approximately 77.0 m. The backshore is undeveloped land, which is characterized with mature trees, shrubs, and grasses.

Photo 3: View of the eastern extent of the subject property looking south.

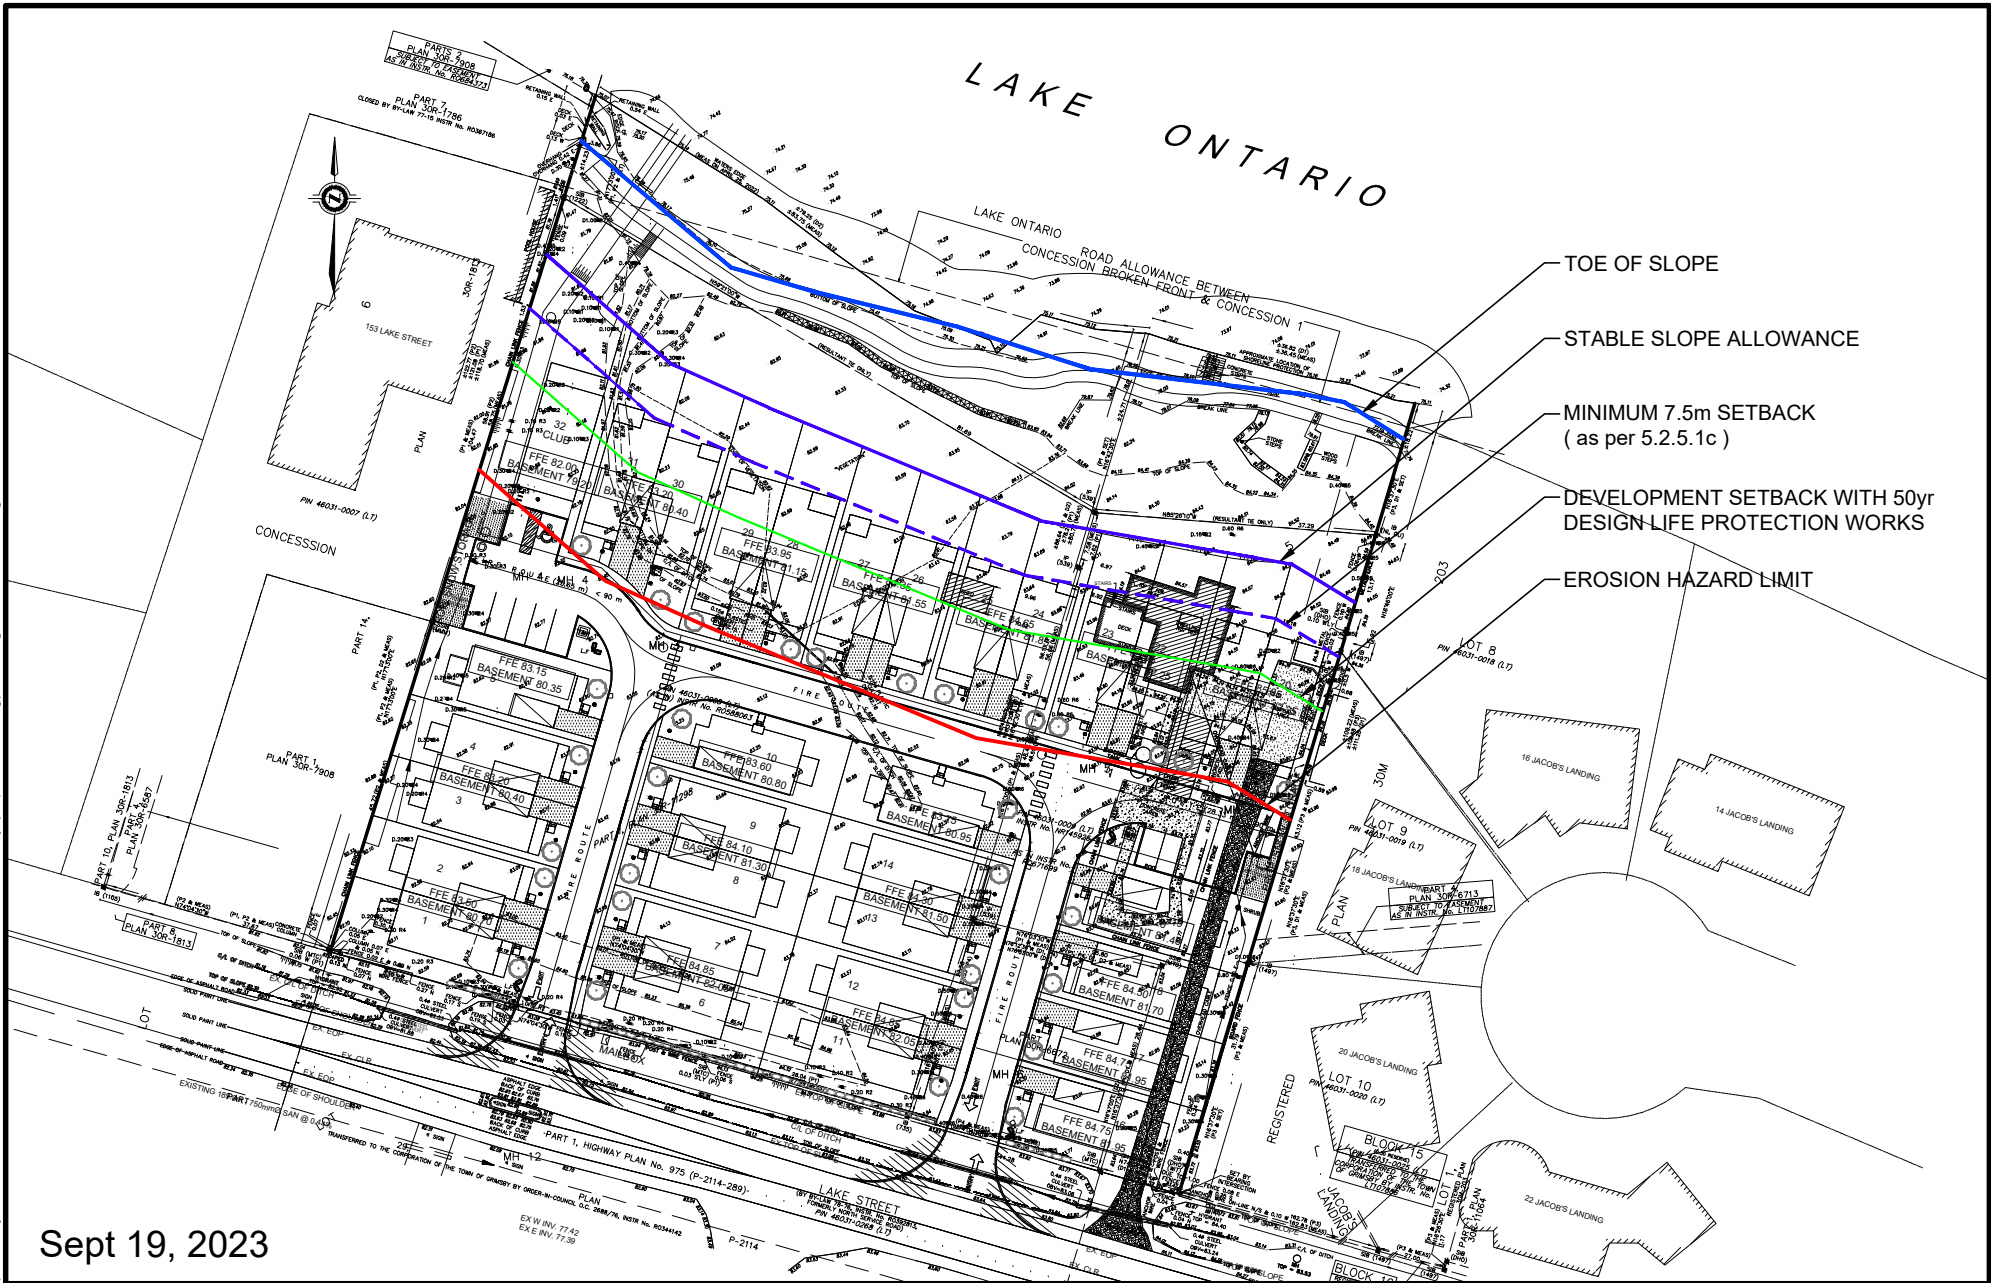
Figure 1
165 Lake St Grimsby
Site Plan

The line located 7.5 m landward of the stable slope allowance is also shown on the Figure 1. It has been our experience that NPCA accepts this 7.5 m development setback when robust shore protection works with maintenance access are provided. The maintenance access must be at least 5 metres wide

A new shoreline protection structure, consisting of an armour stone revetment with a 50-year design life, is proposed to be designed and constructed along the shoreline of the property. An application for a permit to construct these protection works will be submitted for approval to the NPCA in due course. With the protection works in place, the new development can then encroach into the erosion hazard. With a fifty-year design life the erosion hazard allowance would be reduced to one half. The development setback with the proposed structure is indicated on Figure 1 as Development Setback with 50 Year Design Life.
