Project
GRIMSBY CONDOS

File Name
TREE INVENTORY AND DETAILS

Drawing No.
TMP2

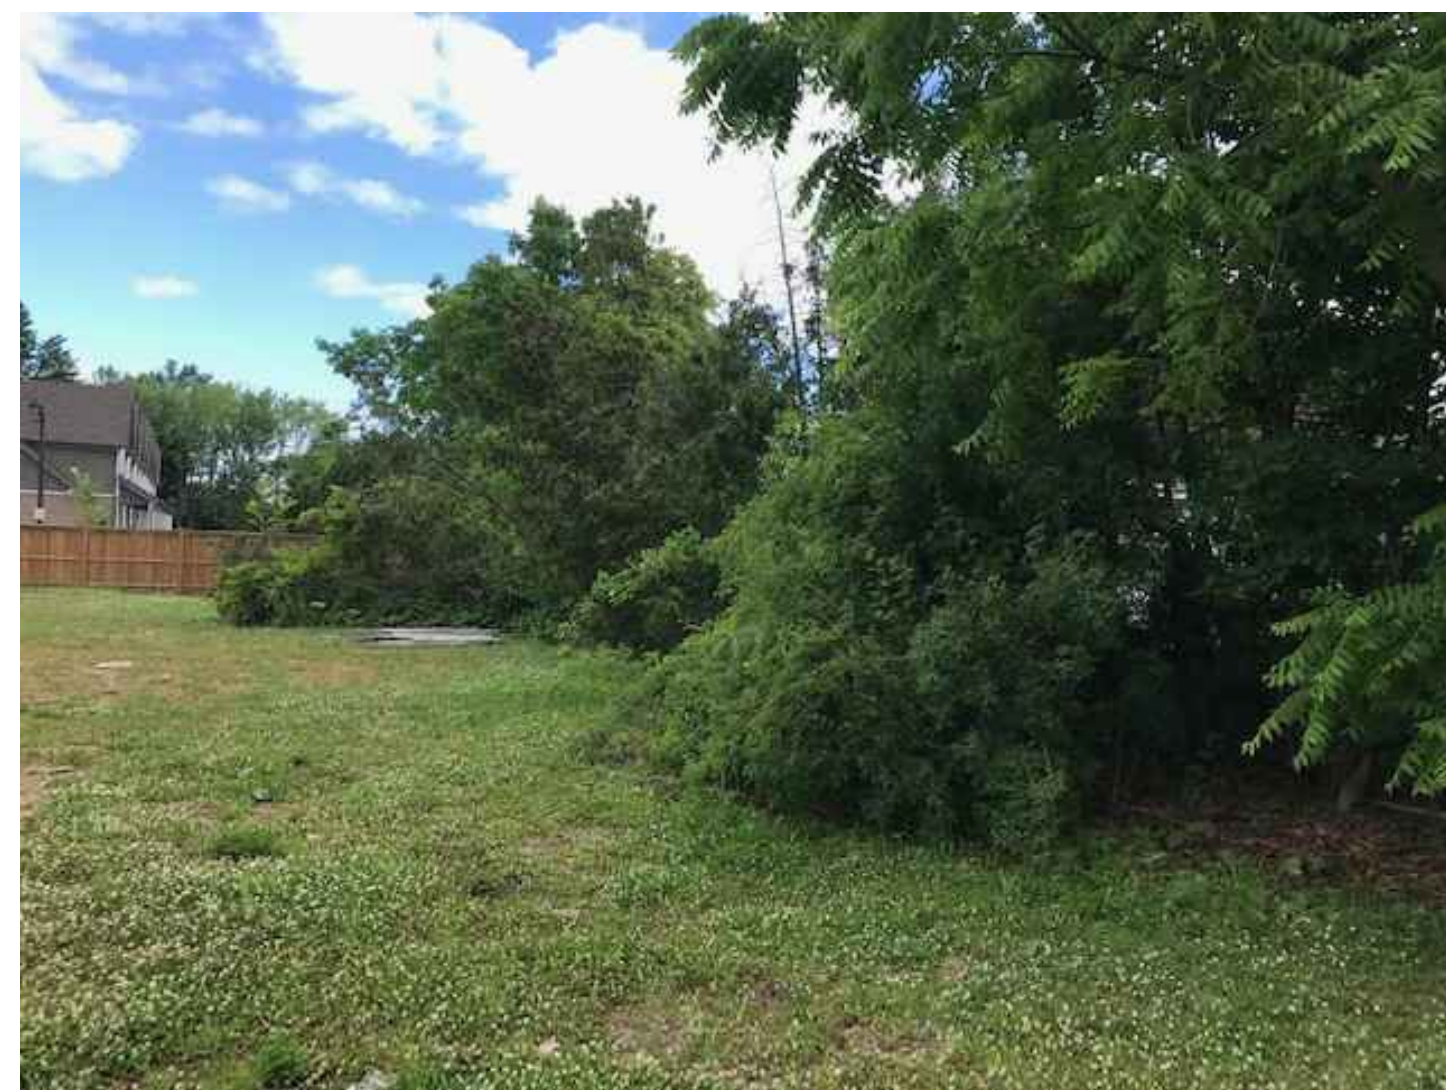
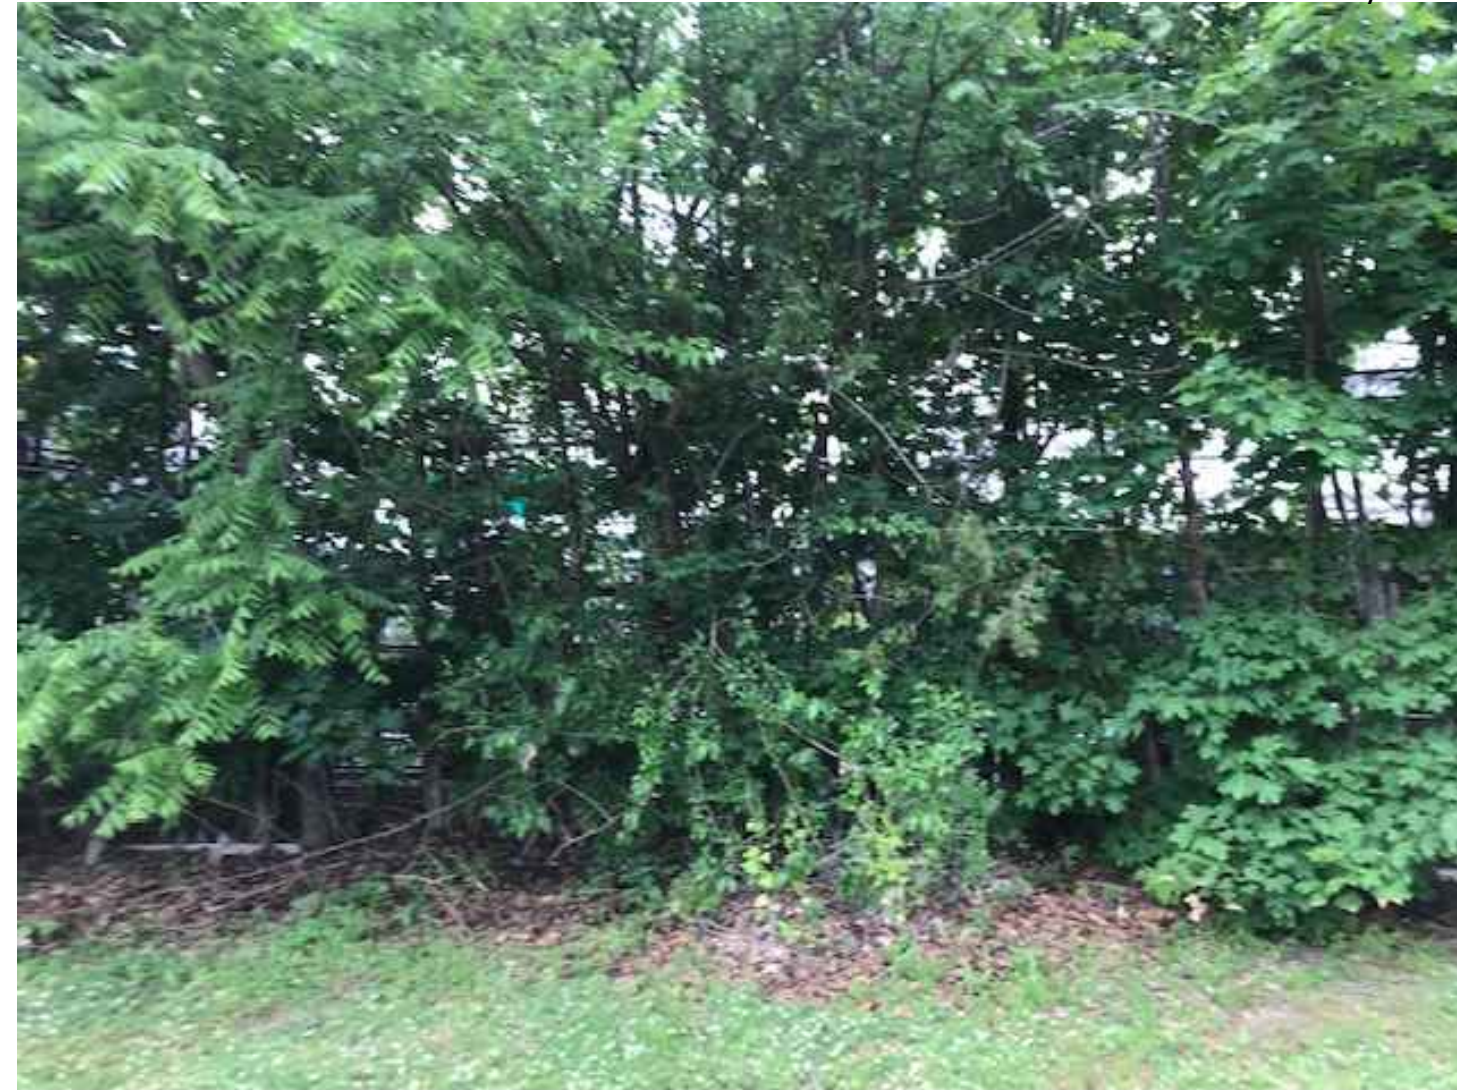
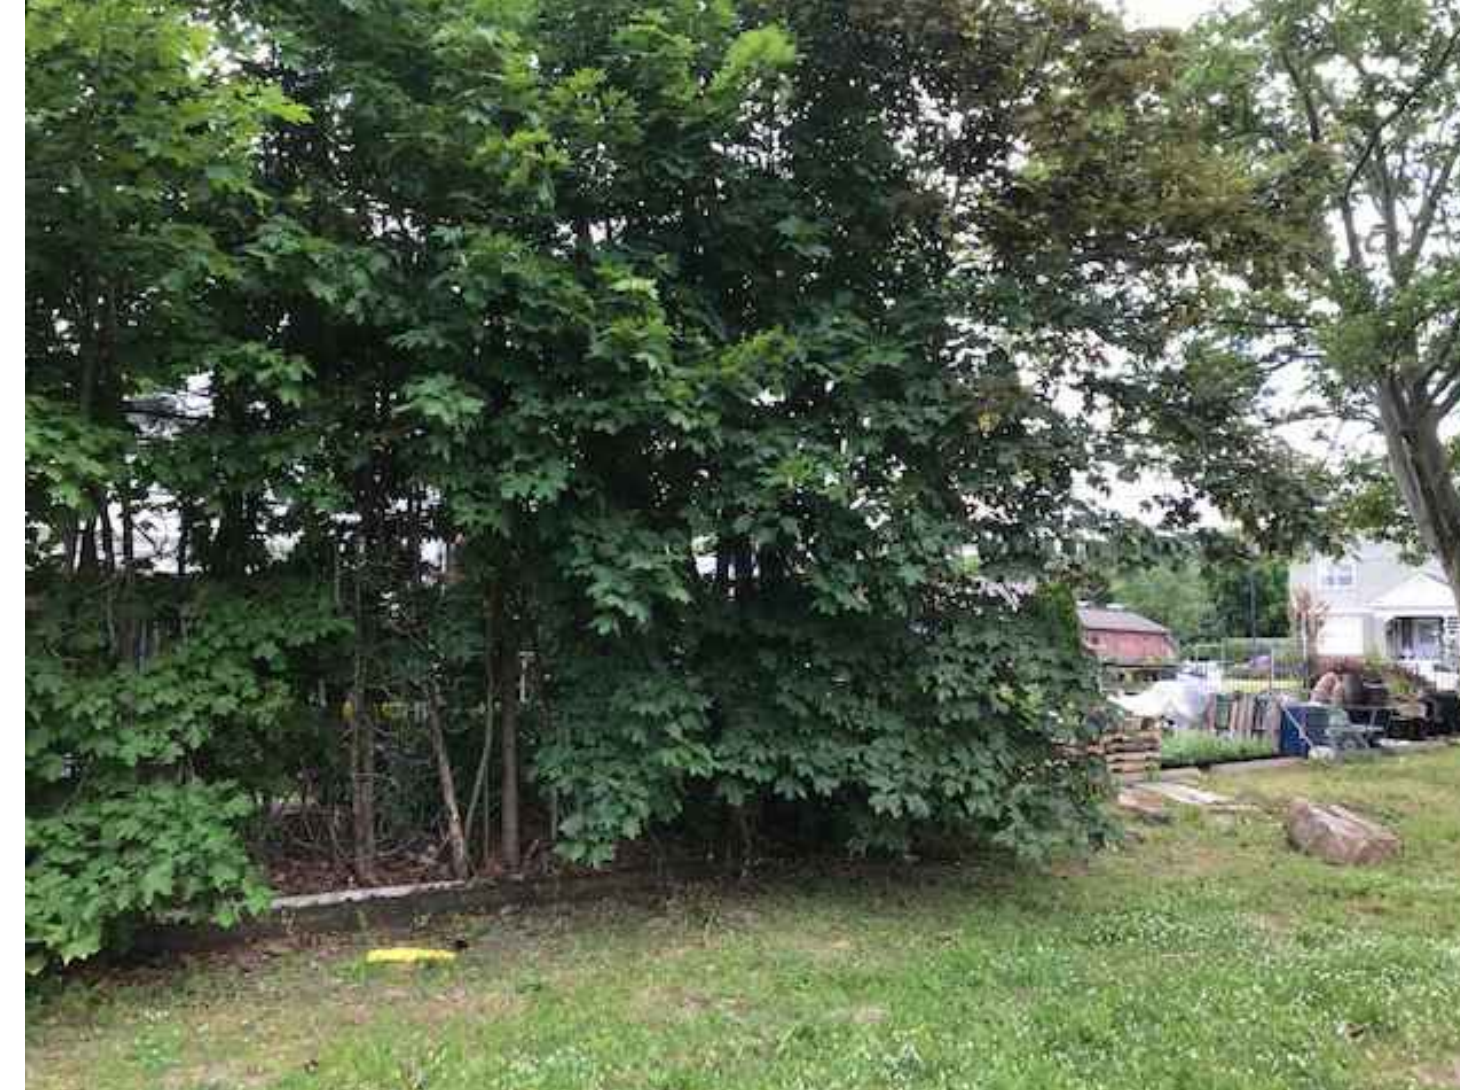
VIEW OF EXISTING FENCE LINE HEDGE/SCRUB PLANTING - (ALSO REVIEWED UNDER THE 133 MAIN STREET APPLICATION BY ADESSO)
