# Arborist Report

## GRIMSBY CONDOS

147 Main Street East, Grimsby, Ontario

Prepared for:  
Losani Homes  
430 McNeilly Road  
Stoney Creek, Ontario  
L8E 5E3  
July 16 2020

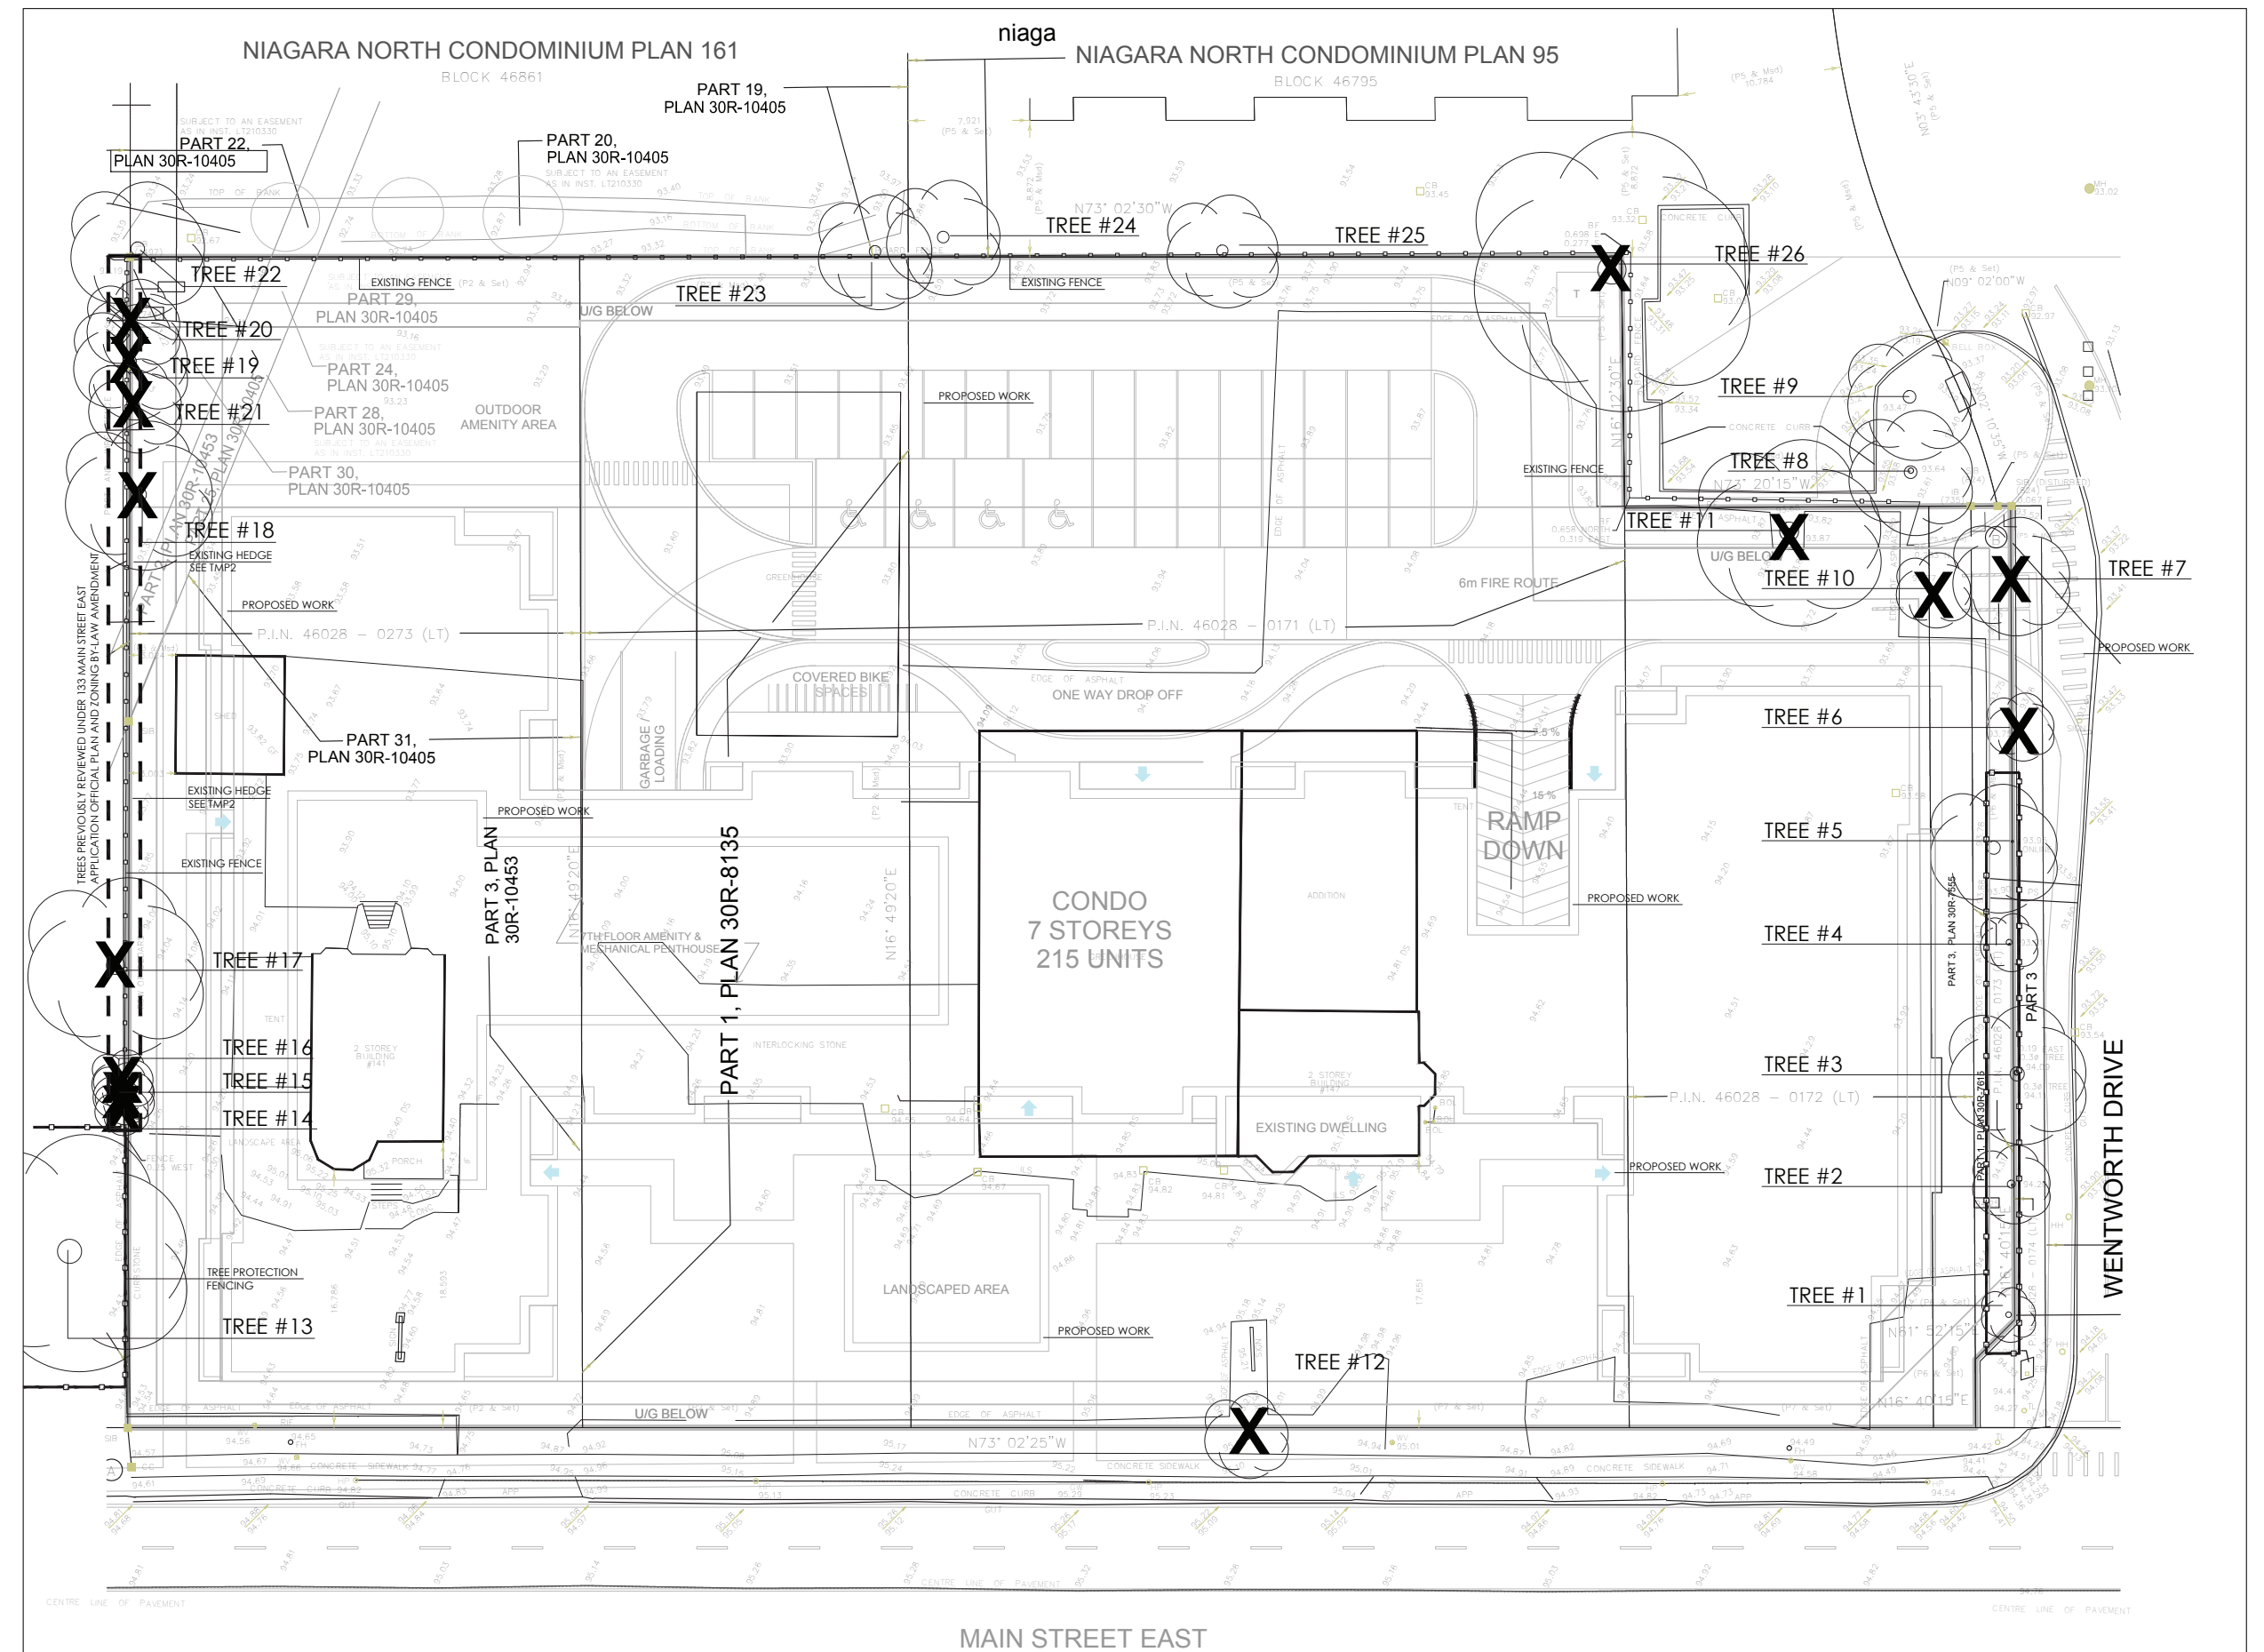
**1 TREE MANAGEMENT PLAN**  
TMP1 1:200

KEY	BOTANICAL NAME	COMMON NAME	SIZE (DBH)	SPREAD	HEALTH	STRUCTURE	NOTES	ACTION
1	CERCIDIPHYLLUM JAPONICUM	KATSURA TREE	11 cm	3.7m	GOOD/FAIR	GOOD	IN GOOD CONDITION	RETAIN
2	PYRUS CALLERYANA	ORNAMENTAL PEAR	7 cm	5m	GOOD	GOOD	IN GOOD CONDITION	RETAIN
3	PLATANUS X ACERFOLIA	LONDON PLANE TREE	28 cm	9m	GOOD	GOOD	IN GOOD CONDITION	RETAIN
4	SYRINGA RETICULATA	IVORY SILK LILAC	11 cm	3.8m	GOOD	GOOD	IN GOOD CONDITION	RETAIN
5	ACER PLATANOIDES	NORWAY MAPLE	22 cm	8.3m	GOOD	GOOD	IN GOOD CONDITION	RETAIN
6	ACER PLATANOIDES	NORWAY MAPLE	12 cm	4.3m	GOOD	GOOD	VERY DENSE CANOPY	REMOVE
7	GYMNOCLADUS DIOICUS	KENTUCKY COFFEE TREE	23 cm	7.6m	GOOD	GOOD	IN GOOD CONDITION	REMOVE
8	PINUS NIGRA	AUSTRIAN PINE	32 cm	8.1m	FAIR	GOOD	SHOWS SIGNS OF DIPLODIA, OFF SITE	RETAIN
9	PINUS NIGRA	AUSTRIAN PINE	38 cm	8.7m	FAIR	GOOD	SHOWS SIGNS OF DIPLODIA, OFF SITE	RETAIN
10	ACER PLATANOIDES 'HARLEQUIN'	NORWAY MAPLE	12 cm	4.7m	GOOD	GOOD	HAS RETAINED ITS VARIATION	REMOVE

11	JUGLANS NIGRA	BLACK WALNUT	21-24 cm	12m	GOOD	GOOD	CO-DOMINANT GROWTH	REMOVE
12	PRUNUS VIRGINIANA 'SCHUBERT'	SCHUBERT CHOKECHERRY	15 cm	5.6m	GOOD	GOOD	IN GOOD CONDITION	REMOVE
13	PLATANUS X ACERFOLIA	LONDON PLANE TREE	62 cm	16.2 m	GOOD	GOOD	OFF SITE	PROTECT DURING CONSTRUCTION
14*	ACER PLATANOIDES	NORWAY MAPLE	13 cm	3.6m	FAIR	FAIR	GROWTH MOSTLY ON ONE SIDE, IN FENCE	REMOVE
15*	ULMUS THOMASII	ROCK ELM	18-25 cm	4.0m	FAIR	FAIR	GROWING IN FENCE, GROUP OF 3	REMOVE
16*	MORUS ALBA	WHITE MULBERRY	17 cm	4m	FAIR	FAIR	GROWTH MOSTLY ON ONE SIDE	REMOVE
17*	JUGLANS NIGRA	BLACK WALNUT	28 cm	12m	GOOD	FAIR	GROWTH MOSTLY ON ONE SIDE	REMOVE
18*	JUGLANS NIGRA	BLACK WALNUT	24 cm	9.5cm	GOOD	FAIR	GROWING IN FENCE	REMOVE
19	JUGLANS NIGRA	BLACK WALNUT	19 cm	7.3m	GOOD	GOOD	IN GOOD CONDITION	REMOVE
20*	ACER PLATANOIDES	NORWAY MAPLE	22cm	6m	FAIR	FAIR	N/C	REMOVE
21*	JUGLANS REGIA	ENGLISH WALNUT	18 cm	6m	FAIR	POOR	GROWTH MOSTLY ON ONE SIDE, POOR FORM	REMOVE

22	JUGLANS NIGRA	BLACK WALNUT	24cm	9m	GOOD	GOOD/FAIR	COULD BE A HYBRID WALNUT	RETAIN
23	ACER NEGUNDO	MANITOBA MAPLE	10-11 cm	7.3m	GOOD	GOOD/FAIR	OFF SITE	PROTECT DURING CONSTRUCTION
24	ACER NEGUNDO	MANITOBA MAPLE	15 cm	7.3m	GOOD	GOOD/FAIR	OFF SITE	PROTECT DURING CONSTRUCTION
25	CATALPA SPECIOSA	NORTHERN CATALPA	21-22 cm	7m	GOOD	GOOD	OFF SITE	PROTECT DURING CONSTRUCTION
26	JUGLANS NIGRA	BLACK WALNUT	60 cm	18.2m	GOOD	GOOD	IN GOOD CONDITION	REMOVE

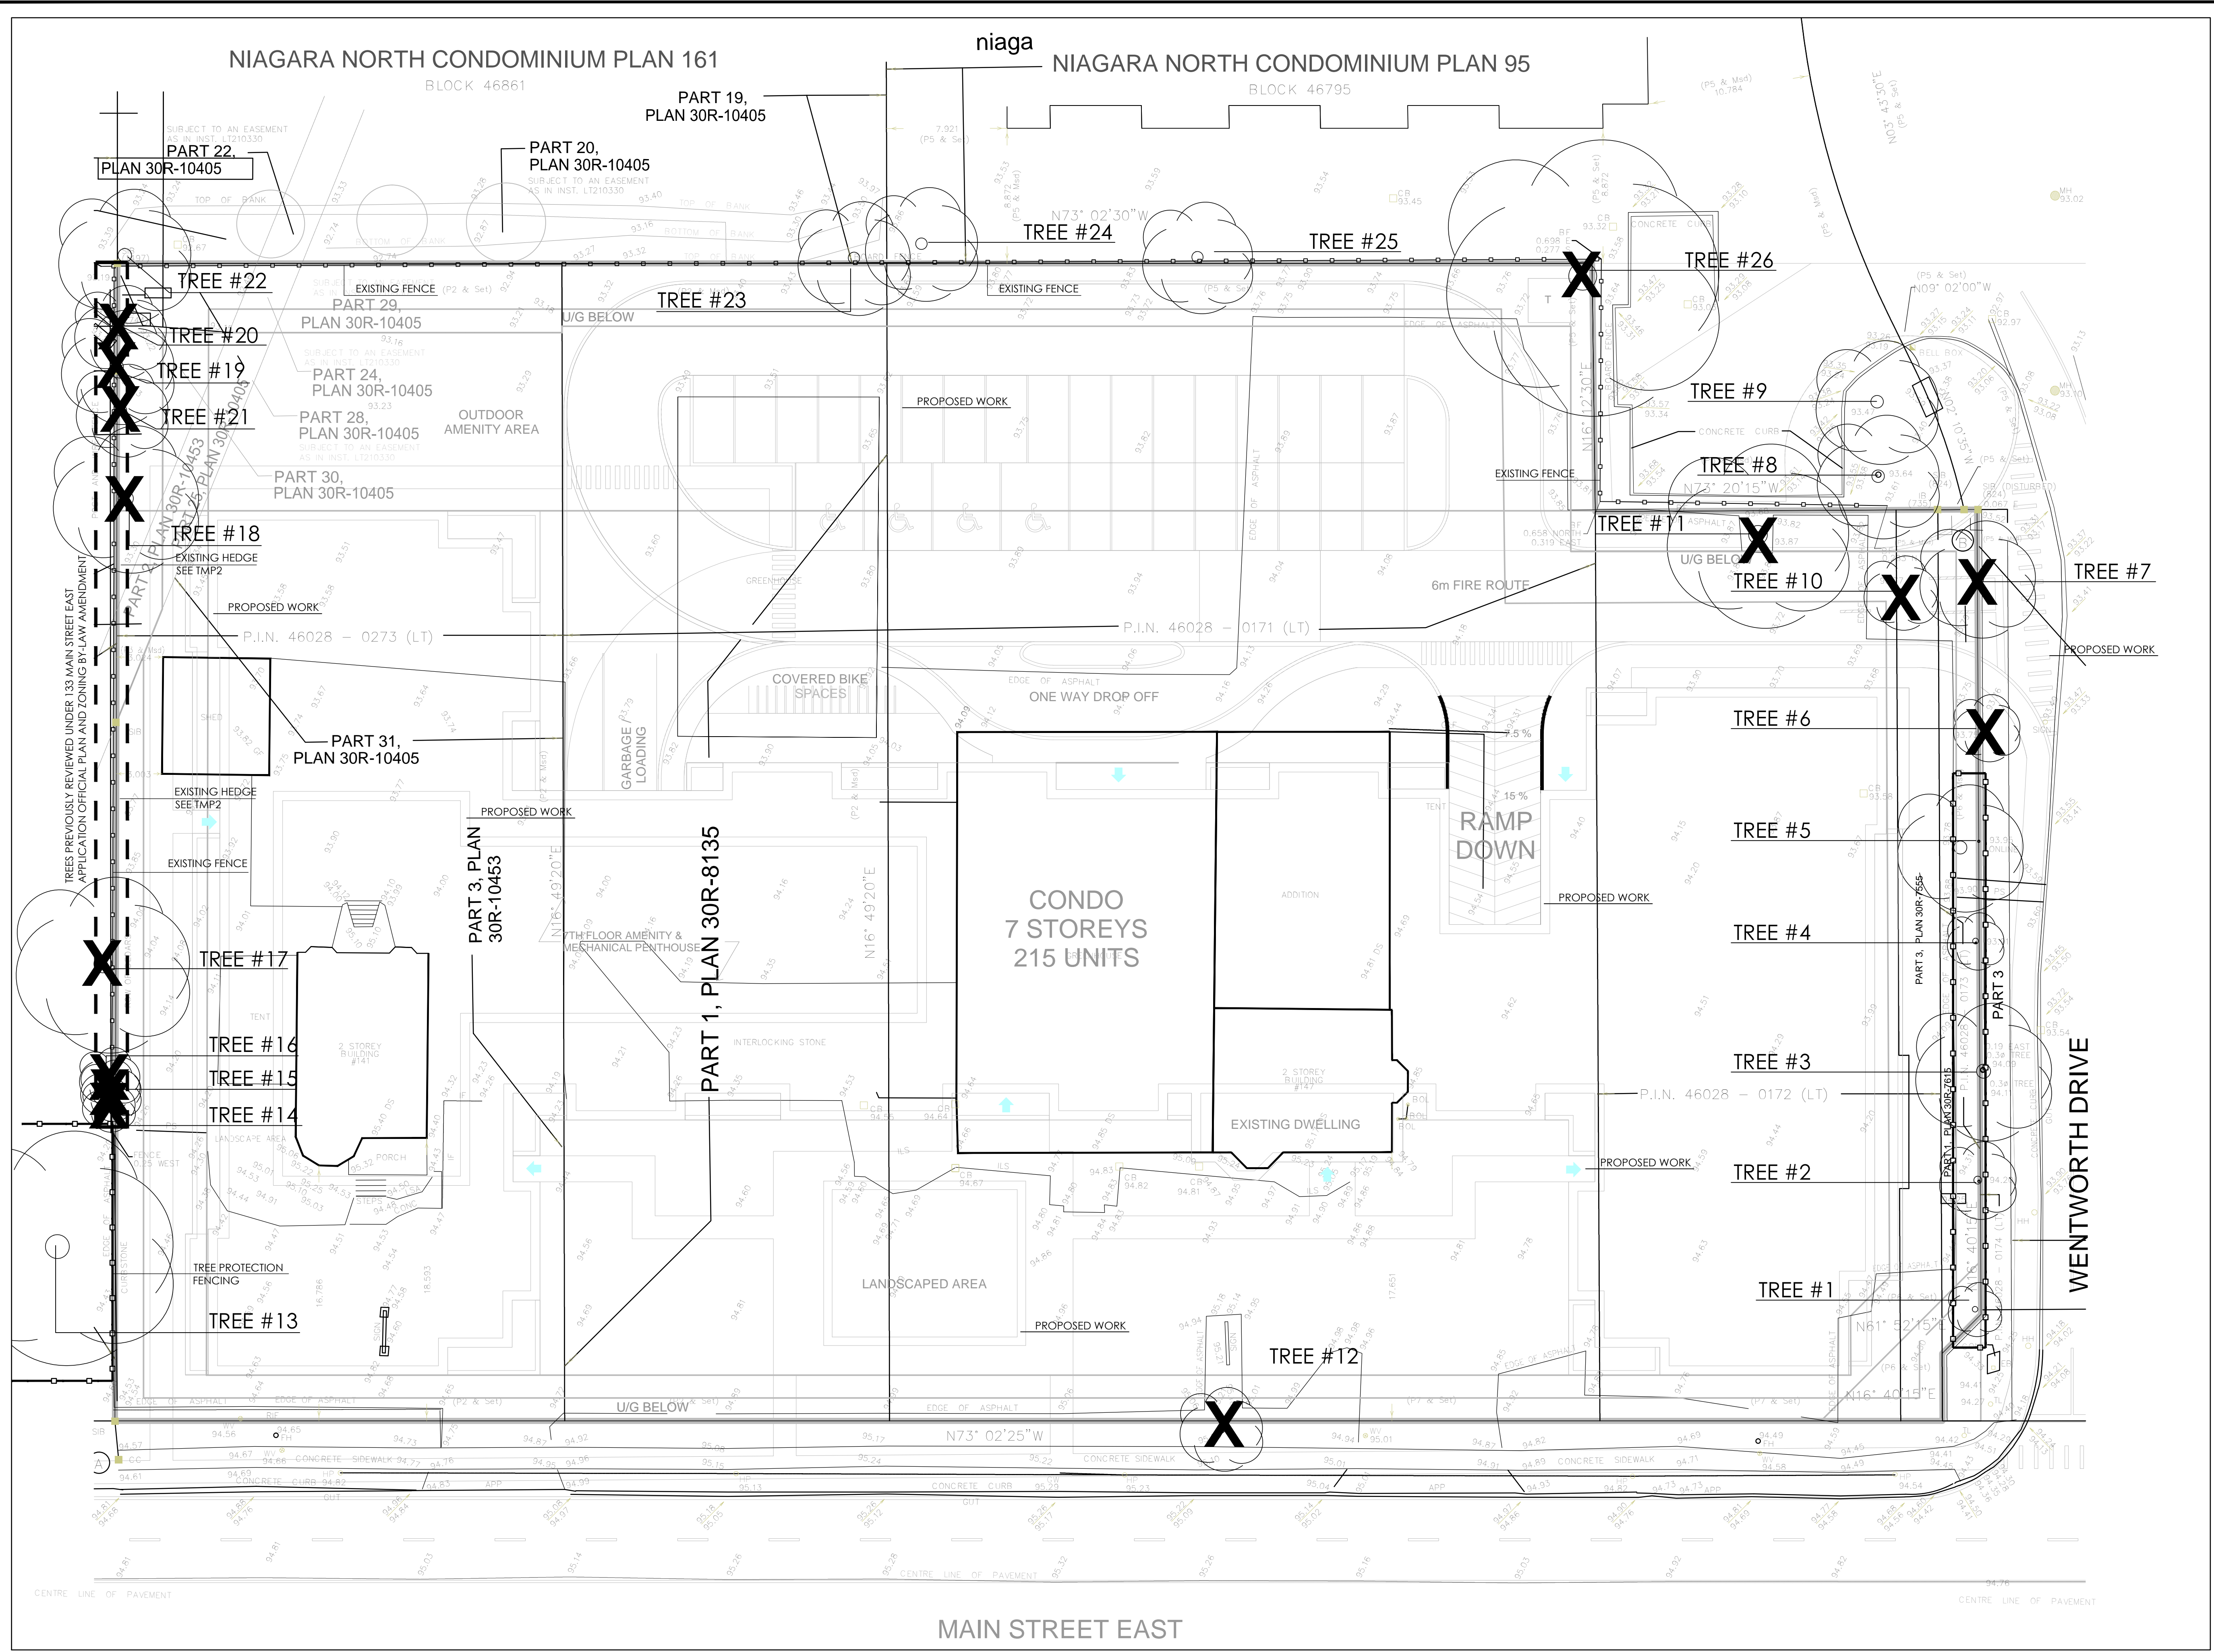
**1 TREE MANAGEMENT PLAN**  
TMP1 1:200

KEY	BOTANICAL NAME	COMMON NAME	SIZE (DBH)	SPREAD	HEALTH	STRUCTURE NOTES	ACTION	
1	CERCIDIPHYLLUM JAPONICUM	KATSURA TREE	11 cm	3.7m	GOOD/FAIR	GOOD	IN GOOD CONDITION	RETAIN
2	PYRUS CALLERYANA	ORNAMENTAL PEAR	7 cm	5m	GOOD	GOOD	IN GOOD CONDITION	RETAIN
3	PLATANUS X ACERFOLIA	LONDON PLANE TREE	28 cm	9m	GOOD	GOOD	IN GOOD CONDITION	RETAIN
4	SYRINGA RETICULATA	IVORY SILK LILAC	11 cm	3.8m	GOOD	GOOD	IN GOOD CONDITION	RETAIN
5	ACER PLATANOIDES	NORWAY MAPLE	22 cm	8.3m	GOOD	GOOD	IN GOOD CONDITION	RETAIN
6	ACER PLATANOIDES	NORWAY MAPLE	12 cm	4.3m	GOOD	GOOD	VERY DENSE CANOPY	REMOVE
7	GYMNOCLADUS DIOICUS	KENTUCKY COFFEE TREE	23 cm	7.6m	GOOD	GOOD	IN GOOD CONDITION	REMOVE
8	PINUS NIGRA	AUSTRIAN PINE	32 cm	8.1m	FAIR	GOOD	SHOWS SIGNS OF DIPLODIA, OFF SITE	RETAIN
9	PINUS NIGRA	AUSTRIAN PINE	38 cm	8.7m	FAIR	GOOD	SHOWS SIGNS OF DIPLODIA, OFF SITE	RETAIN
10	ACER PLATANOIDES 'HARLEQUIN'	NORWAY MAPLE	12 cm	4.7m	GOOD	GOOD	HAS RETAINED ITS VARIATION	REMOVE

11	JUGLANS NIGRA	BLACK WALNUT	21-24 cm	12m	GOOD	GOOD	CO-DOMINANT GROWTH	REMOVE
12	PRUNUS VIRGINIANA 'SCHUBERT'	SCHUBERT CHOKECHERRY	15 cm	5.6m	GOOD	GOOD	IN GOOD CONDITION	REMOVE
13	PLATANUS X ACERFOLIA	LONDON PLANE TREE	62 cm	16.2 m	GOOD	GOOD	OFF SITE	PROTECT DURING CONSTRUCTION
14*	ACER PLATANOIDES	NORWAY MAPLE	13 cm	3.6m	FAIR	FAIR	GROWTH MOSTLY ON ONE SIDE IN FENCE	REMOVE
15*	ULMUS THOMASII	ROCK ELM	18-25 cm	4.0m	FAIR	FAIR	GROWING IN FENCE, GROUP OF 3	REMOVE
16*	MORUS ALBA	WHITE MULBERRY	17 cm	4m	FAIR	FAIR	GROWTH MOSTLY ON ONE SIDE	REMOVE
17*	JUGLANS NIGRA	BLACK WALNUT	28 cm	12m	GOOD	FAIR	GROWTH MOSTLY ON ONE SIDE	REMOVE
18*	JUGLANS NIGRA	BLACK WALNUT	24 cm	9.5cm	GOOD	FAIR	GROWING IN FENCE	REMOVE
19	JUGLANS NIGRA	BLACK WALNUT	19 cm	7.3m	GOOD	GOOD	IN GOOD CONDITION	REMOVE
20*	ACER PLATANOIDES	NORWAY MAPLE	22cm	6m	FAIR	N/C		REMOVE
21*	JUGLANS REGIA	ENGLISH WALNUT	18 cm	6m	FAIR	POOR	GROWTH MOSTLY ON ONE SIDE POOR FORM	REMOVE

22	JUGLANS NIGRA	BLACK WALNUT	24cm	9m	GOOD	GOOD/FAIR	COULD BE A HYBRID WALNUT	RETAIN
23	ACER NEGUNDO	MANITOBA MAPLE	10-11 cm	7.3m	GOOD	GOOD/FAIR	OFF SITE	PROTECT DURING CONSTRUCTION
24	ACER NEGUNDO	MANITOBA MAPLE	15 cm	7.3m	GOOD	GOOD/FAIR	OFF SITE	PROTECT DURING CONSTRUCTION
25	CATALPA SPECIOSA	NORTHERN CATALPA	21-22 cm	7m	GOOD	GOOD	OFF SITE	PROTECT DURING CONSTRUCTION
26	JUGLANS NIGRA	BLACK WALNUT	60 cm	18.2m	GOOD	GOOD	IN GOOD CONDITION	REMOVE
