PROJECT NO.: SM 188450-E

**PHASE ONE ENVIRONMENTAL SITE ASSESSMENT
9 AND 11 KERMAN AVENUE
GRIMSBY, ONTARIO**

**SOIL-MAT ENGINEERS & CONSULTANTS LTD.
130 LANCING DRIVE
HAMILTON, ONTARIO
L8W 3A1**

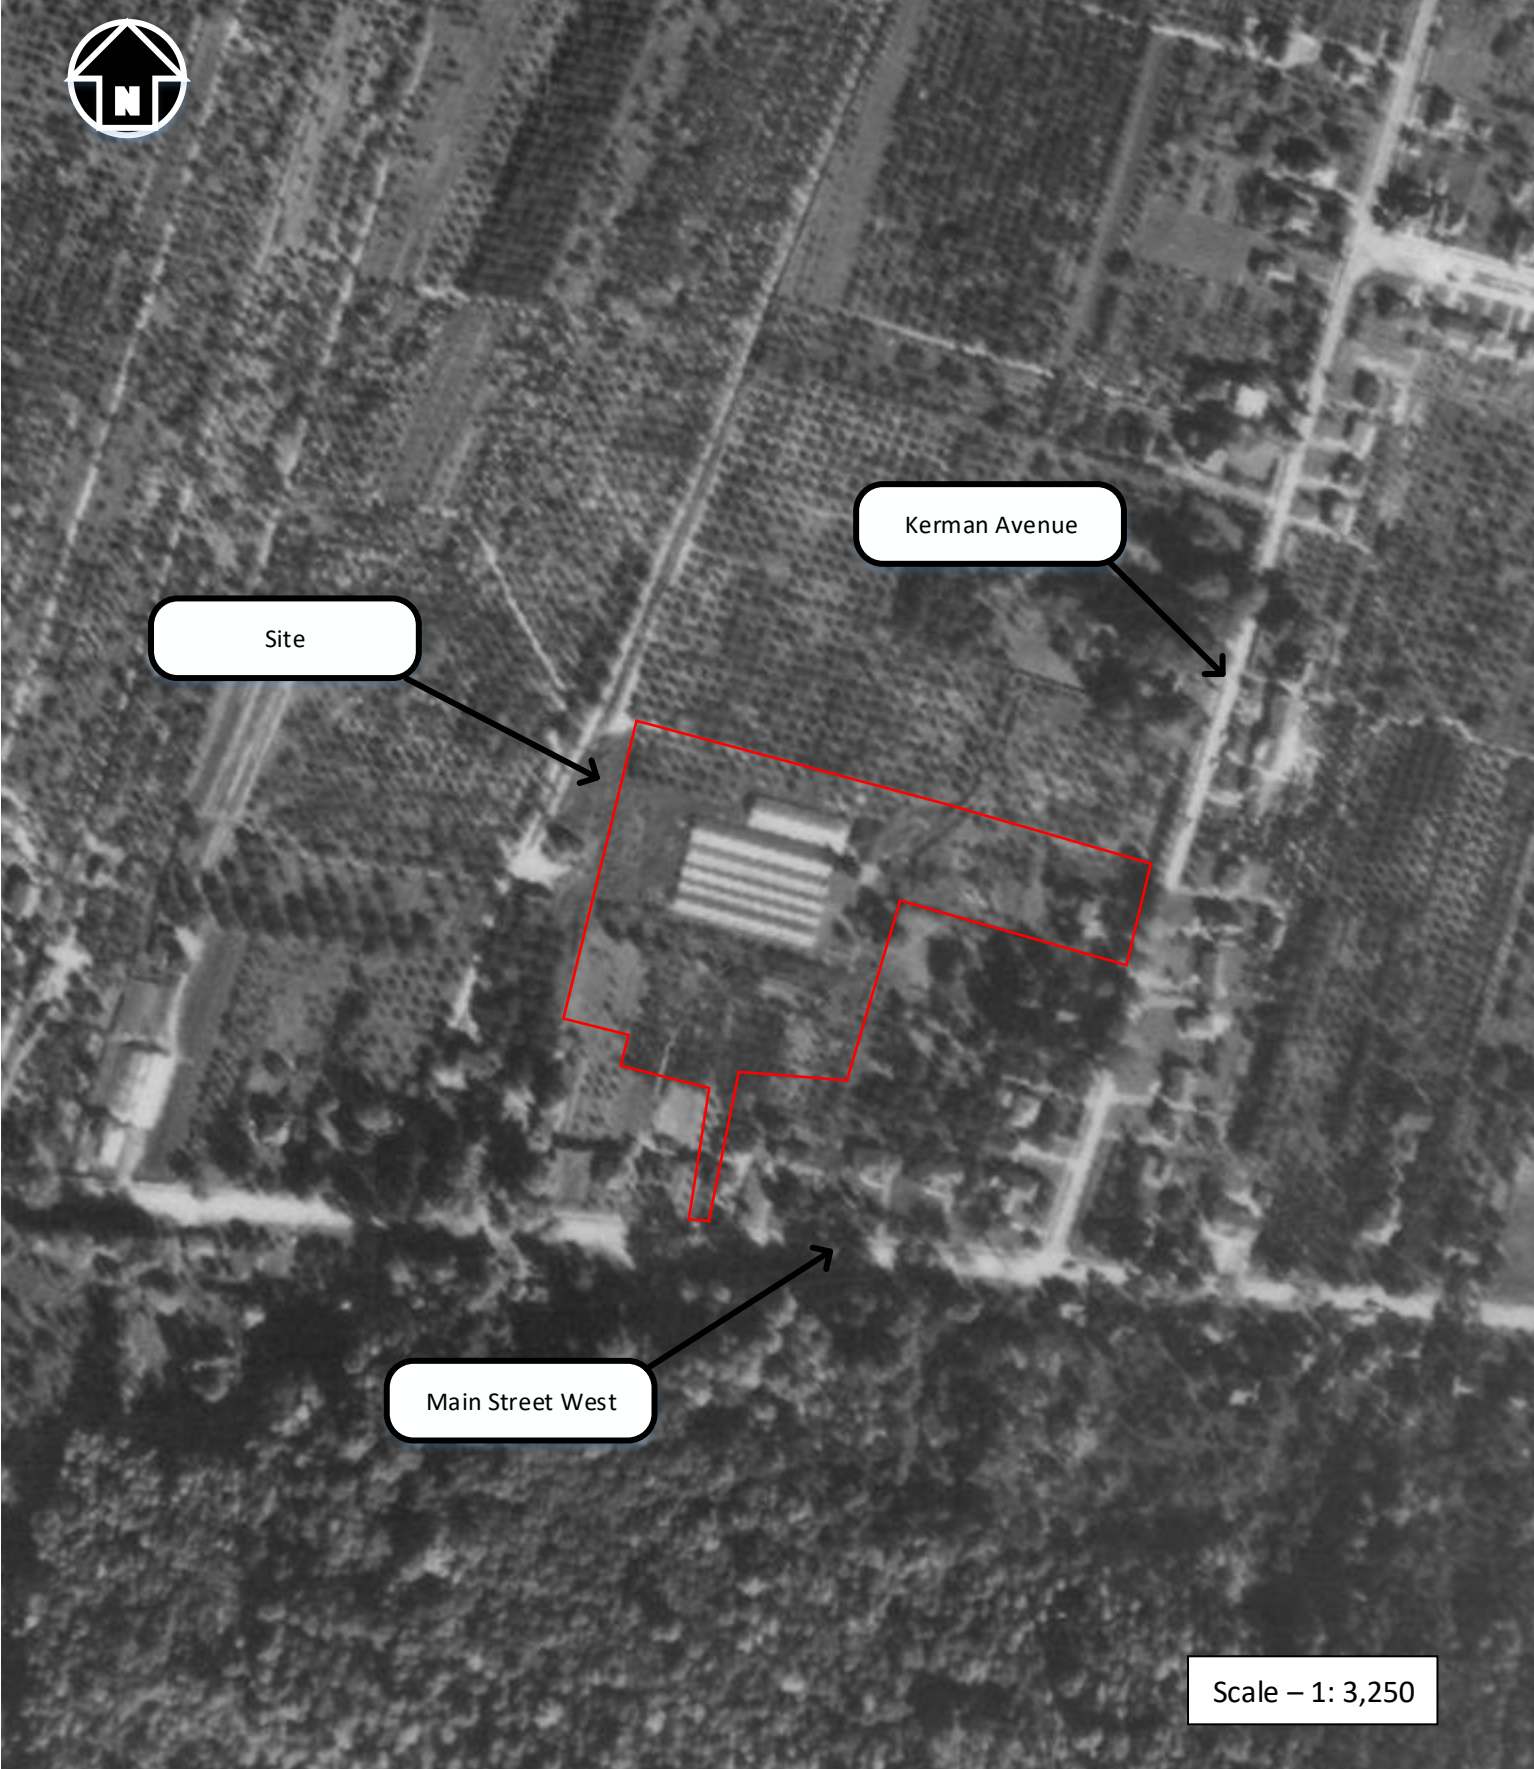
Aerial Photo - 1965

1965 [1:3,250]	Additional greenhouse structures have been erected to the north and south of the existing greenhouse operation on the Site. Some of the orchards on the Site have been removed and replaced with grass surfaced areas.	There is residential development to the east of the Site.
1978 [1:3,250]	The greenhouse buildings have been demolished and a new greenhouse structure has been erected. The driveway connecting to Kerman Avenue appears to have been resurfaced with either granular or asphaltic-concrete.	Livingston Avenue has been extended to the west of Kerman Avenue and now runs north of the Site. There is residential development along the extension of Livingston Avenue as well as to the east of Kerman Avenue.
