REPORT TO: B. Longfield, Chair and Members of the Heritage Advisory Committee

RE: **Proposal for Designation, Carnegie Building (1912), 25 Adelaide Street**

DATE: September 13, 2004

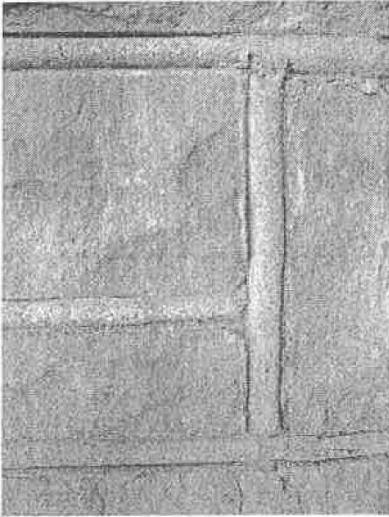
The stone foundation wall is laid in a Random Ashlar pattern. The individual stones have a rock-faced finish. The mortar joints are raised in a plain semicircular cross section.

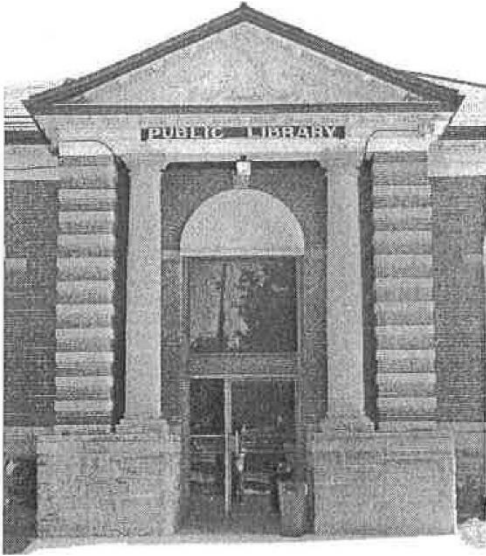
The windows have three vertical panes divided by pilastered mullions. The windows are topped with a semicircular arch with a simple 3-pane sunburst and are sitting on a paneled base. The brick arches surrounding the windows are highlighted by a concrete key and bases.

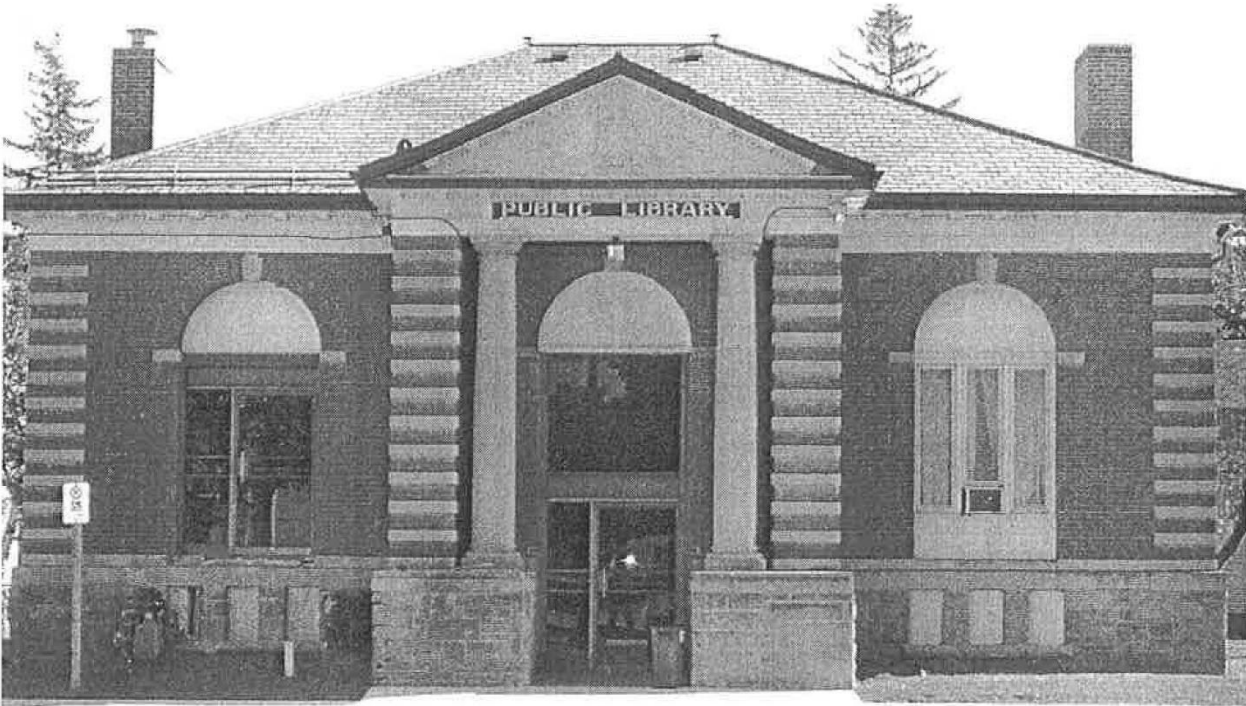
South Elevation

The basement windows and the arches above all of the window and door have been boarded up. The middle pane of the easterly window has been shortened to accommodate an air conditioning unit.

The main entrance has been lowered, presumably to improve access to the basement, and the steps have been removed. A steel framed glass doorway has replaced the main door. A steel framed stained glass panel has been inserted between the new door and the arch.

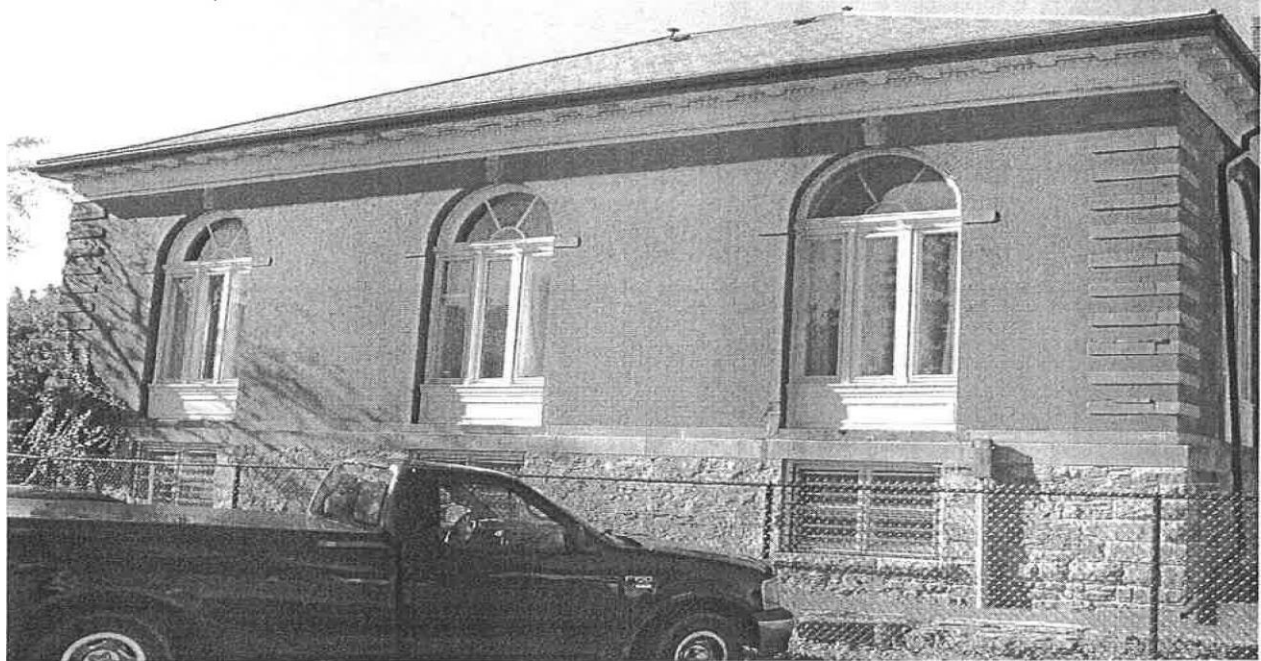
North Side Elevation

This elevation has sustained the least number of changes. The windows are intact and have not been covered up.

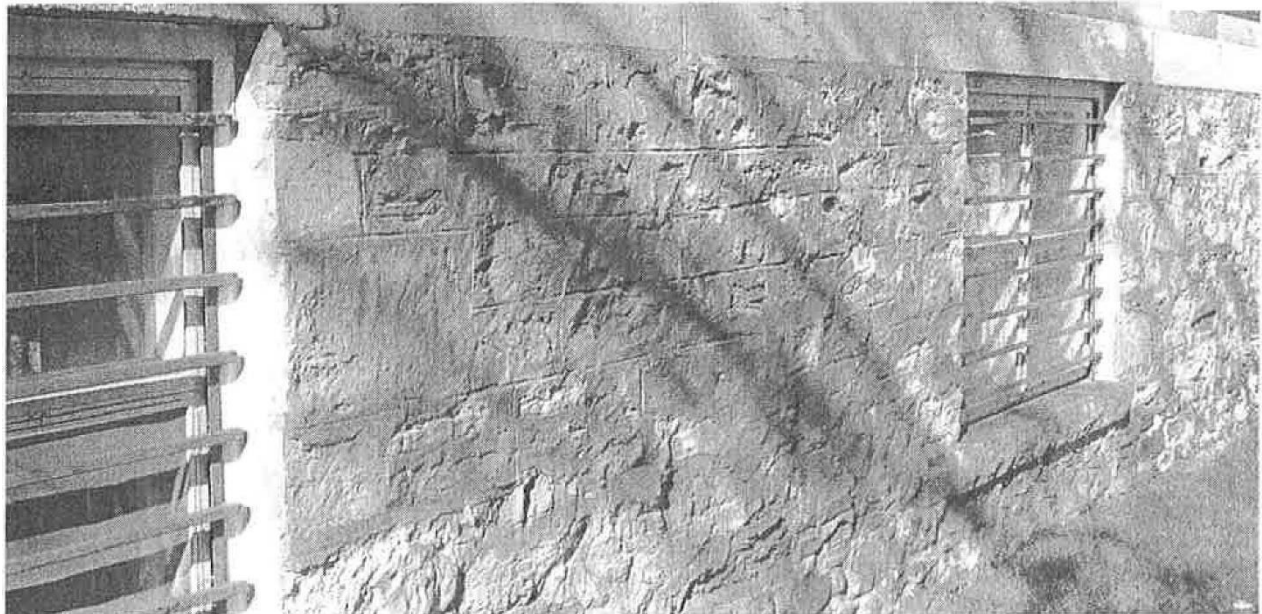
The stone foundation on this side appears to have been covered up at one time with a course material similar to that of the mortar used between the stones. About half has fallen off.
