SCOPED ENVIRONMENTAL IMPACT STATEMENT
540-544 NORTH SERVICE ROAD, TOWN OF GRIMSBY

LJM Developments Inc.

Colville Consulting Inc.

File: C23062
October 2023

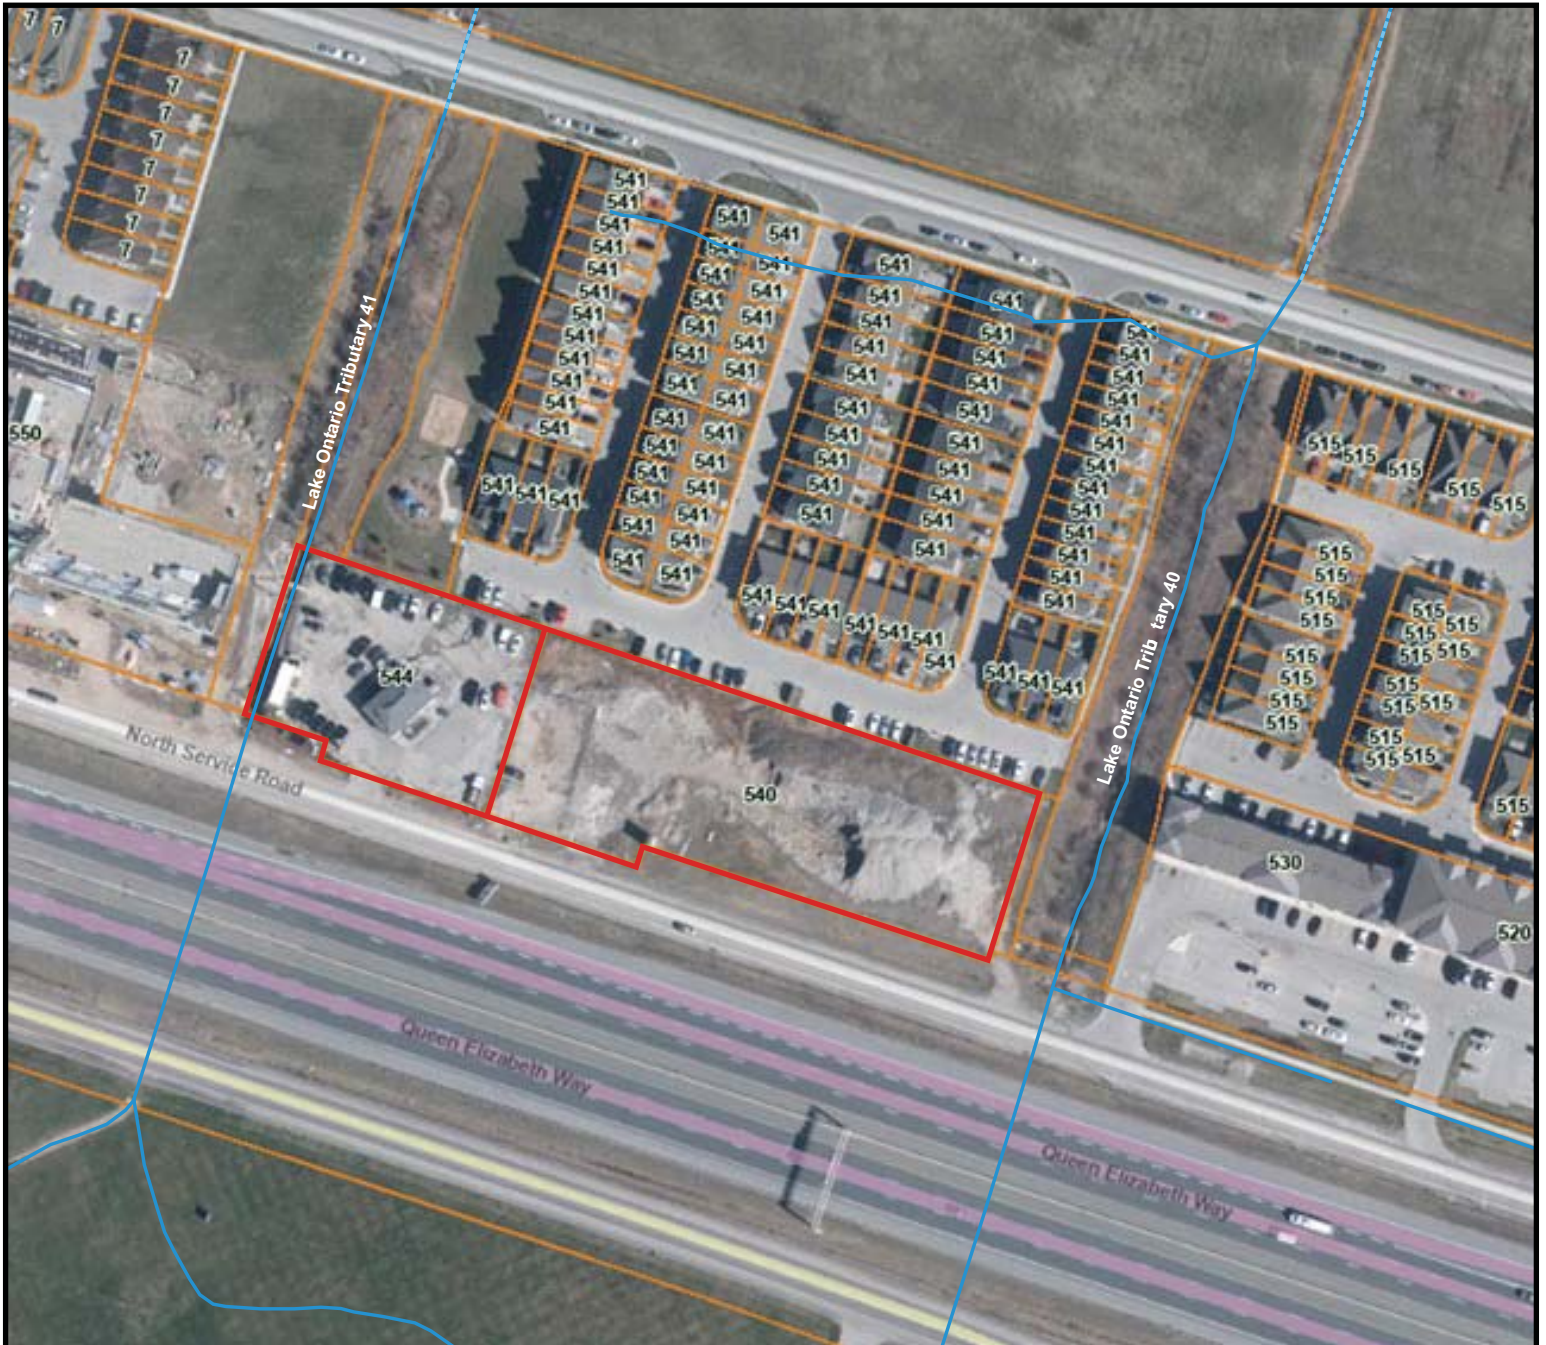
Figure 2
Mapped Extent of Natural Heritage Features on the Subject Properties

Based on our review of NPCA mapping, it is our understanding that regulated features on and adjacent to the properties consist of the channels associated with Lake Ontario Tributaries 40 and 41 (see Figure 2).

Mapped regulated features on the Subject Properties are limited to Lake Ontario Tributaries 41, which is located along the west side of the 544 North Service Road property. A second watercourse, Lake Ontario Tributary 40 is located east of the 540 North Service Road property.

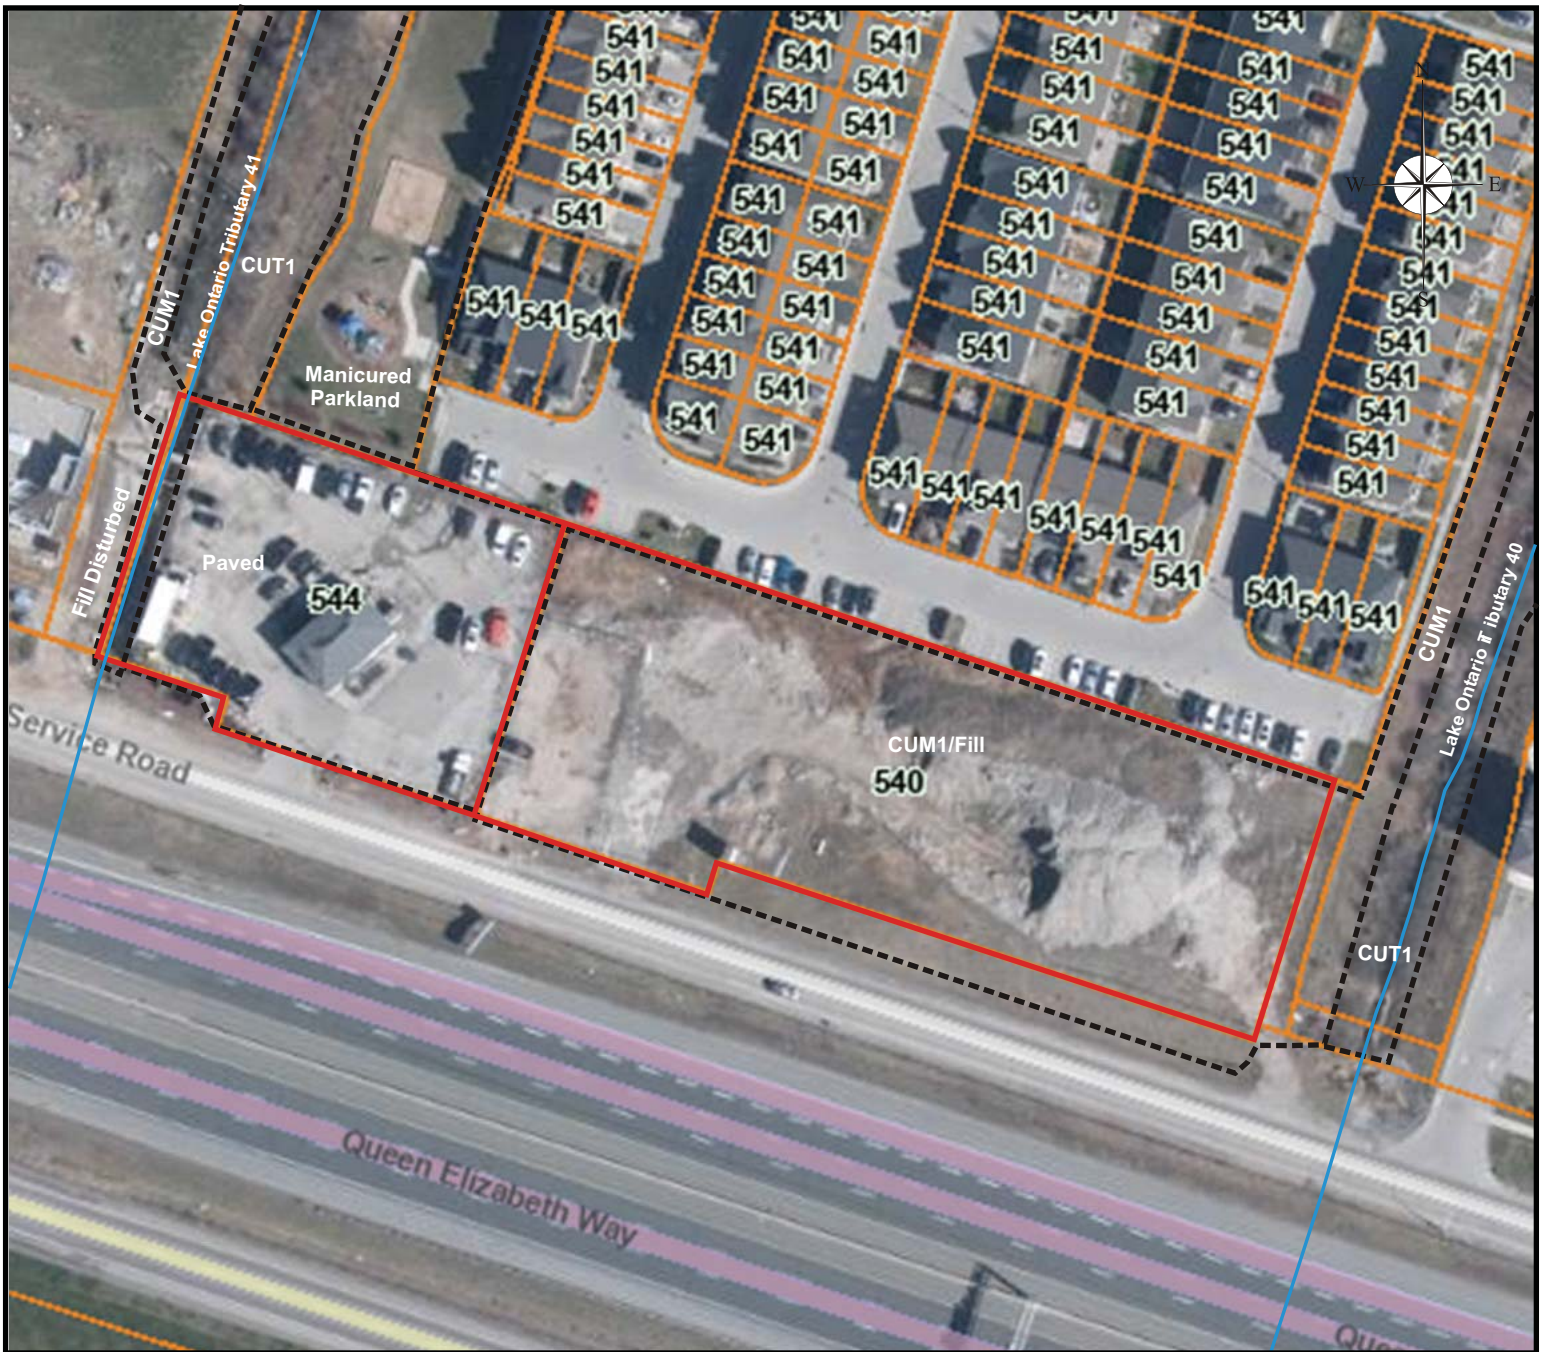
**Figure 3
Extent of Vegetation Communities
on and Adjacent to the Subject Properties**

The Subject Properties measure approximately 0.79ha (1.95 acres) in size, with the majority of lands highly disturbed or paved. Naturalized vegetation communities on these properties are generally limited to a cultural meadow on the 540 North Service Road property, with narrow bands of thicket associated with the riparian areas of the watercourses. Further descriptions of these communities are provided below and illustrated in Photos 9 and 10 of Appendix C.

Located primary on the 540 North Service Road property is a Mineral Cultural Meadow Ecosite (CUM1). This community occurs primarily on fill and disturbed lands. Species such as Common Ragweed, Goldenrods, Kentucky Blue Grass, Orchard Grass, Curly Dock, Wild Carrot White Sweet-clover and Red Clover dominate this community.

Located adjacent to Lake Ontario Tributaries 40 and 41 are narrow bands of Mineral Cultural Thicket Ecosite (CUT1). Hawthorn species dominate this community, which occurs primarily on the bank and adjacent lands of the watercourses. Ground covers consist of species similar to the meadow.

As illustrated in Figure 3 Lake Ontario Tributary 41 is located on the west side of the Subject Lands. This watercourse appears to originate at the railway tracks approximately 500m south of the property and also conveys water intermittently north to Lake Ontario.

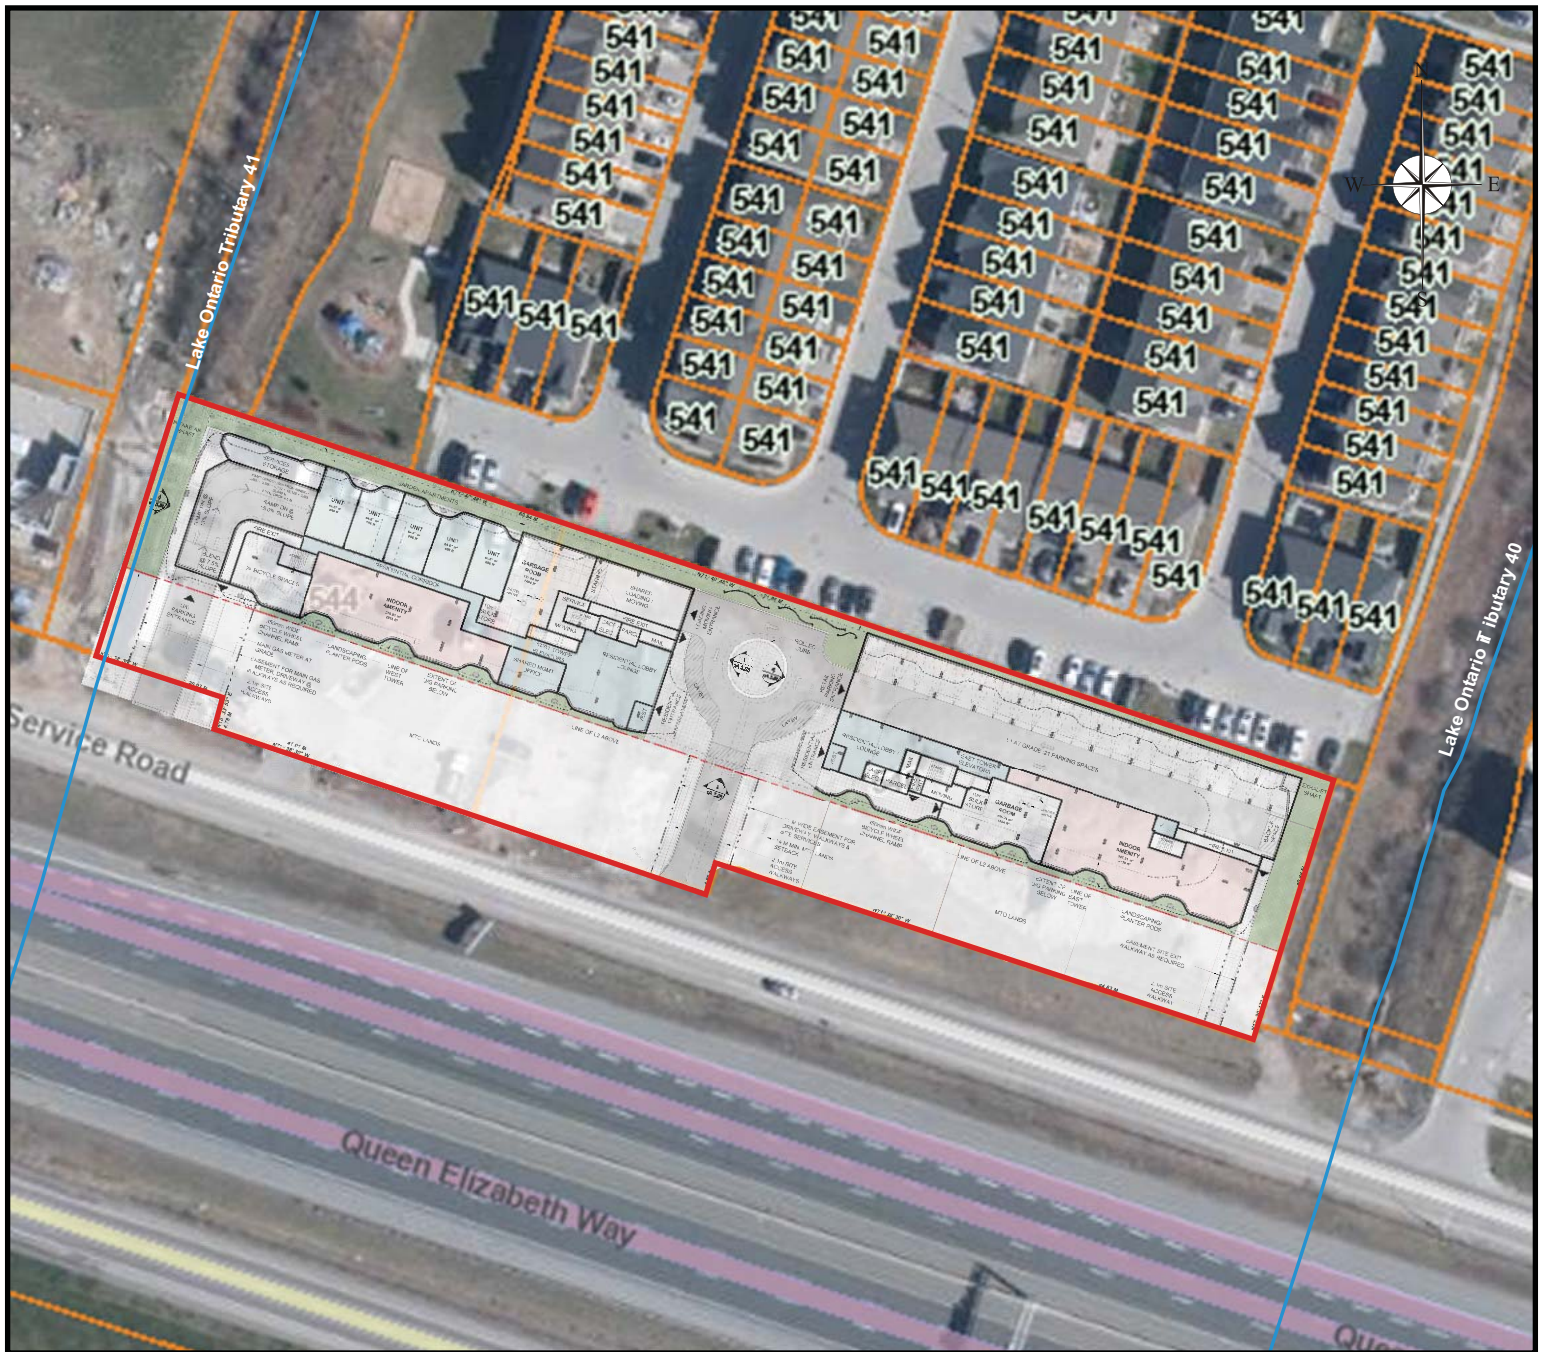
Figure 4
Refined Natural Heritage Features
on and Adjacent to the Subject Properties

As illustrated in Figure 4, the channel associated with Lake Ontario Tributary 41 is located approximately 4m from the proposed west tower. Based on our assessment, construction of the west tower will not impact the water conveyance function of Lake Ontario Tributary 41 and no impact to fish habitat or ecological functions will occur as a result of this project.

During our assessment it was noted that the east bank of this watercourse is supported by a concrete block retaining wall. Little to no naturalized vegetation occurs east of the retaining wall, as this area is generally paved and formerly used as parking area associated with the past uses of the building on the property.

It is our understanding that pavement adjacent to the channel is intended to be removed as part of this project, with the lands between the building and channel to be landscaped. To minimize the potential for any additional non-native or invasive species to be introduced to this area, it is recommended that only native or non-invasive species be utilized in the landscape plan.

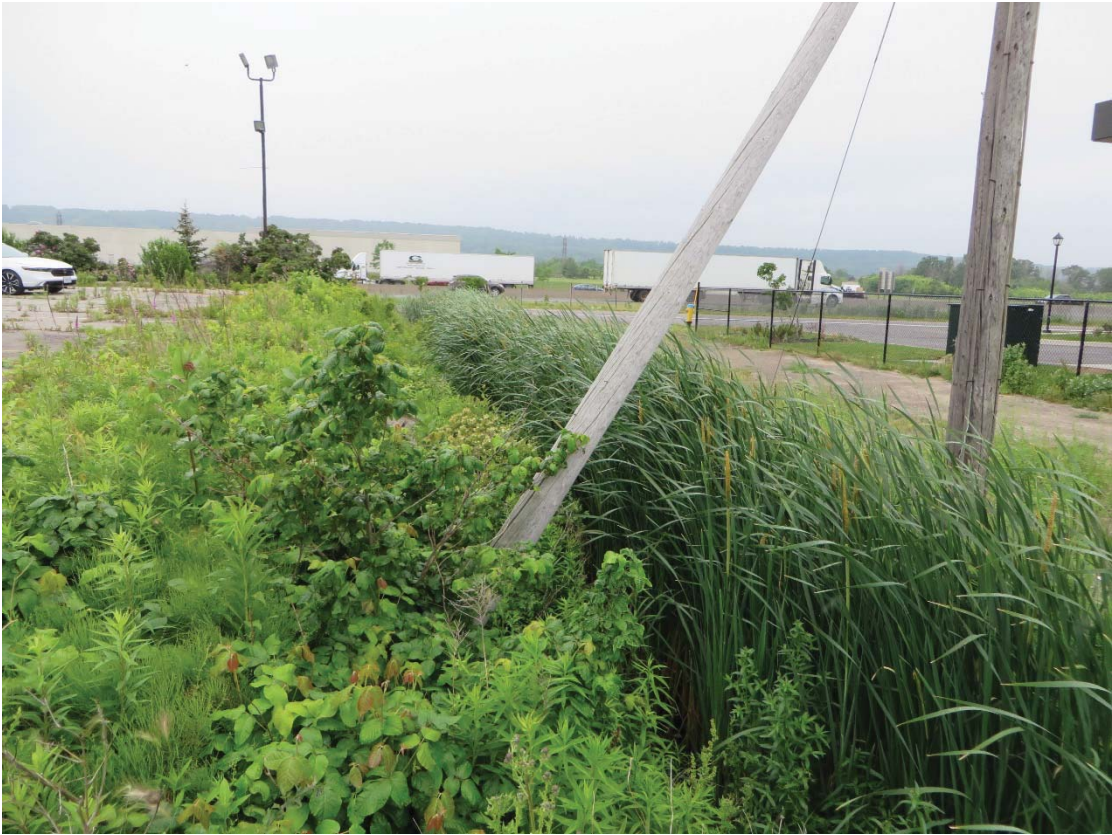
This watercourse emerges from the QEW culvert on the north side of the North Service Road, near the south property limit of 544 North Service Road. The channel of Lake Ontario Tributary 41 on the property is well defined and generally steep sided. The low flow channel of this watercourse is approximately 1.0m in width, while the channel is generally approximately 3.5-4.0m in wide at the top of bank. The eastern edge of the watercourse on this property is generally defined by a concrete block retaining wall on property, while the west bank is generally naturalized (see Photos 1 and 2 of Appendix C).

Photo 1. Example of vegetative conditions within and adjacent to LO Tributary 41 on the west side of the property. Photo from east edge of channel facing south.

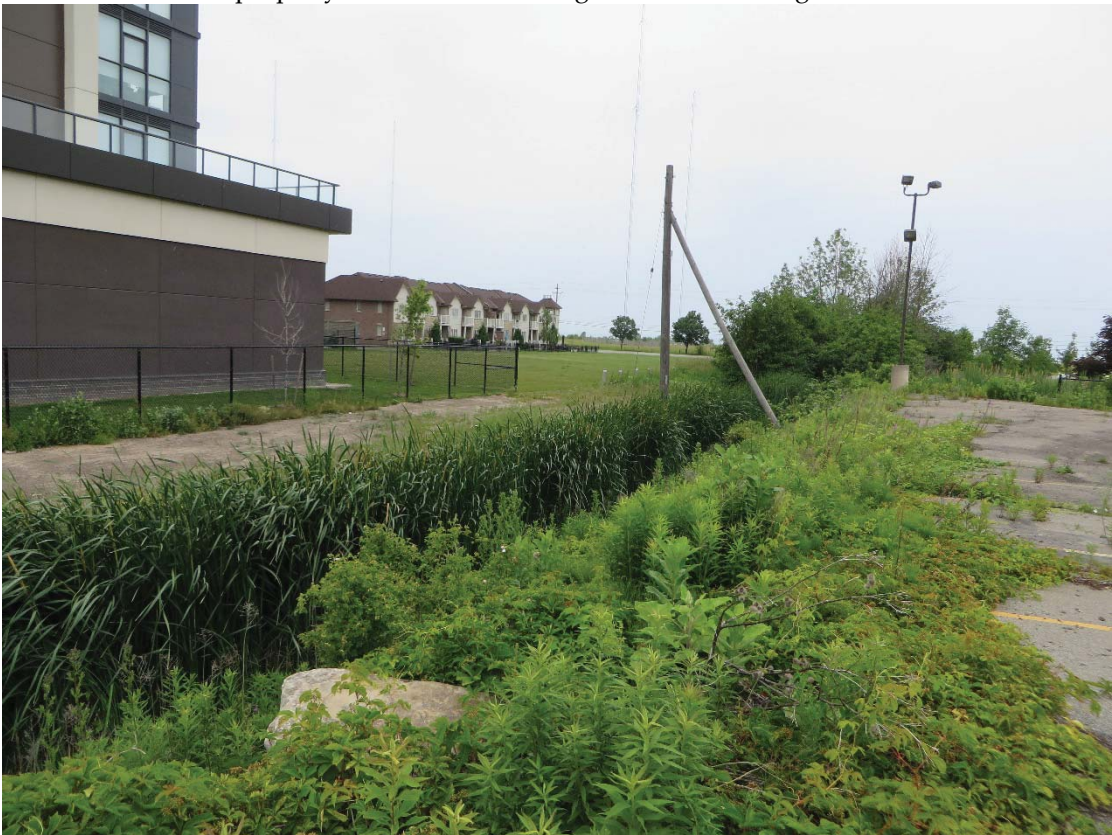
Photo 2. Example of vegetative conditions within and adjacent to LO Tributary 41 on the west side of the property. Photo from east edge of channel facing north.

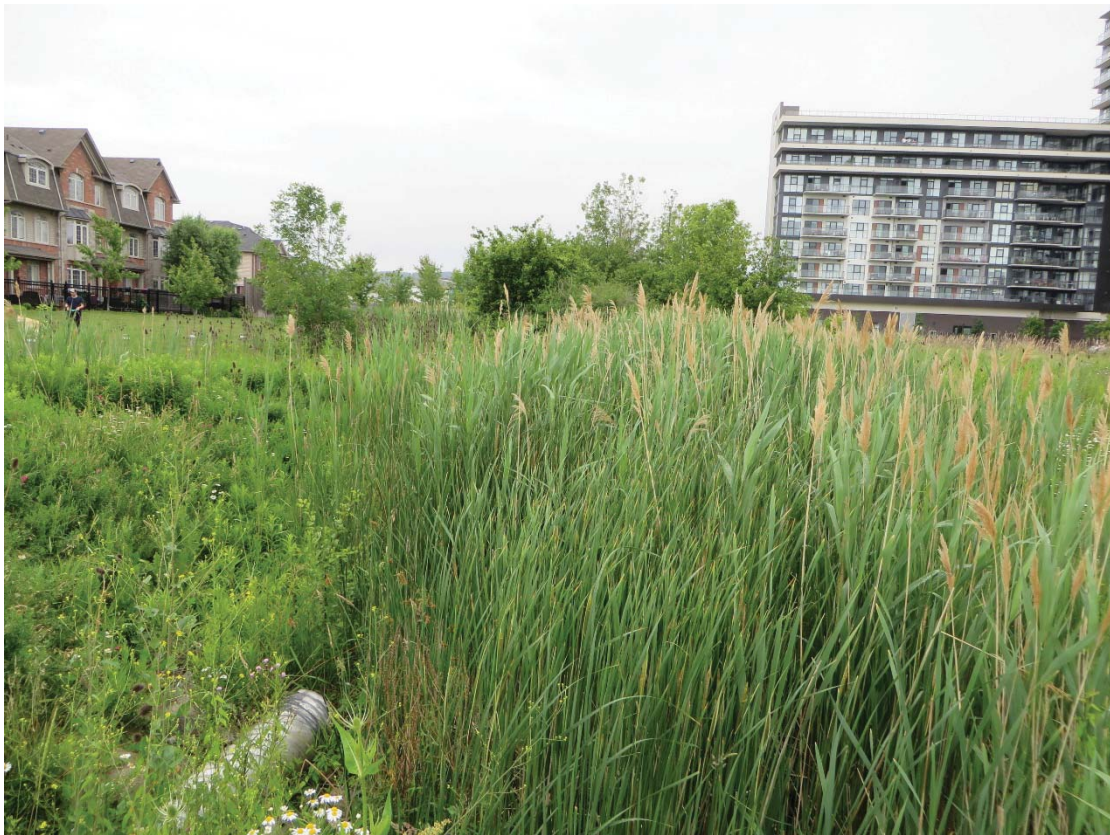
Substrates in the channel consist primarily of silt and clay, which supports emergent species such as Cattails, Common Reed, Soft-stem Bullrush and Water Plantain. Hawthorns and a mix of meadow species occur adjacent to low flow channel north of the property, before transitioning to a Common Reed dominant channel south of Winston Road (see Photo 3 of Appendix C).

Photo 3. Example of vegetative conditions within and adjacent to LO Tributary 41 downstream of property. Photo from south side of Winston Road facing south.

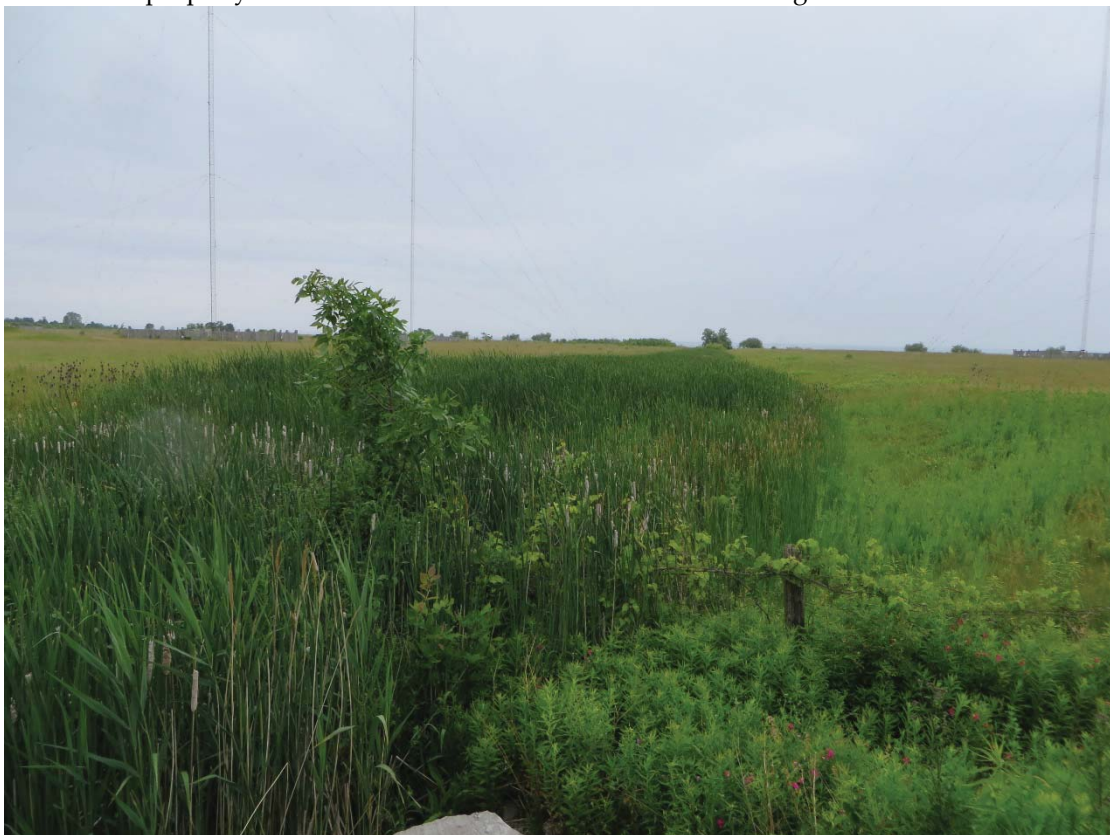
The channel of Lake Ontario Tributary 41 from Winston Road to Lake Ontario is broad and shallow, containing a dense cover of Common Reed and Cattails (see Photo 4 of Appendix C). Similar to Lake Ontario Tributary 40, the outlet of this watercourse at Lake Ontario has also been lined with rip rap. Armour stone shore protection has also been installed across the channel and appears to impede drainage and potential fish movement (see Photo 6 of Appendix C).

Photo 4. Example of vegetative conditions within and adjacent to LO Tributary 41 downstream of property. Photo from north side of Winston Road facing north.

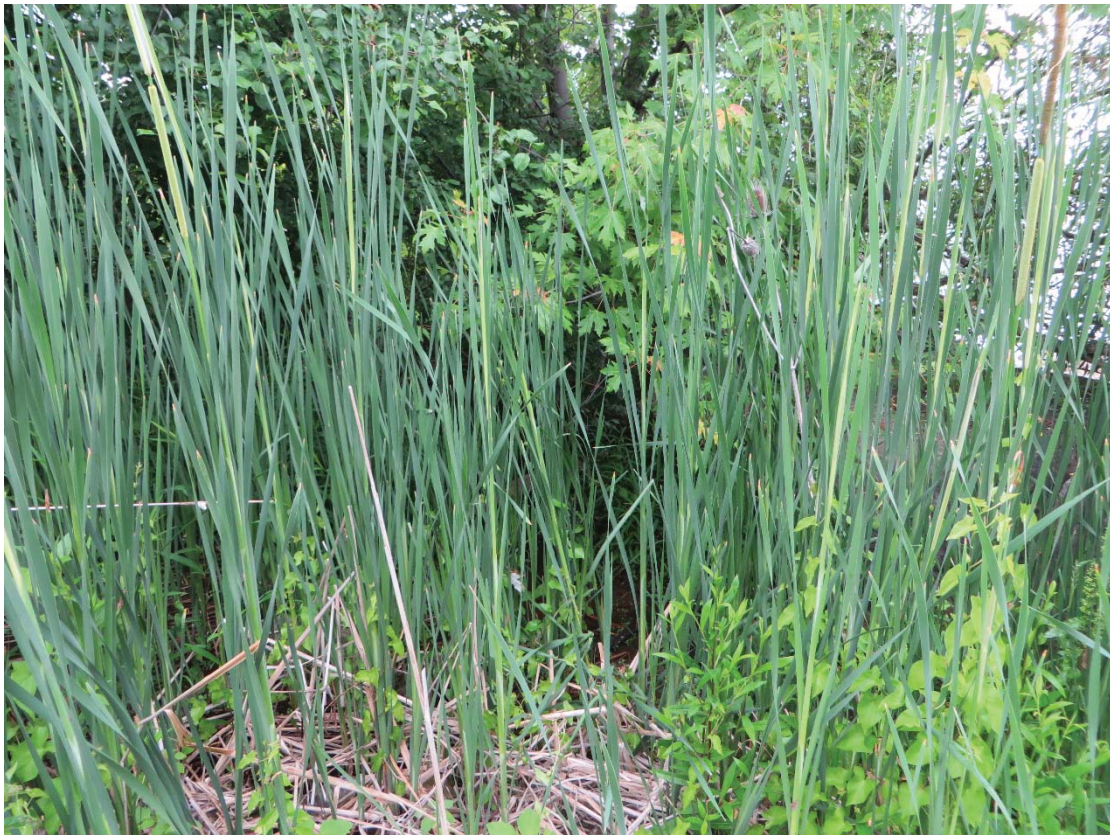
Photo 5. Example of vegetative conditions within and adjacent to LO Tributary 41 at outlet to Lake Ontario.

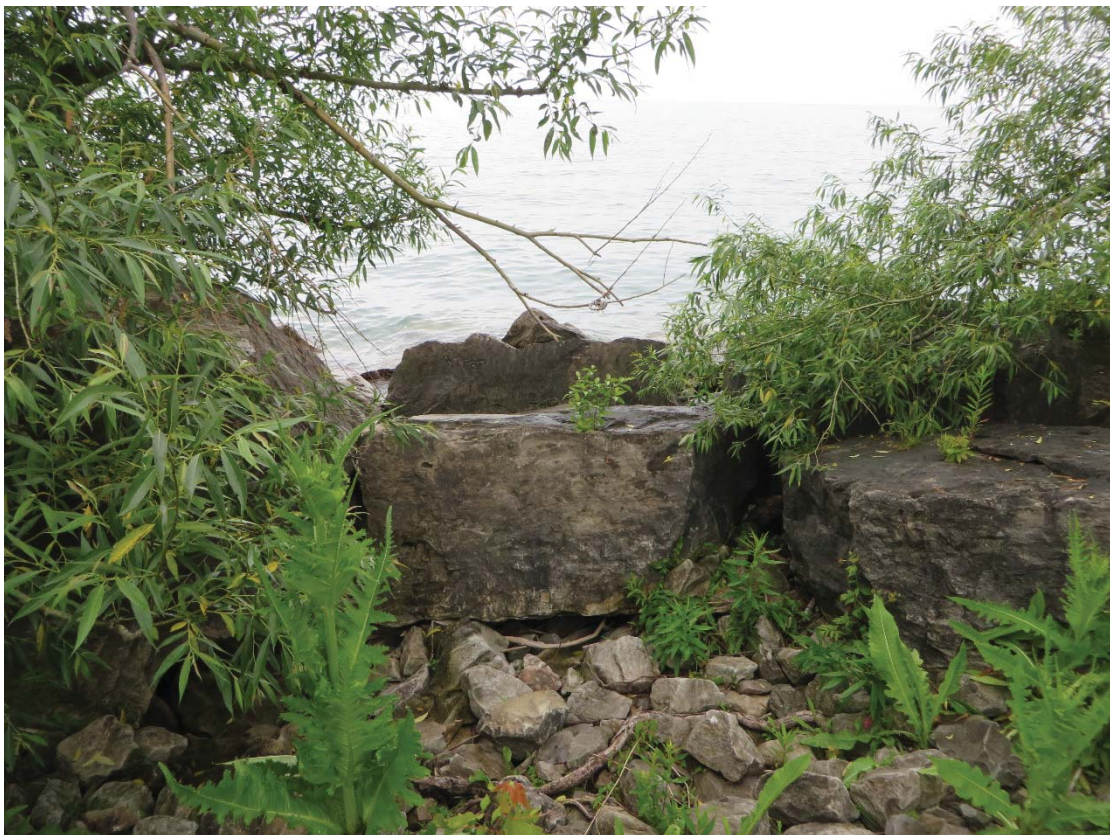
Similar to Lake Ontario Tributary 40, this watercourse does not appear to be capable of providing permanent fish habitat, and barriers to fish movement located at the outlet to Lake Ontario will limit potential seasonal movements of fish into the channel. Therefore, this watercourse is considered to be only contributing to fish habitat in Lake Ontario and does not constitute direct fish habitat.

Photo 6. Example of shore protection across outlet of LO Tributary 41 at Lake Ontario.

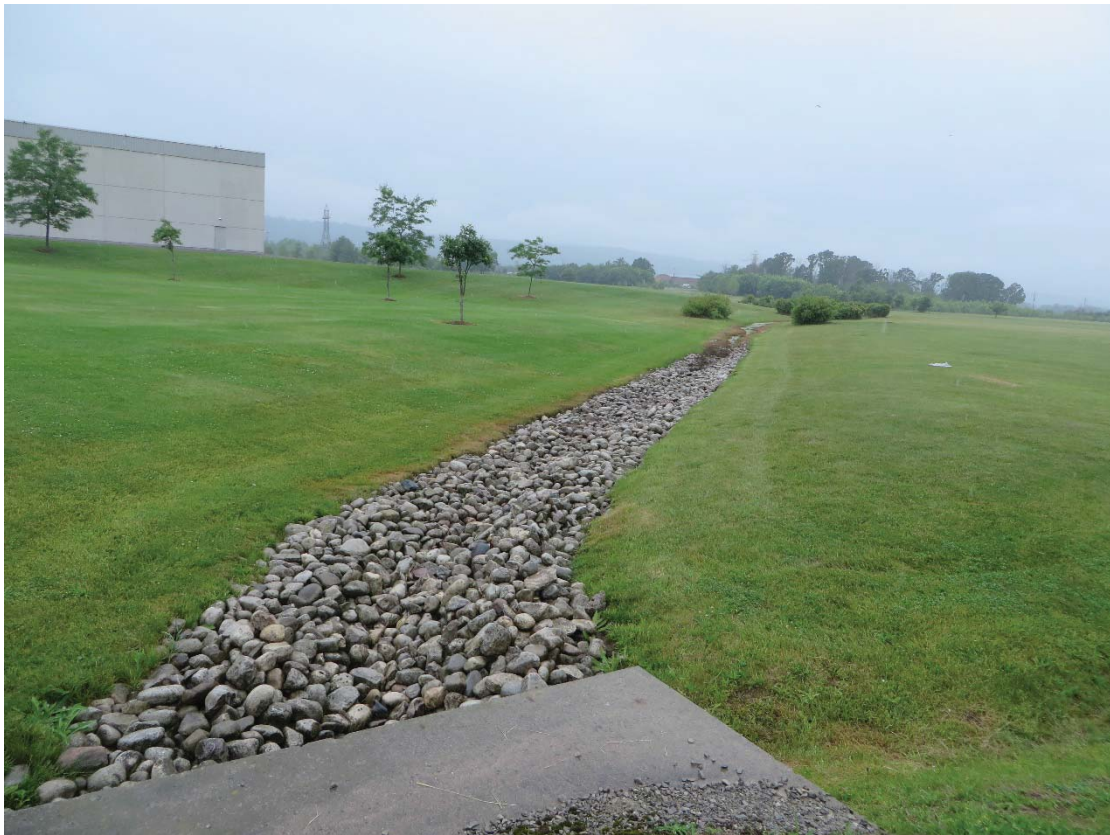
The channel of Lake Ontario Tributary 41 was assessed upstream of the QEW during our field works. Based on observations, this watercourse consists primarily of a shallow, rock-lined channel through mowed lawn (see Photo 7 of Appendix C). No flow was observed in the watercourse upstream of the QEW on June 23, 2023.

Photo 7. Example of vegetative conditions within and adjacent to LO Tributary 41 upstream of QEW. Photo from south side of South Service Road facing south.

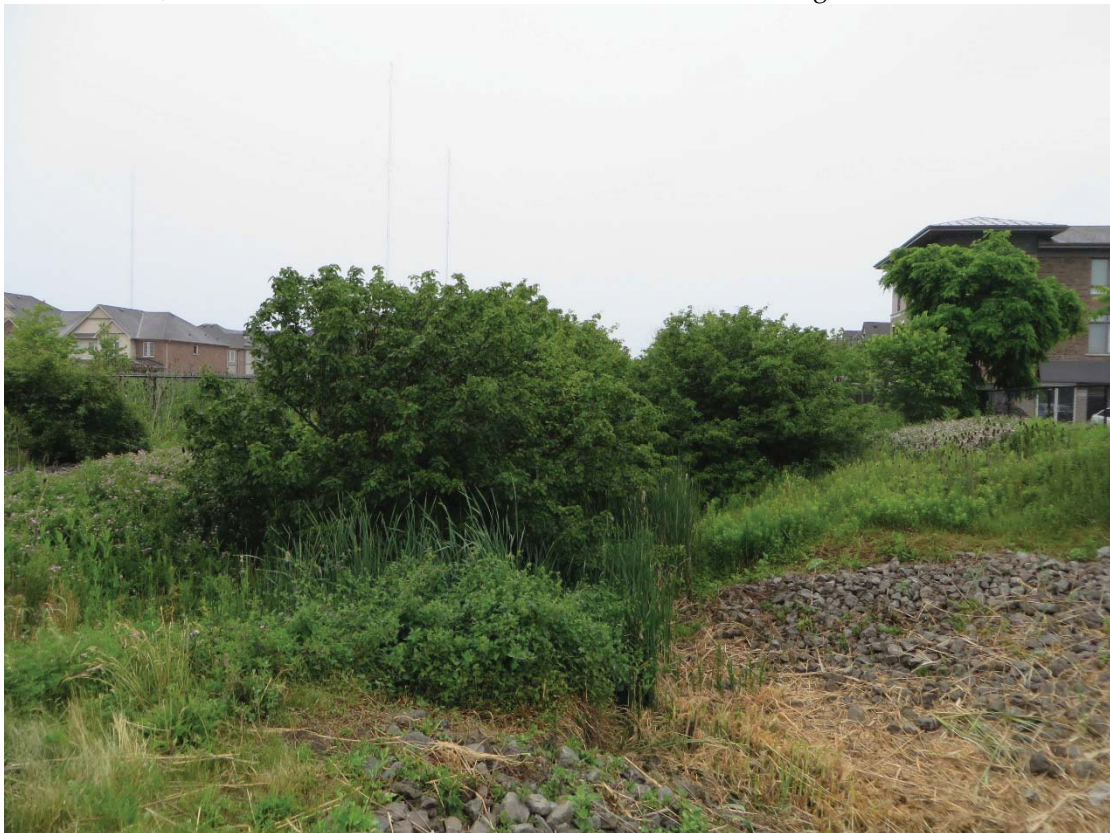
Photo 8. Example of vegetative conditions within and adjacent to LO Tributary 40 east of the property. Photo from North Service Road facing north.

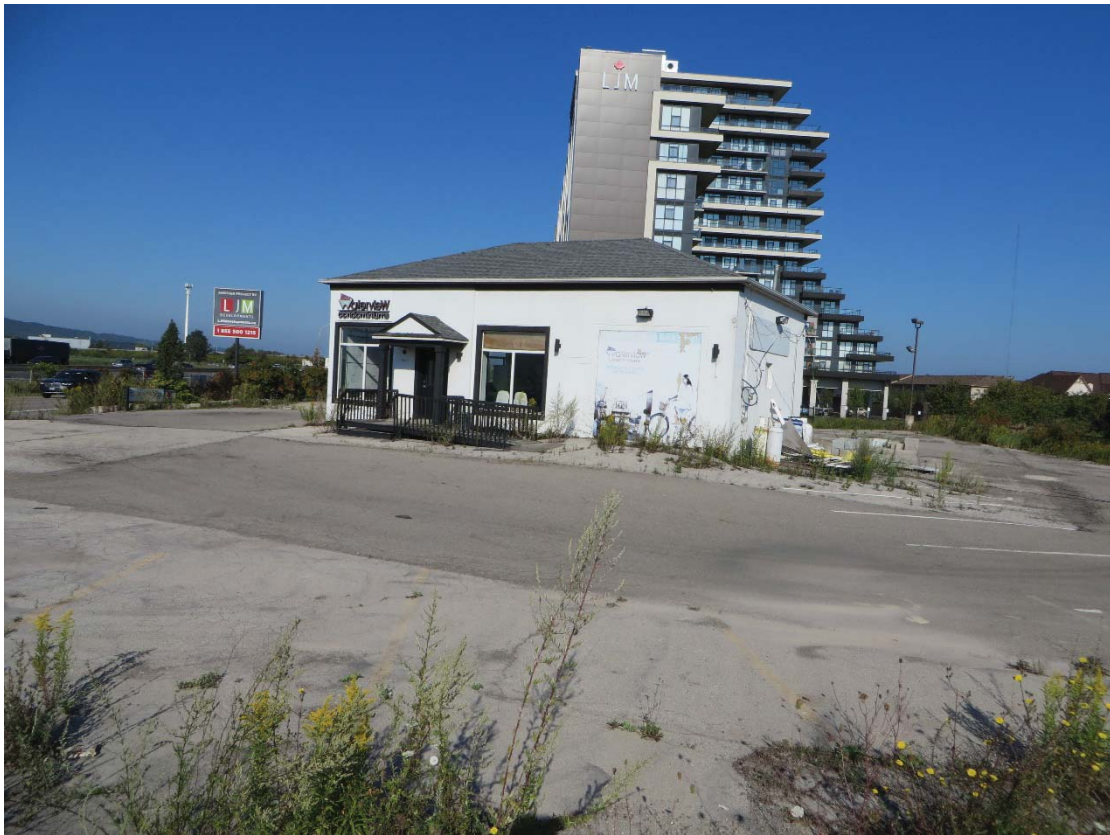
Photo 9. Example of site conditions on the 544 North Service Road property. Photo from east property line facing west.

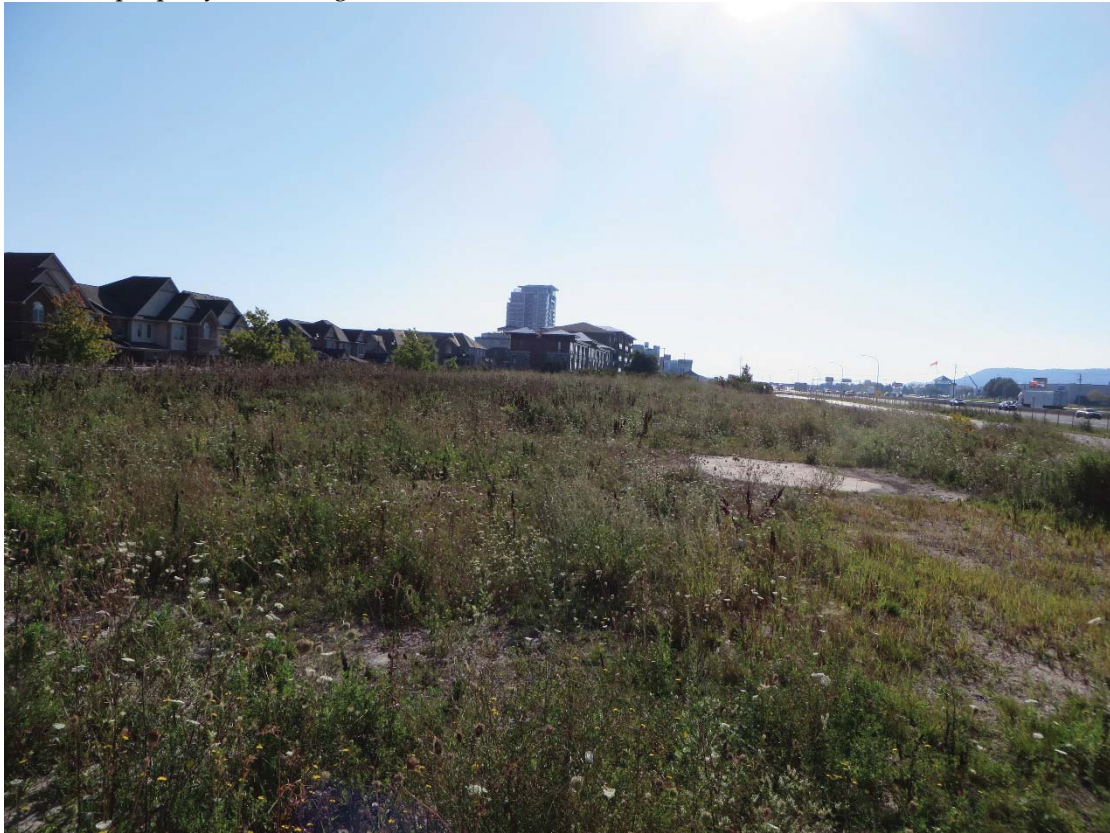
Photo 10. Example of site conditions on the 540 North Service Road property. Photo from western portion of property facing east.
