REPORT TO: B. Longfield, Chair and Members of the Heritage Advisory Committee

RE: Application for Designation HR-08-1, Udell House (1888), 224 Main Street East

DATE: April 22, 2008

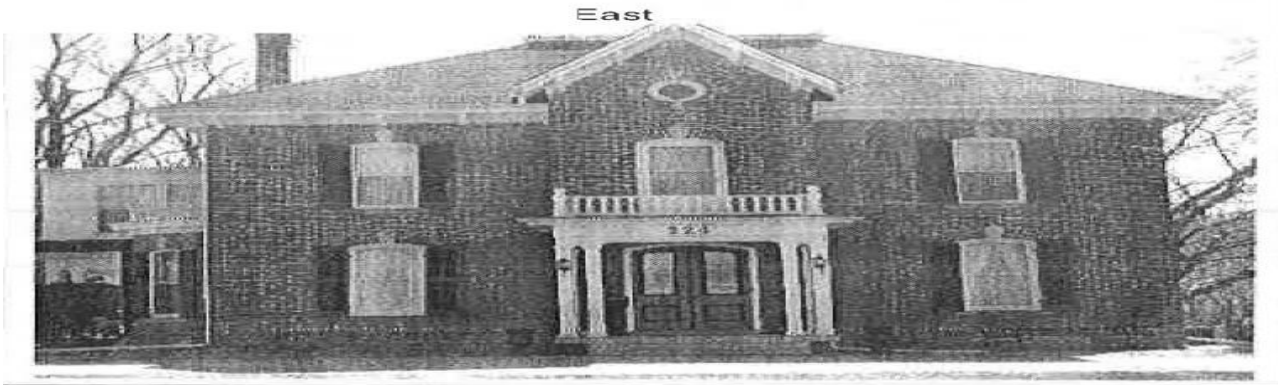
Unique to Ontario is a design for a two storey square residence with projecting eaves and ornate cornice brackets promoted by *The Canadian Farmer* journal in 1865. This residence provided a classical alternative to the Gothic Cottage. People wanted a large house with many bedrooms that had some interesting detailing. A two storey rectangular building with a mild hip roof, a projecting front is piece and generous eaves with ornate cornice brackets, was the basis of the style. Classical elements are used, **but** in a secondary role. There was no pattern book for details or any main architect promoting the style; this was simply a fashion that took hold.

Often added to this model was an eclectic combination of some rural Gothic features such as verge boards or lancet windows, a variety of Classical details and wall finishes executed in a typically stylized or exaggerated mode of the style. The Ontario version was a compromise. It satisfied the desire to be modern or up-to-date with Italianate features, but not to a lavish extent. The subject building, 224 Main Street East is a typical example of this style of architecture. Several examples of this style can be found in Grimsby primarily along Main Street East and West.

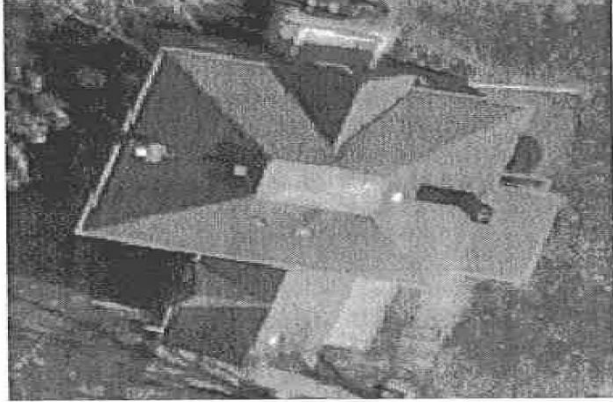
Figure 4 - Aerial Photo of Roof Structure

The house consists of two main sections being the north (front) portion, which is generally a box shape with a hip roof, and the south wing, which has a gable roof. The aerial photograph illustrates the general shape of the house. The hip roof has a flatpeak.

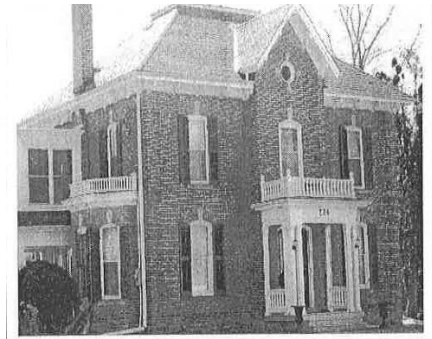
There are several projections from these basic shapes. On the front facade are a gable-topped frontispiece and a front porch. On the east facade are a one-storey bay window and a porch with sunroom above. The roof of the main structure is pierced by two chimneys centrally located on the east and west sides. The east side of the south wing has a one-storey porch and shed dormer while the west side has a secondary gable. The photo to the right illustrates many of these features.

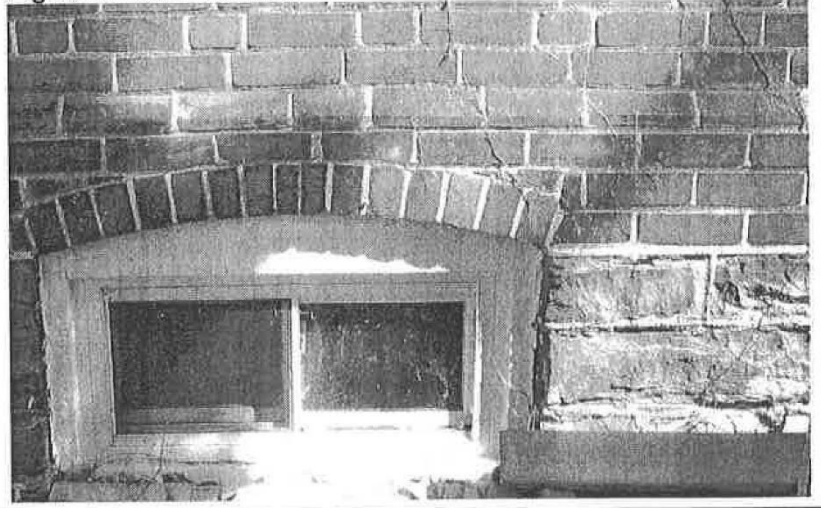
Figure 6 - Stone Foundation

The owners indicate that the house is of double brick construction with a granite stone foundation. The photo to the right details the brickwork and the foundation at the northwest corner of the house. The owners indicate that the stone may have been quarried in Grimsby above Gibson Street. The color is similar to many stone structures in Grimsby.

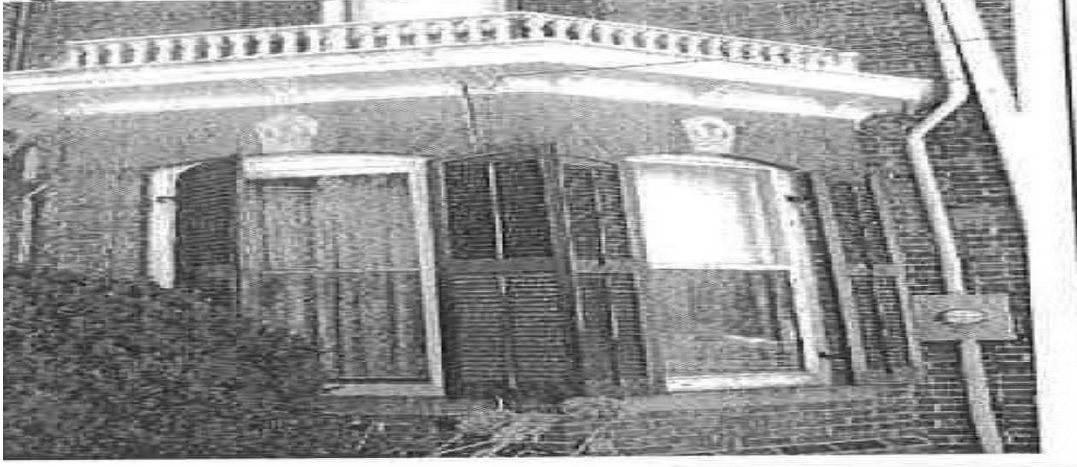
Figure 11 – Bay Window

The bay window at the north east corner of the house (Figure 11) is ornately decorated with brackets windows and capped with a false railing.

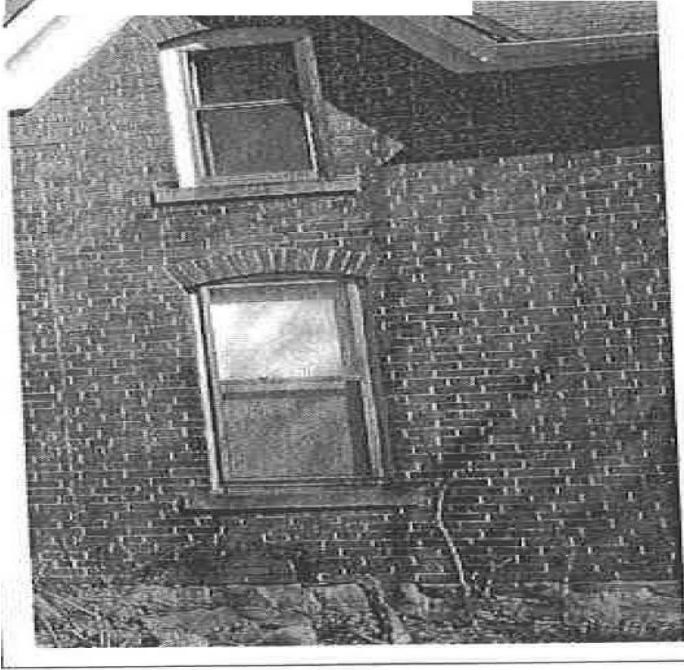
Figure 13 West Side kitchen wing - illustrates the south side of the main house and the west side of the kitchen wing illustrating the difference in ornamentation.

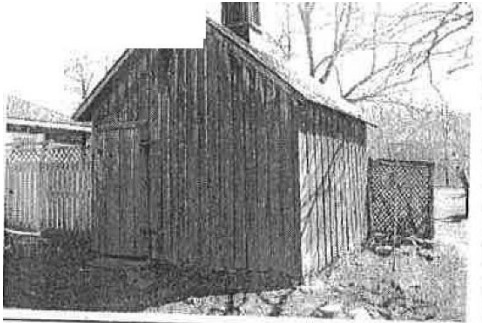
The barn board icehouse is historically significant as one of the few icehouses

remaining in Ontario of that era. There is also a small garage circa 1920's that still has the original boards in the floor.

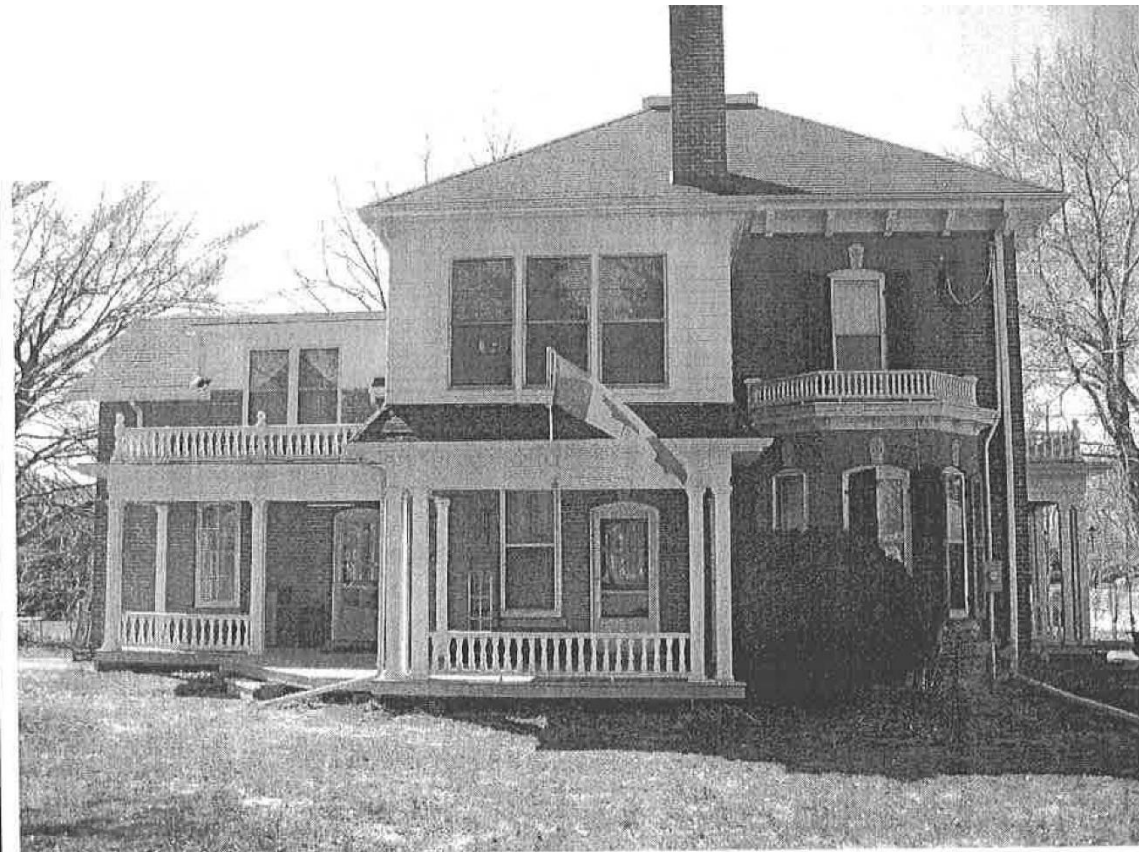
Figure 18 shows the east side of the building with some of the Shafer additions including the porch pillars, the second storey sunroom and the shed dormer on the second floor of the kitchen wing.

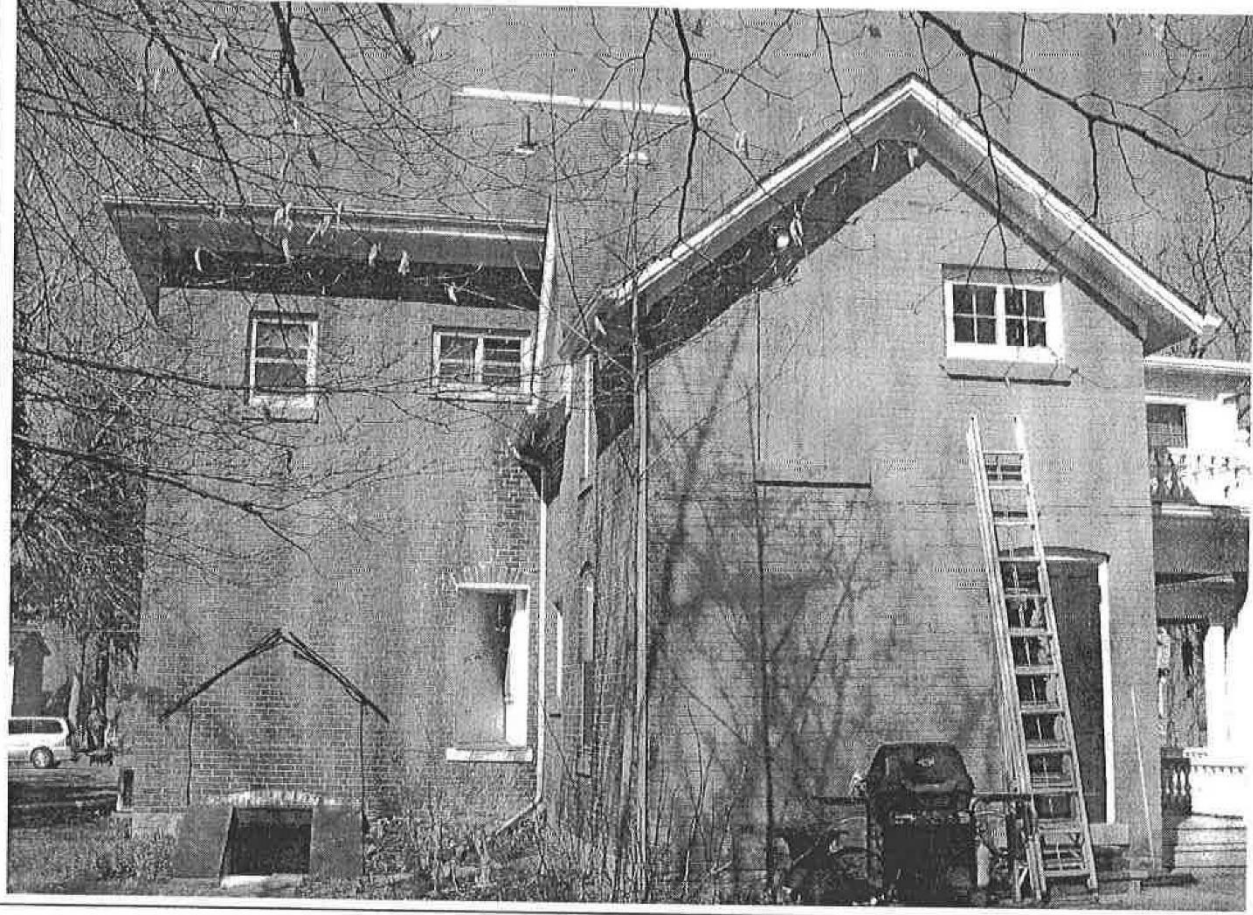
Figure 19 - South Side

The Shafer Brothers may have also installed the windows on the second shown here in Figure 19.

This photo also shows the entrance into the basement at the southeast corner of the house.
