**PHASE ONE  
ENVIRONMENTAL SITE ASSESSMENT  
19 ELM STREET & 13 MOUNTAIN STREET  
GRIMSBY, ONTARIO**

**Prepared for:** **Valentine Coleman Inc.**  
225 Commissioners Street  
Toronto, Ontario  
M4M 0A1

File No 7-18-0051-41  
May 3, 2018

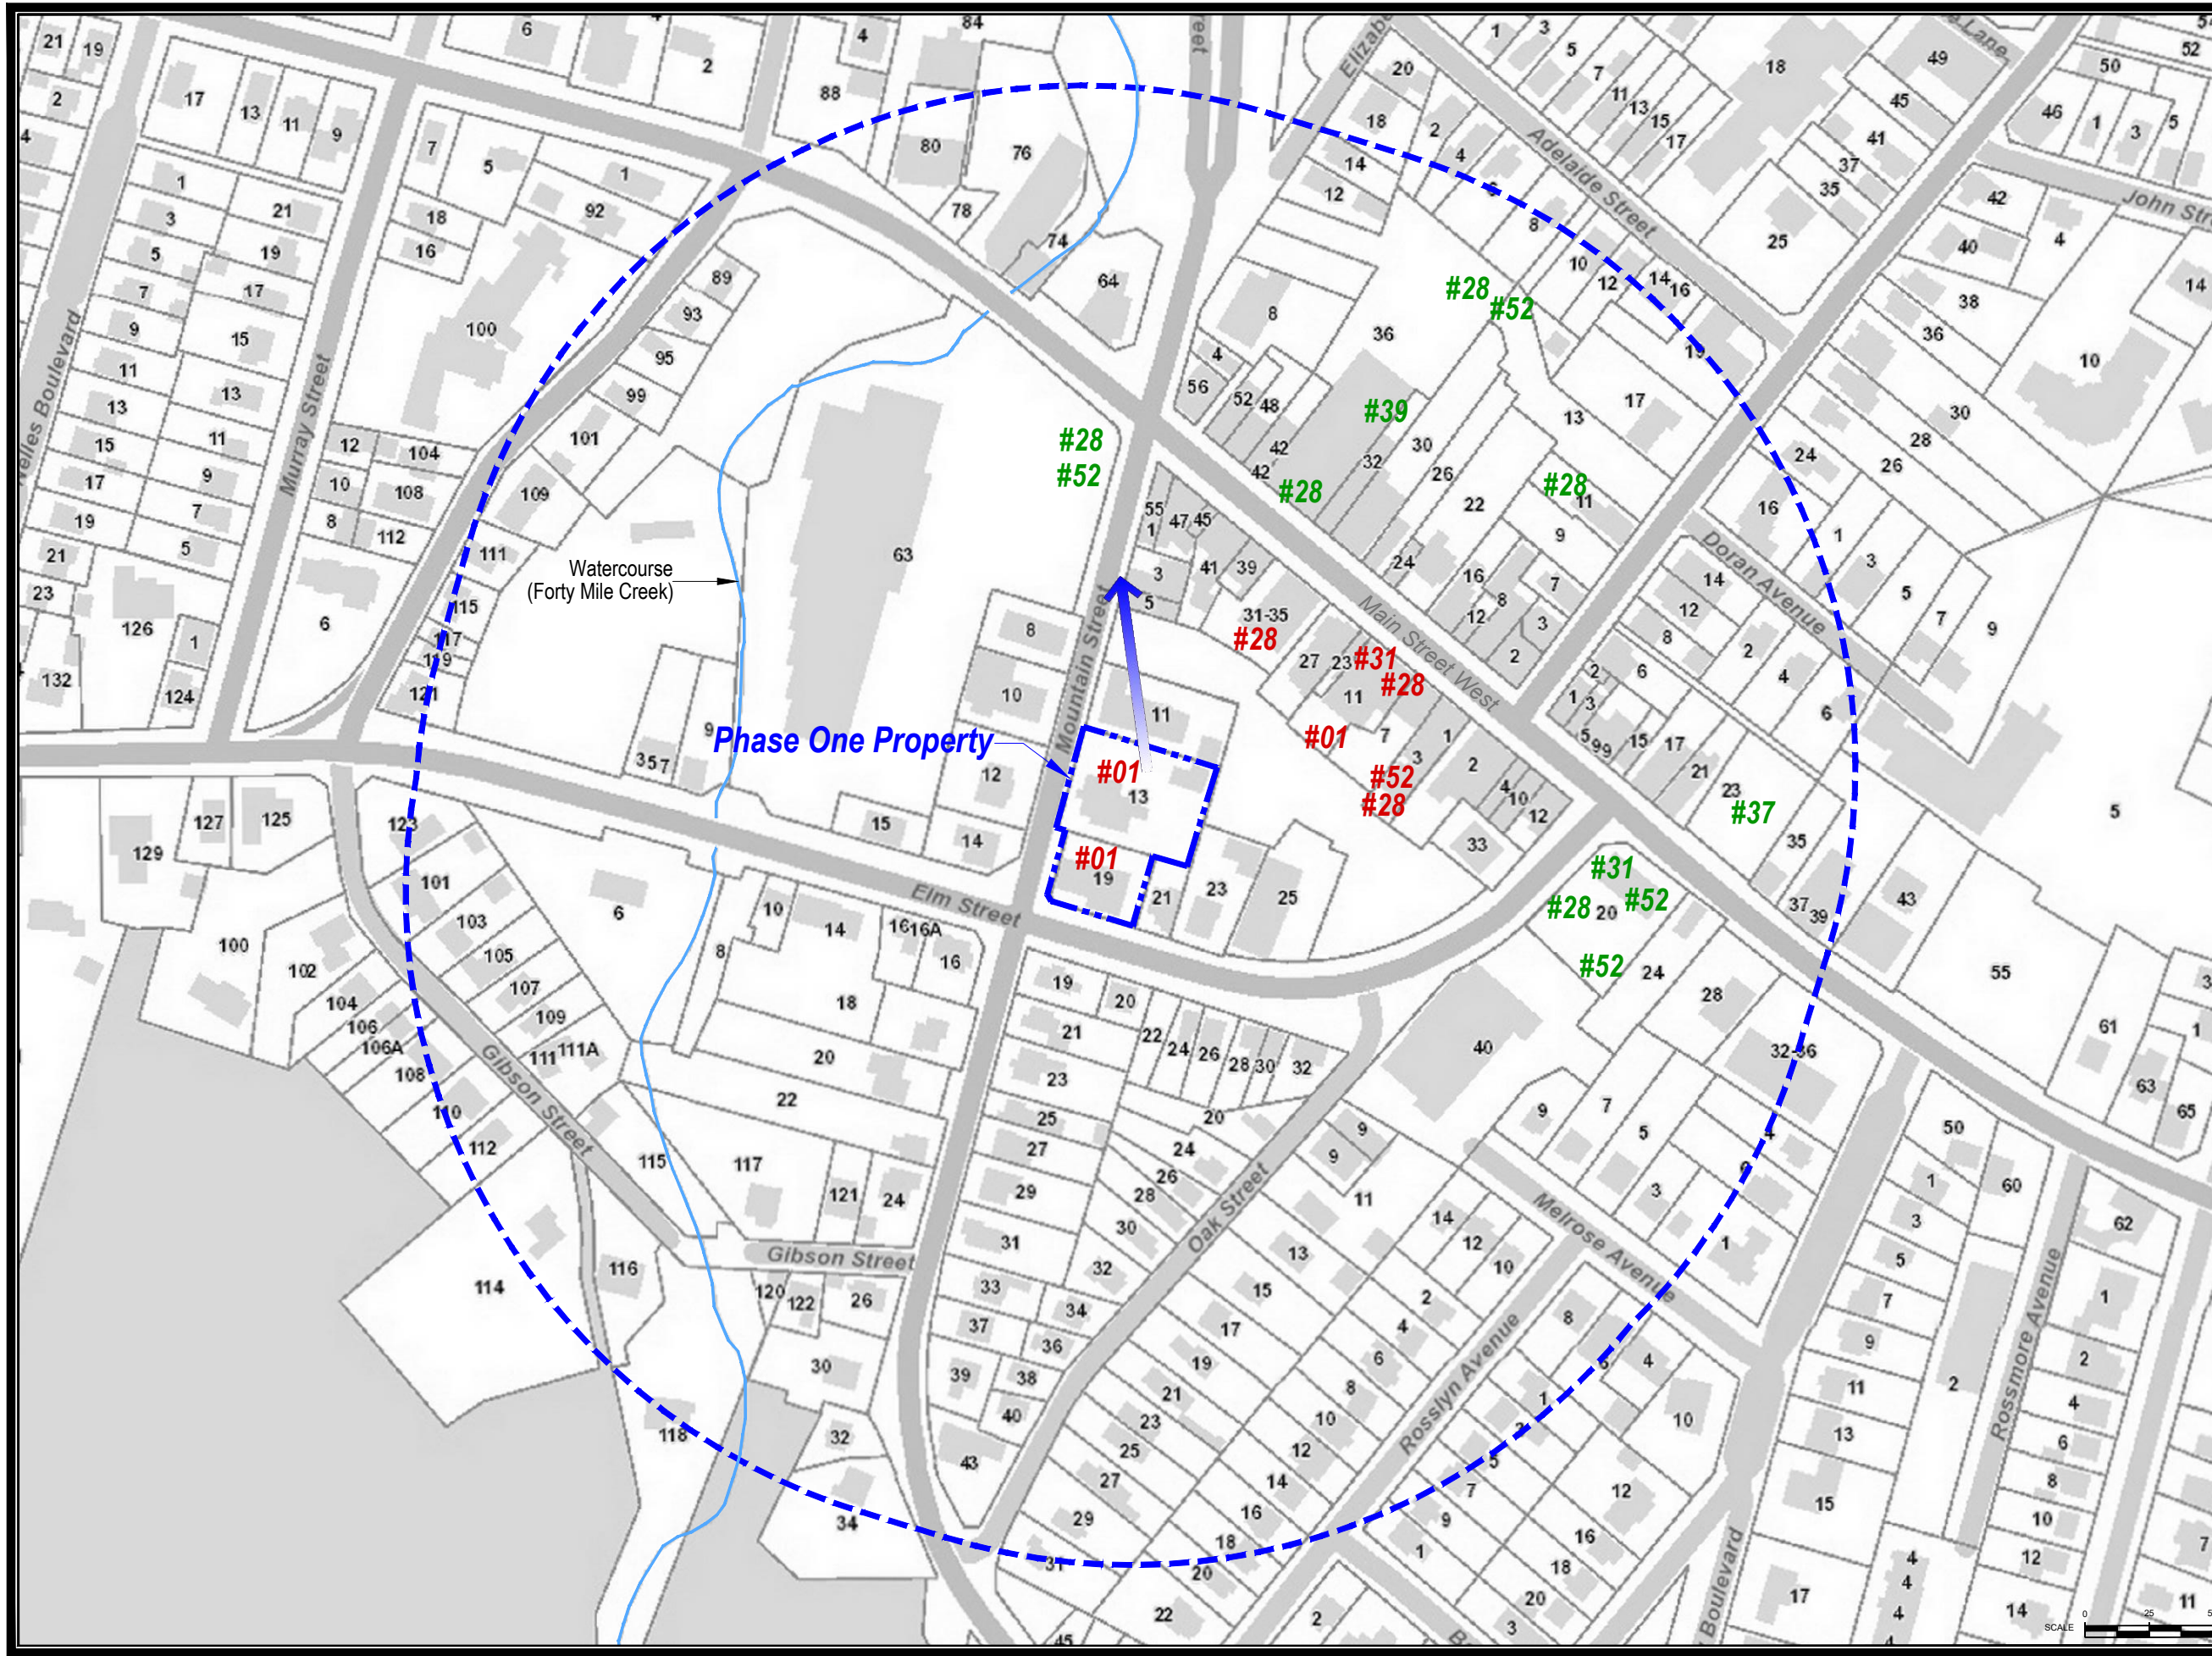
REV NO.: 0	FILE NO.: 7-18-0051-41
SCALE: AS SHOWN	FIGURE NO.: <b>5</b>
DATE: May 2018

The Phase One Environmental Site Assessment identified the following PCAs on the Property and within the Study Area. The locations of the PCAs are illustrated in Figure 5.

**FIGURE TITLE:**  
 POTENTIALLY CONTAMINATING ACTIVITIES

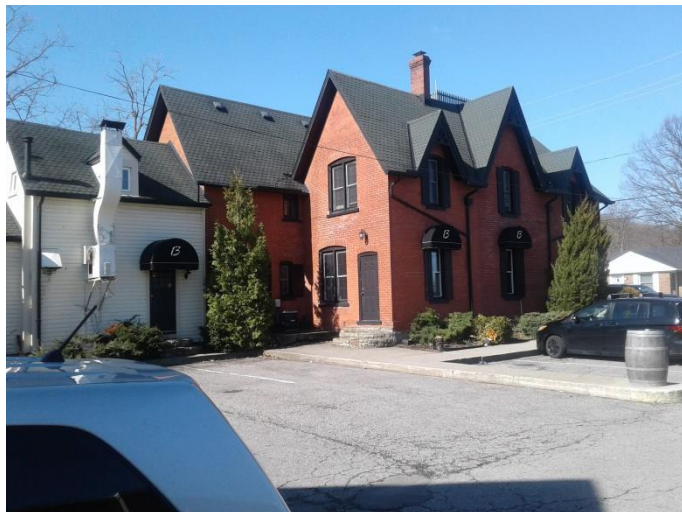
Photograph 1

Location: Phase One Property  
Viewing: Southwest  
Description: View of the restaurant located on the northern portion of the Property

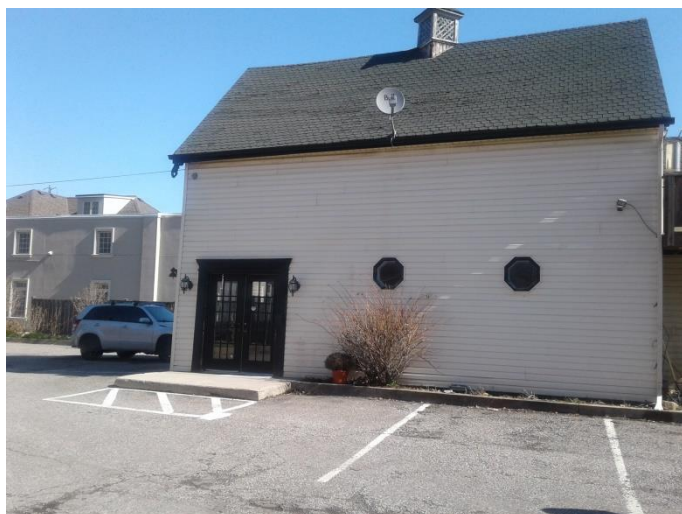
Photograph 2

Location: Phase One Property  
Viewing: North  
Description: View of the retail and residential building located on the northeast portion of the Property. This building was formerly used as a carriage house

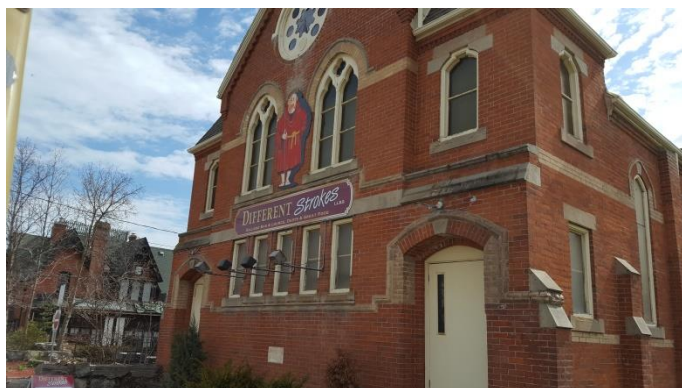
Photograph 3

Location: Phase One Property  
Viewing: Northeast  
Description: View of the former church that is currently occupied by a billiard hall; located on the northwest corner of the Property

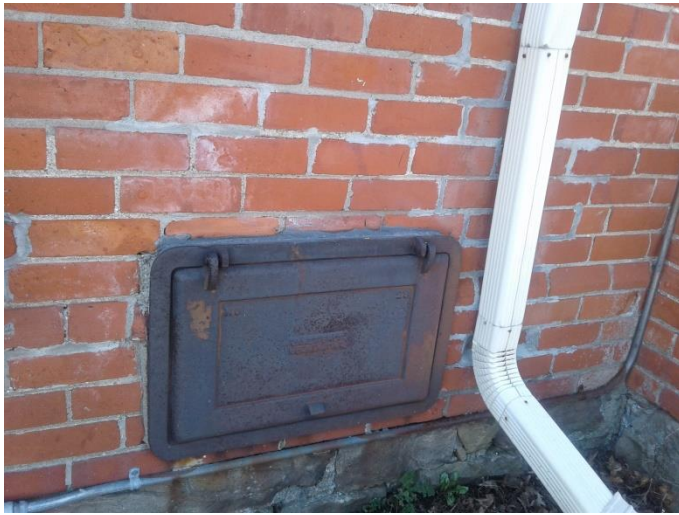
Photograph 4

Location: Phase One Property  
Viewing: South  
Description: View of a metal access hatch located along the north facing exterior wall of the building located at 19 Elm Street. The hatch is most likely a former coal chute

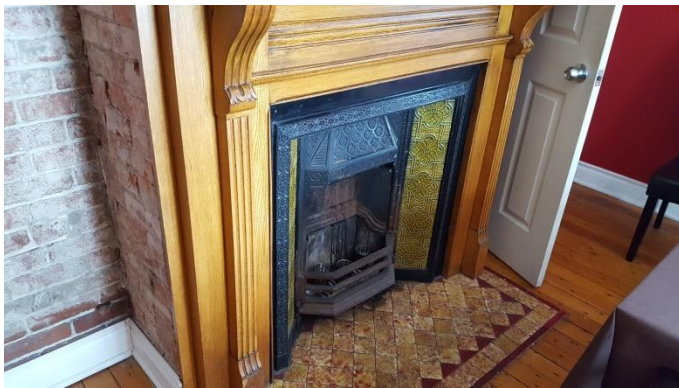
Photograph 5

Location: Phase One Property  
Viewing: Interior of 13 Mountain Street  
Description: View of a fire place, that was formerly used to burn coal, located in one of the upstairs private dining areas of the restaurant at 13 Mountain Street

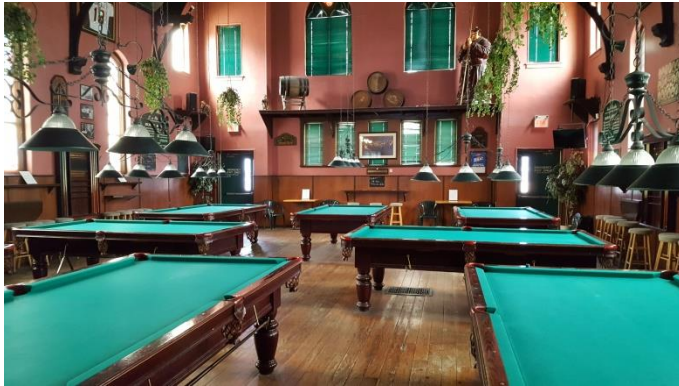
Photograph 7

Location: Phase One Property  
Viewing: North  
Description: View of the billiard hall located in the former church located at 19 Elm Street

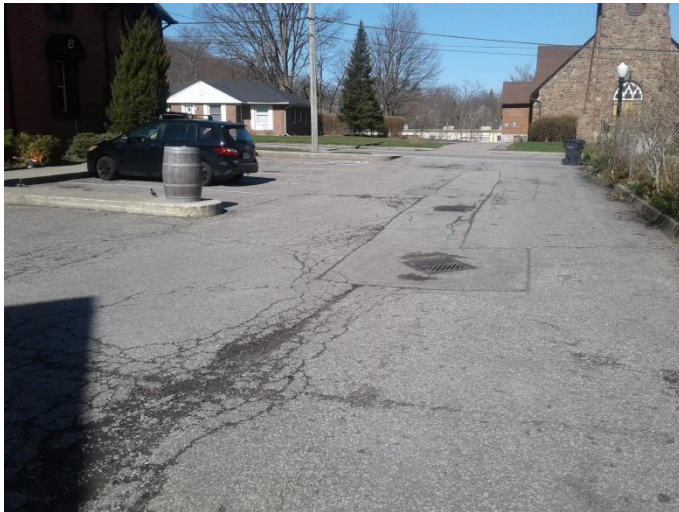
Photograph 8

Location: Phase One Property  
Viewing: West  
Description: View of the parking lot and driveway located on the northern portion of the Property

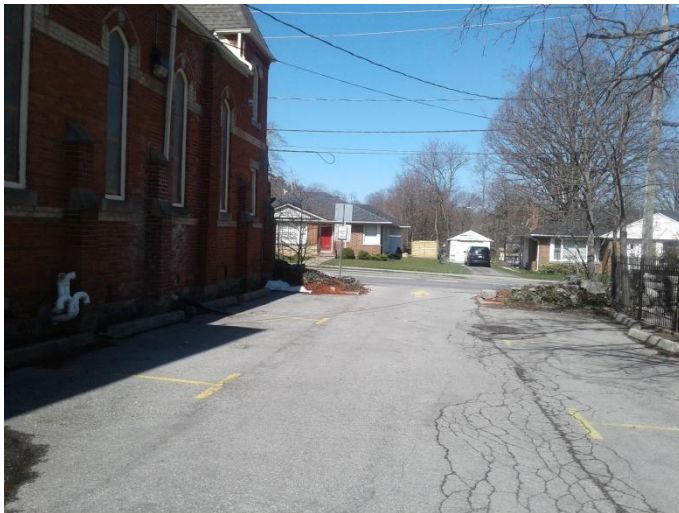
Photograph 9

Location: Phase One Property  
Viewing: West  
Description: View of the parking lot and driveway located on the central portion of the Property
