LAKE LAWN  
376 NELLES ROAD NORTH  
1846

**Building Evaluation Sheet**

**Name** Lake Lawn  
**Location** 376 NELLES ROAD NORTH

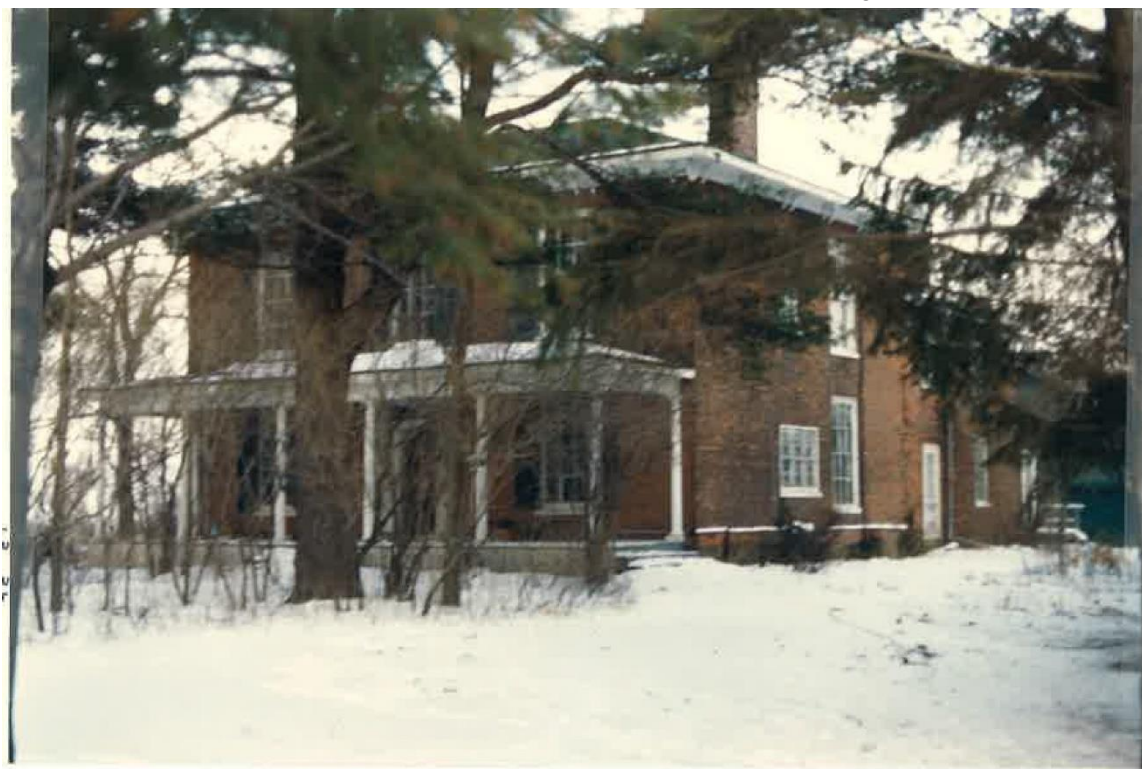
The house is located on 1.43 hectares (3.54ac) of land on the south-east corner of Lake Street and Nelles Road. The two storey brick house laid in a Common and Flemish Bond with stone foundation was originally a rectangular shape in plan but subsequent additions gave it an L-shape.

The low pitched hip roof is covered with asphalt shingles and has two inside end chimneys and a rear inside chimney. The roof trim, made up of a plain box cornice, frieze and soffit, has bracket pairings occurring at approximate four foot intervals.

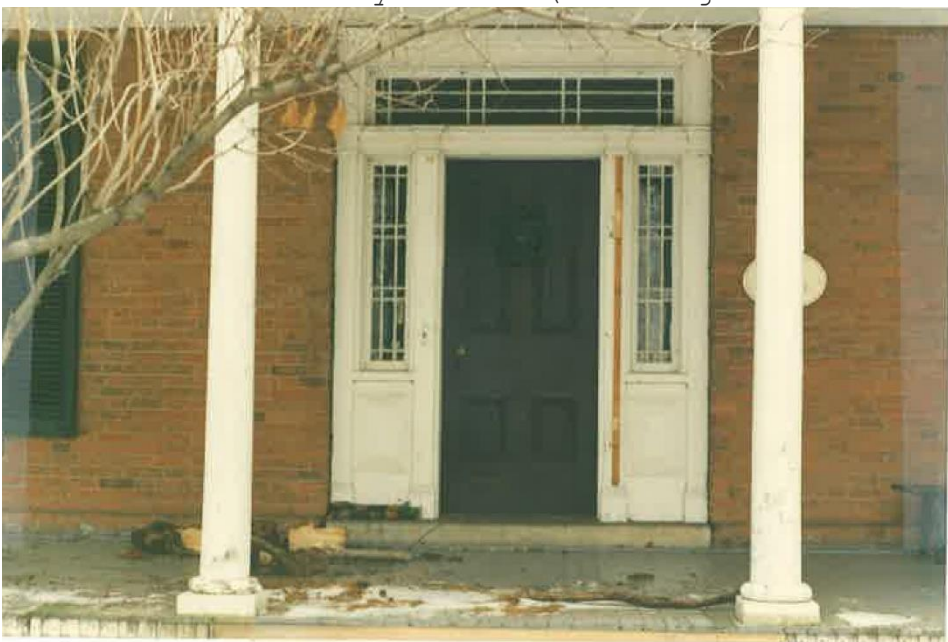
2.2 West Elevation

The front west elevation is symmetrical in shape with a three bay Flemish Bond facade. The double hung sash windows contain 12 panes and are covered by storm windows and are trimmed with flat arch brick work overhead and black louvered shutters on the sides. The main entrance is composed of a four panel single door, with a rectangular transom and side lights framed by paneled pilasters. A one tier, 5 bay, verandah covers the entranceway with a shed style roof (the original had a deck).

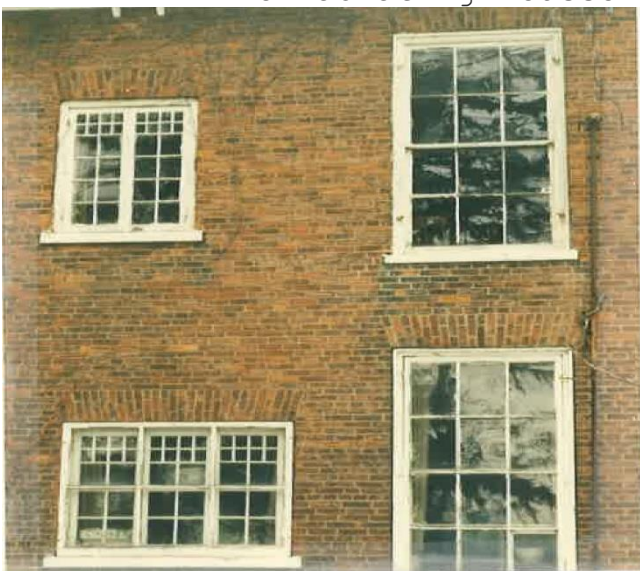
### 2.3 South Elevation

The south elevation is laid in Common Bond displaying five differently styled windows. The upper left window is of a double casement design with eight small panes over eight larger panes. The lower left window is square in shape with three double hung sash windows each 10 panes over 4. The upper right is rectangular shaped with double hung sash (6 over 6) as is the lower right. Below this is a small window for the basement. They all have a flat arch of radiating voussoirs.

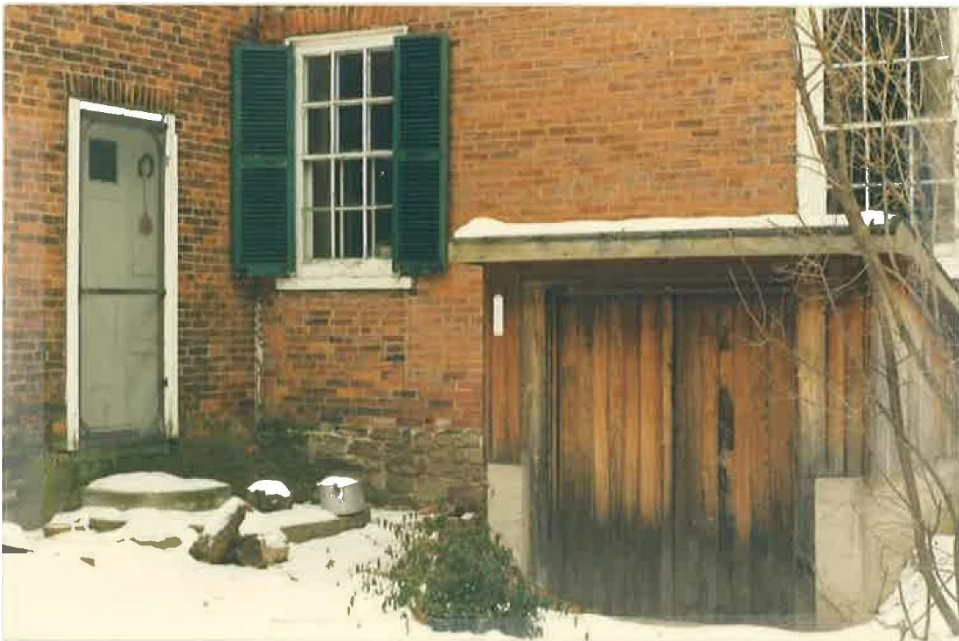
#### 2.4 East Elevation

The rear (east) elevation, half concealed by an addition, also displays a Common Bond facade with a variety of window styles. There are three rectangular double hung sash windows, 6 over 6. One, with louvered shutters, was originally the rear doorway. There is also a wooden cellar entrance with a cement foundation. This appears to be a replacement for what was originally a bulkhead type entrance.
