THE WHITE HOUSE  
159 HAIN STREET WEST  
CIRCA 1830

1.0 History

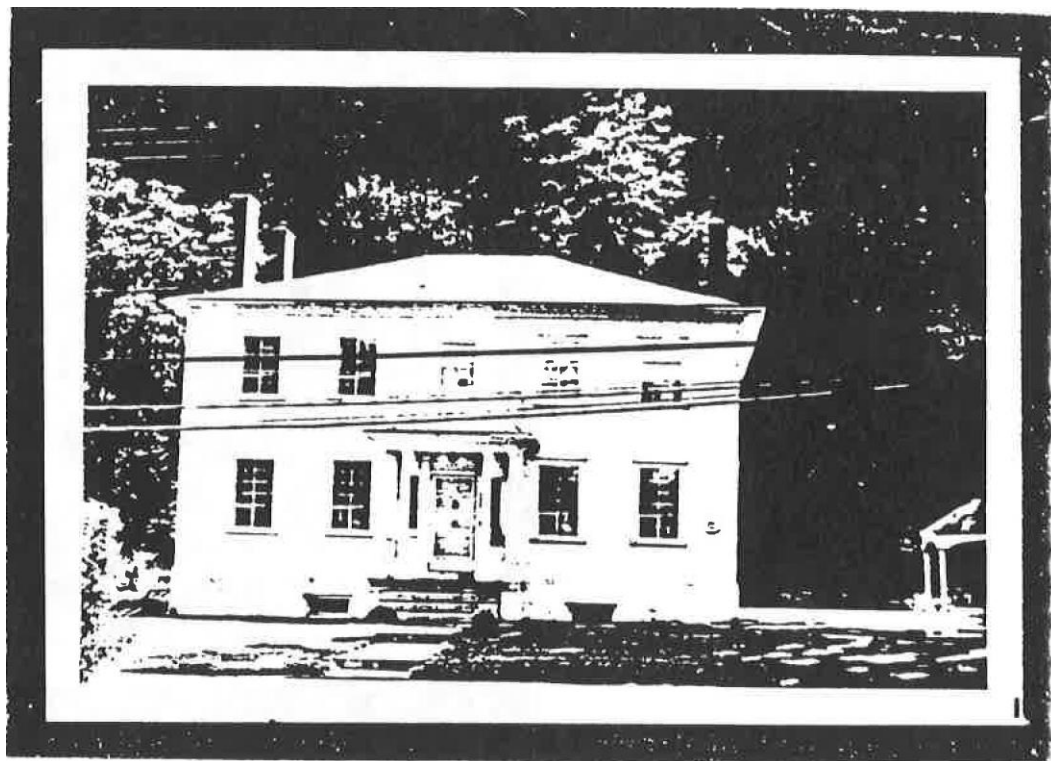
PHOTO 1    ORTH SIDE ELEVATION

DETAILING THE FACADE FROM  
MAIN STREET AND ROOF AND  
CHIMNEYS

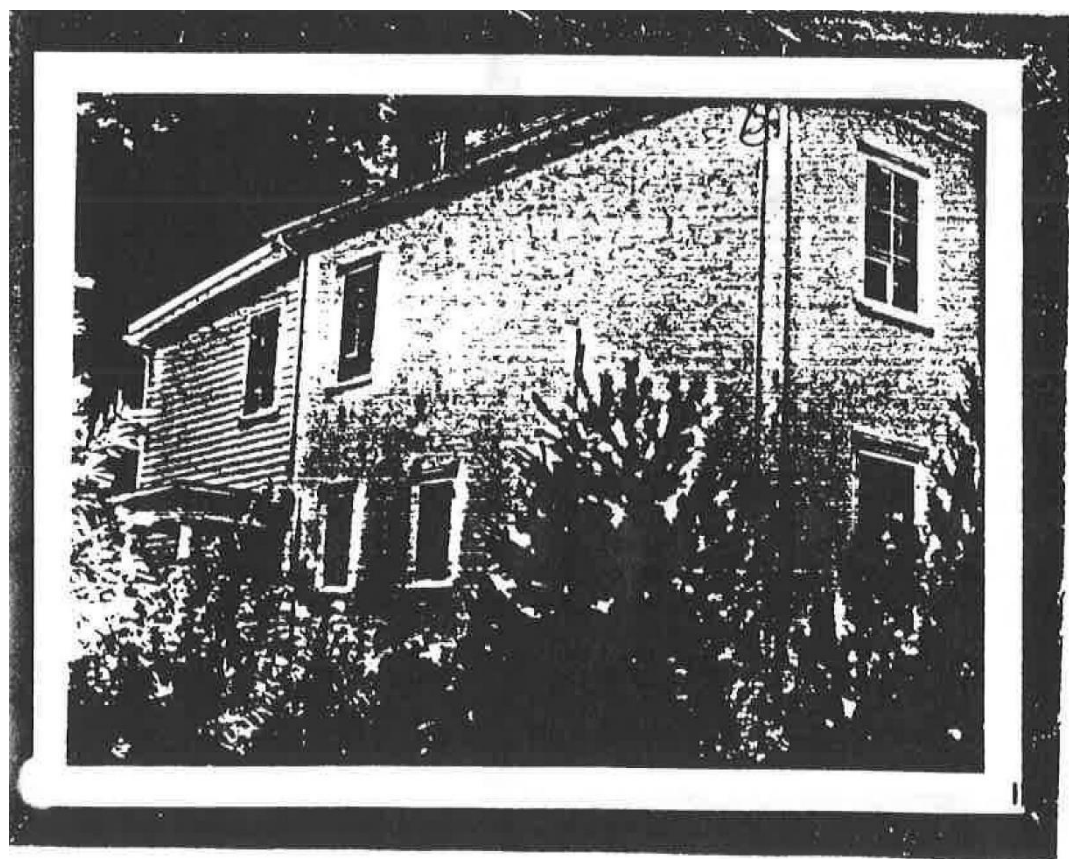
PHOTO 2

EAST SIDE ELEVATIO  
OF MAIN HOUSE AND  
EXTENSION

### 2.3 East Side Elevation Main Rouse/Extension (Refer to Photo 2)
